Long-term performance of the “Laguna de Barlovento” reservoir waterproofing using a PVC-P geomembrane

Blanco, M., Leiro, A., Soriano, J., Crespo, M.A., Zornberg, J.G., Aguiar, E., Rico, G., and Pargada, L. (2012). “Long-term Performance of the “Laguna de Barlovento” Reservoir Waterproofing using a PVC-P Geomembrane.” *Fifth European Geosynthetics Conference, EuroGeo5*, 16-19 September, Valencia, Spain, pp. 55-63.

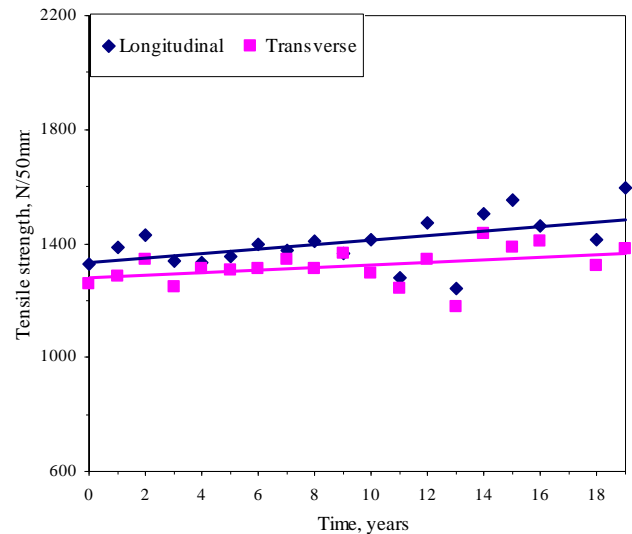
Tensile strength results and elongation at maximum load values are showed in Figures 3 and 4 respectively. Neither the elongation at break nor the tensile strength results did present significant changes over the 19 years of service. Exposure to weathering only led to a slight increase in tensile strength values, as shown in Fig. 3. The mechanical response of the reinforced geomembrane is dominated by the fabric scrim. The good mechanical response is attributed to the good response to degradation of the resin of the geomembrane. Ac-

Figure 3. Tensile strength evolution over time.

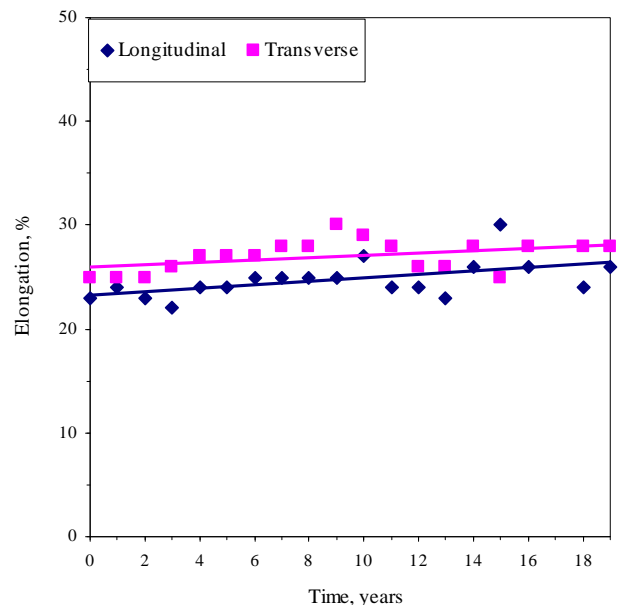
Figure 4. Elongation at maximum load evolution over time.

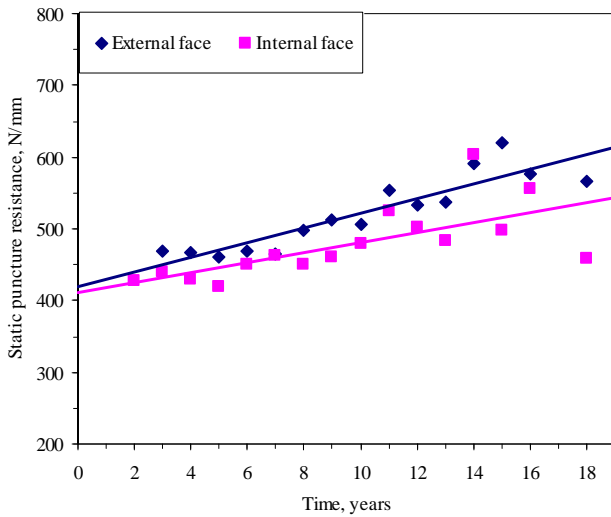
The results of puncture resistance tests are presented in Figures 5 and 6, which show the variation of resistance to static puncture and the displacement of the plunger before perforation, respectively. Puncture resistance values are observed to increase over time, while displacement of the plunger before perforation values decrease. These displacement values are comparatively small because of the presence of the Polyester reinforcement.

Figure 5. Changes in puncture resistance with time.

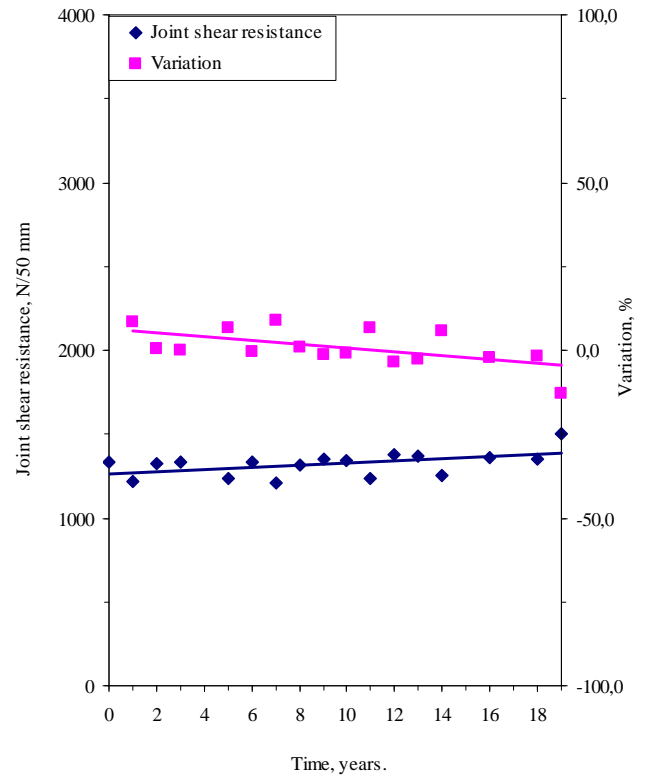
Figure 7. Changes in welding strength with time (weldings conducted on site).

Test results are presented in Figures 7 and 8, which show similar trends for the seams made in the manufacturing facility and those made on site. These results indicate that the quality of the geomembrane installation was good. Figure 9 shows the test results obtained when testing the seams following the peeling procedure. The test results are comparatively high, also verifying the good execution of the seams.

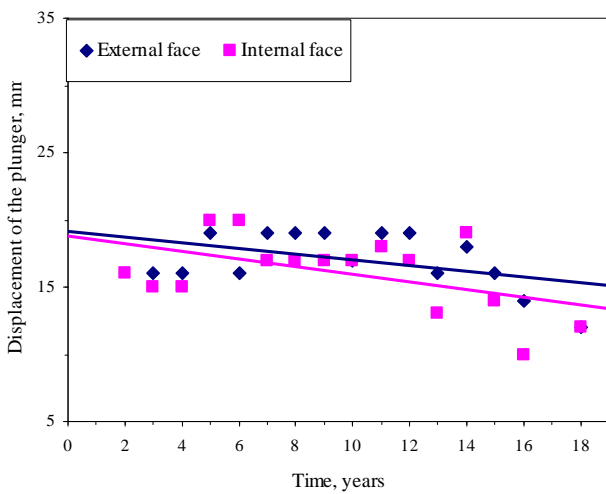
Figure 6. Changes in the measured displacement of the plunger (puncture tests) with time.

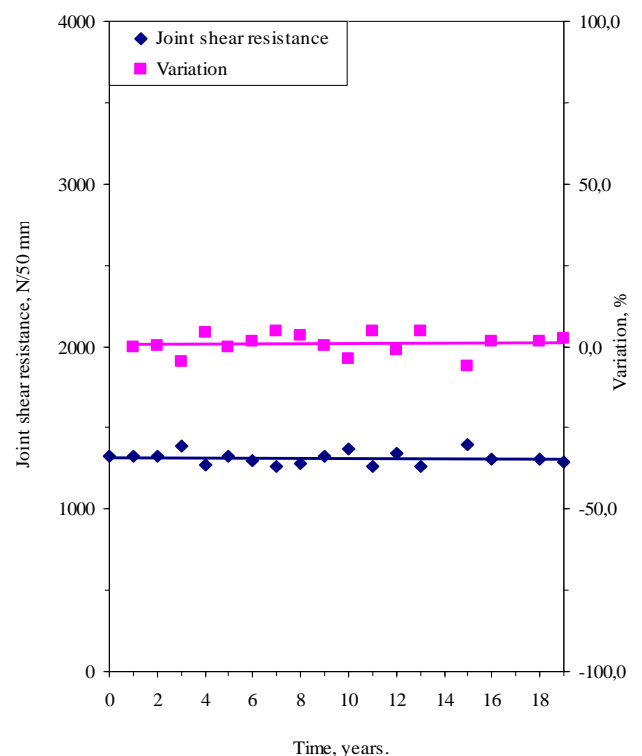
Figure 8. Changes in welding strength with time (weldings conducted in the manufacturing facility).

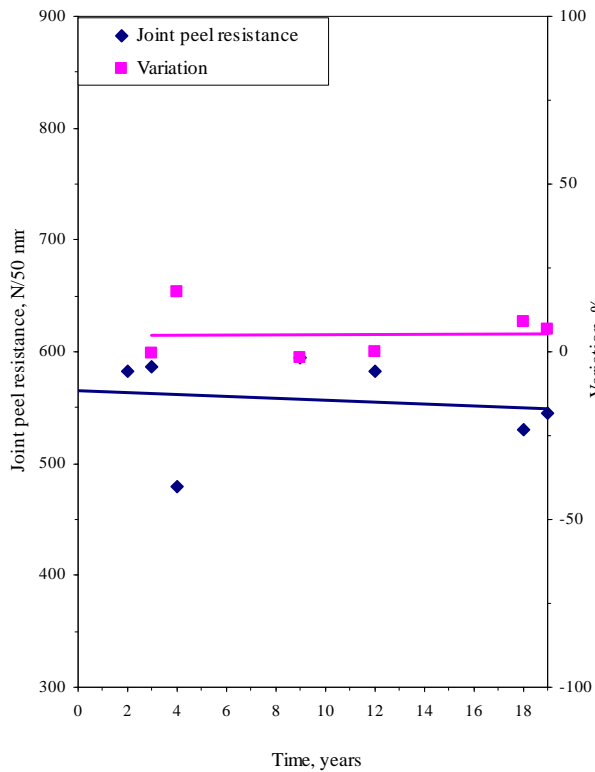
Figure 9. Changes in peeling strength with time of the weldings conducted on site.

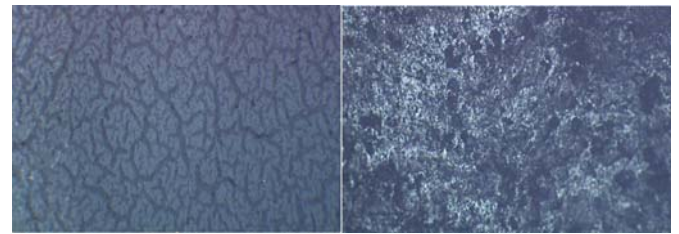
Optical microscopy results revealed a comparatively high density of superficial cracking on the exposed side of the geomembrane. On the other hand, good condition was consistently observed on the non-exposed side of the geomembrane. The results obtained using scanning electron microscopy confirmed these observations.

Figure 10 shows the exposed and non-exposed sides of the geomembrane using 60 x magnification, as obtained by reflection optical microscopy. Figure 11 also shows the two sides of the geomembrane using 90 x magnification, as obtained by scanning electron microscopy. The images shown in these figures were obtained using specimens collected 19 years after the geomembrane installation.

Figure 10. Microphotographs of the PVC-P geomembrane obtained using ROM (x 60): (a) Exposed side; (b) Non-exposed side.

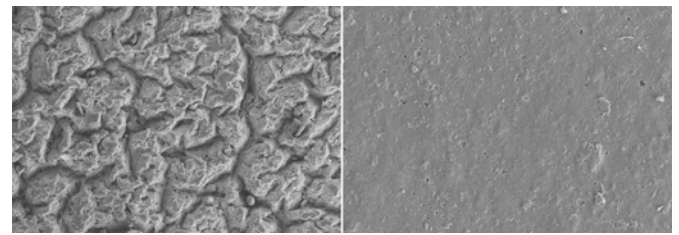
Figure 11. Microphotographs of the PVC-P geomembrane, obtained using SEM (x 90): (a) Exposed side; (b) Non-exposed side.

Results from reflection optical microscopy as well as scanning electron microscopy showed, after 19 years of installed, noticeable cracking on the exposed side of the geomembrane samples while the non-exposed side remained in good conditions.

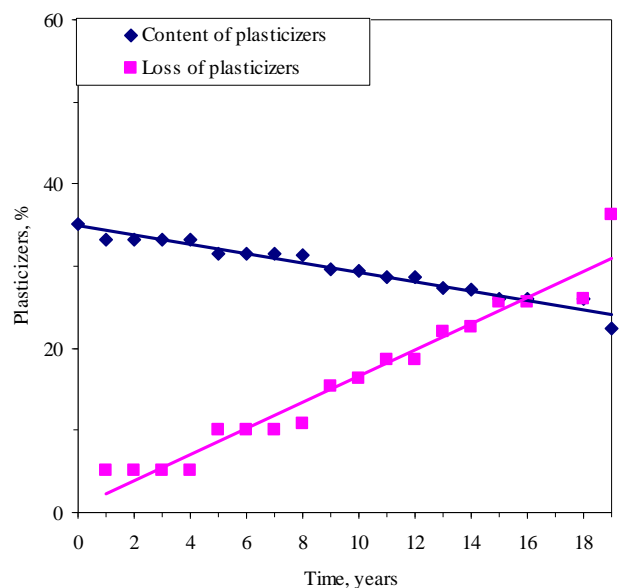
The plasticizer content in the original geomembrane was determined to be 35.1%. Figure 12 shows the changes in plasticizer content (and quantification of its loss) with time. The results are presented in relation to the original value, over 19 years of the geomembrane. The results indicate a plasticizer loss of less than 40% over this period, which is considered an excellent performance for an exposed geomembrane.

Figure 12. Content and loss of plasticizers evolution over time.
