Report No. CDOT-DTD-R-2001-6

# **Results and Recommendations of Forensic Investigation of Three Full-Scale GRS Abutment and Piers in Denver, Colorado**

**COLORADO DEPARTMENT OF TRANSPORTATION  
RESEARCH BRANCH**

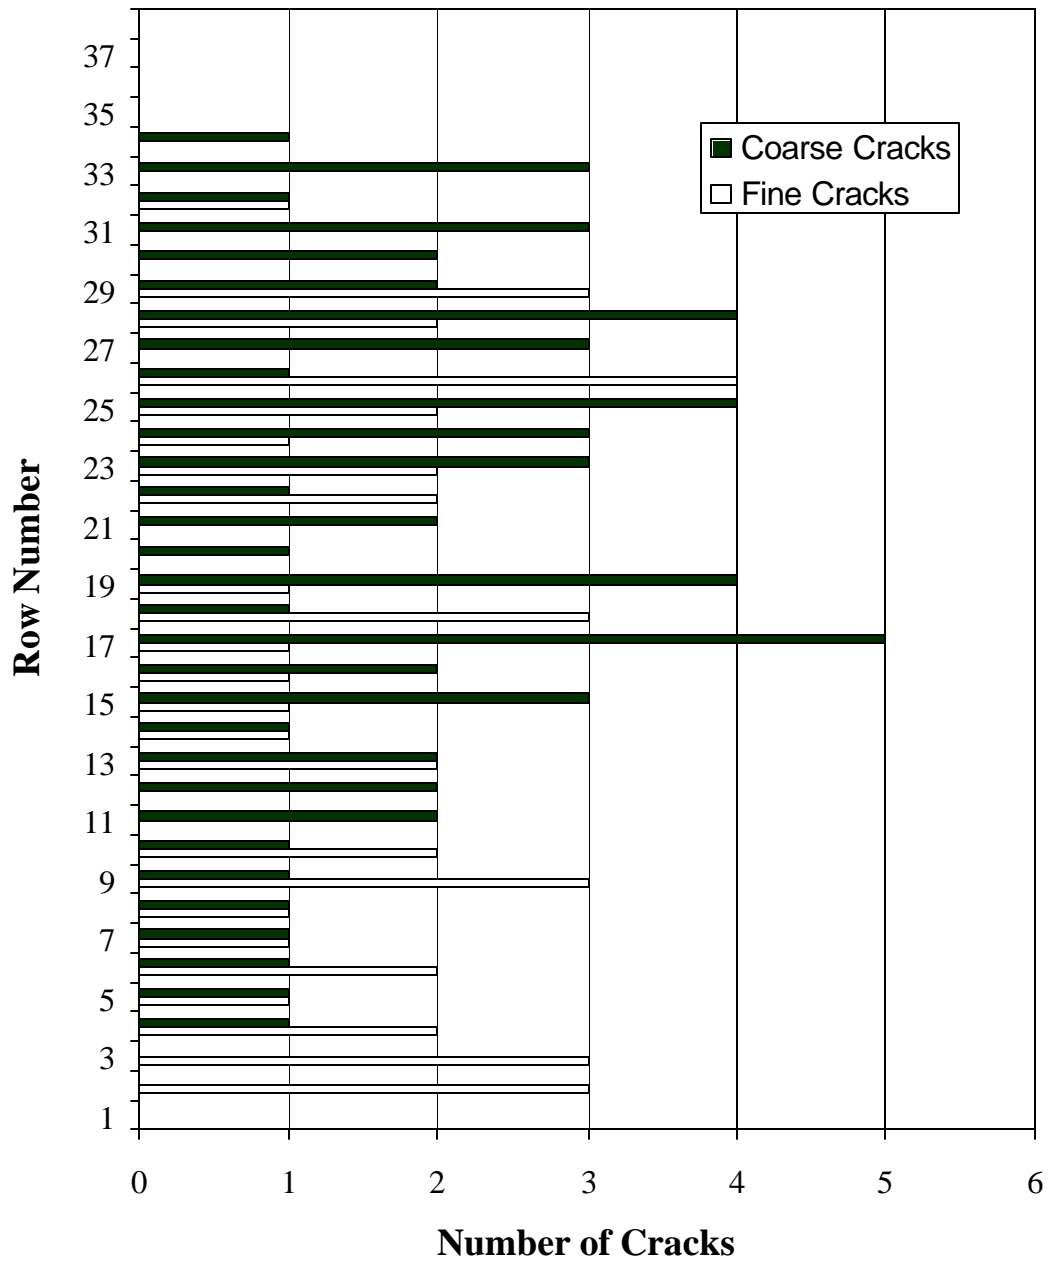
**Figure 6 Density of Cracking along the East Face of the Outer Pier**

The outer pier had 38 rows, numbered from 1 at the bottom to 38 at the top. Scaffolding was placed next to the east face of the outer pier structure enabling complete examination of the 3 m wide face. The numbers of fine cracks up to 1 mm in width and coarse cracks up to 5 mm in width in each row are shown in Figure 6. Cracks were typically aligned with joints in the layers above and below the cracked block (Photos 5, 6, and 7). When a block cracked, the crack would often follow the joints between blocks and cause other blocks to crack. The middle zone, between layer 11 and 34, was heavily cracked, the lower zone was cracked to a lesser degree, and no cracking was noticed in the upper 4 layers. The vertical joints opened up as the blocks moved in the direction perpendicular to the facing. The number of opened joints in each row is shown in Figure 7. The construction of the pier facing targeted a uniform positive batter of 5% from the vertical line (see Figures 1 and 8). It was assumed that each constructed row was placed with a setback of 10 mm (corresponding to a 5% positive batter) from the row below. The current facing out-of-vertical alignment shown in Figure 8 was determined from measurements of distances between the bottom edge of each row and the top edge of the row below. The targeted batter and current out-of-vertical alignments were employed to estimate the outward displacement of each block layer assuming that the leveling pad did not experience any outward

Different types of blocks were used in the construction of the three Havana Yard Structures (Figures 3 to 5). There were few cracks visible in the external face of the abutment before the dismantling began, but during dismantling, a fairly large percentage – as high as 50% – of the blocks in some layers was broken. On most of the levels, most of the broken blocks were on the side where the surcharge load was applied (Figure 1). There were no visible cracks in the external face of the center pier (the pier that was not surcharge loaded) and no internally broken blocks were found during the dismantling operations. The facing of the outer pier (see Photo 5 and 6) was severely damaged, as was observed in the cracking of the external face (Figure 6) and

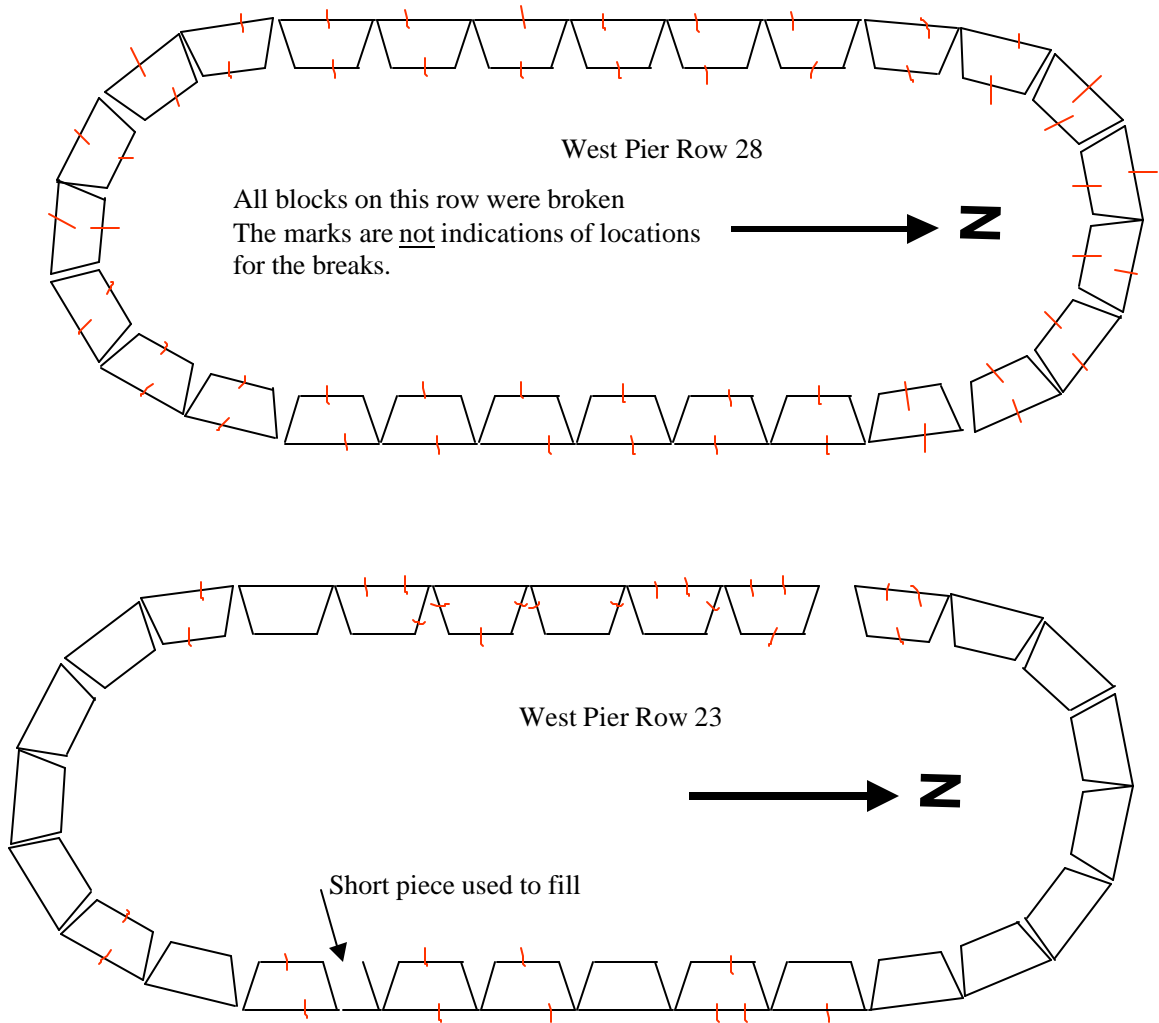
**Figure 11 Mapping Results for the Blocks' Breaks in the Upper Zone of the Outer Pier**  
 (Note: Marks indicate the broken sides, not location of the breaks)

No damage was noticed for the internal sides of the upper four block layers (rows 35 to 38), but all other layers had broken blocks. In rows 33 and 34, the blocks were broken into several pieces. As the dismantling progressed, it became apparent that many of the blocks that appeared from the outside to be whole were also broken. Typical mapping results for the blocks' breaks at different levels in the pier structure are shown in Figures 11, 12, and 13. Note that the marks indicate the broken sides, not exact location of the breaks. From layer 32 down to 30 all of the blocks were broken (~ 27 blocks per layer). In rows 29 through 27 there were only five unbroken blocks. On row 27, all blocks were broken, on row 26 there were two unbroken blocks, on row 25 there were 7 unbroken blocks, and on row 24 there were 5 unbroken blocks. For the entire pier, more blocks on the straight sides of a given layer were broken than in the curves at the ends of the layer (Figure 11 to 13). Most of the unbroken blocks were either on the curves or at the end of the straight sides of the pier (see Figures 11 to 13). From rows 32 to 24, there were almost no unbroken blocks in the straight part of the pier. It is also clear from the mapping results that the lower layers had more unbroken blocks. The breaks in all of the blocks were nearly vertical from the top to the bottom of the block; no intersection of one break with another was observed. Most broken blocks had at least two breaks. Most blocks had only one break per side and most breaks were near a corner, although multiple breaks in a side and breaks near the centers of the faces were found. While many of the blocks were broken in several places, none was shattered.

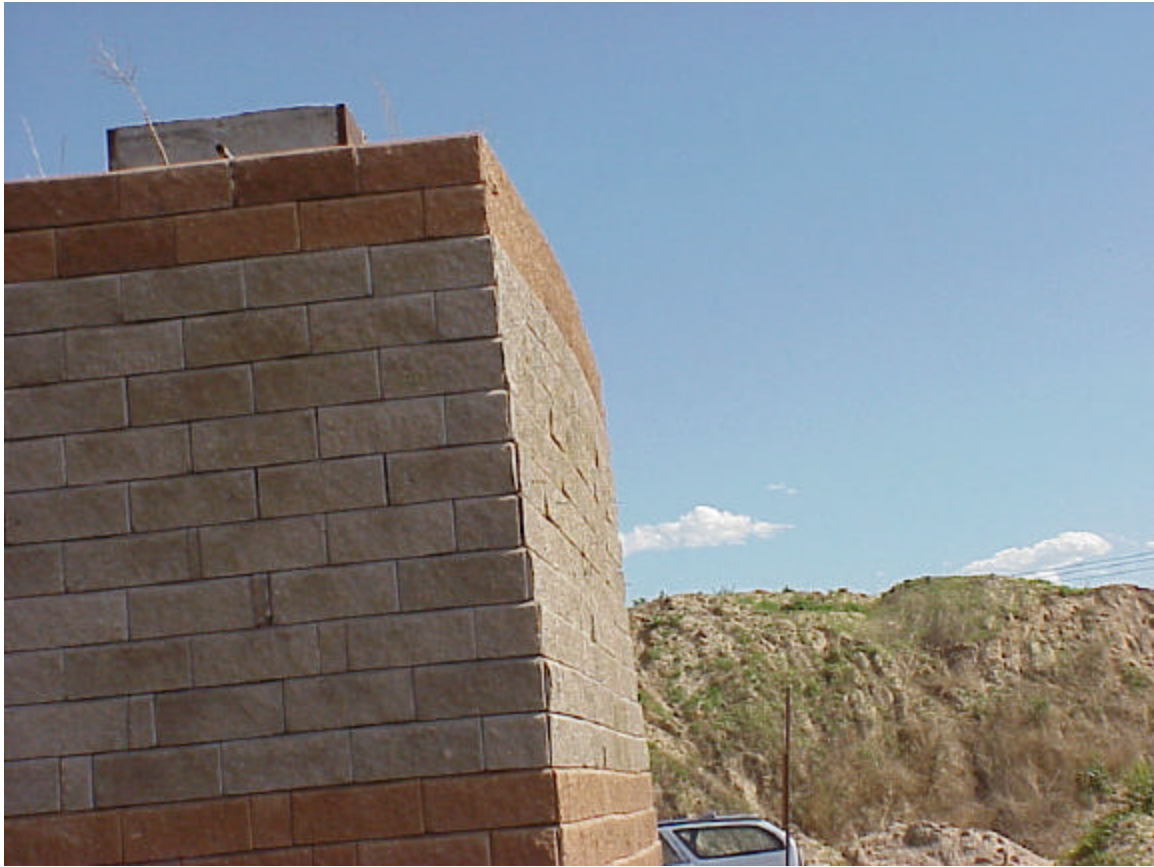
**Photo 4. The Center Pier Structure. Note the outward bow of the top several rows of blocks.**

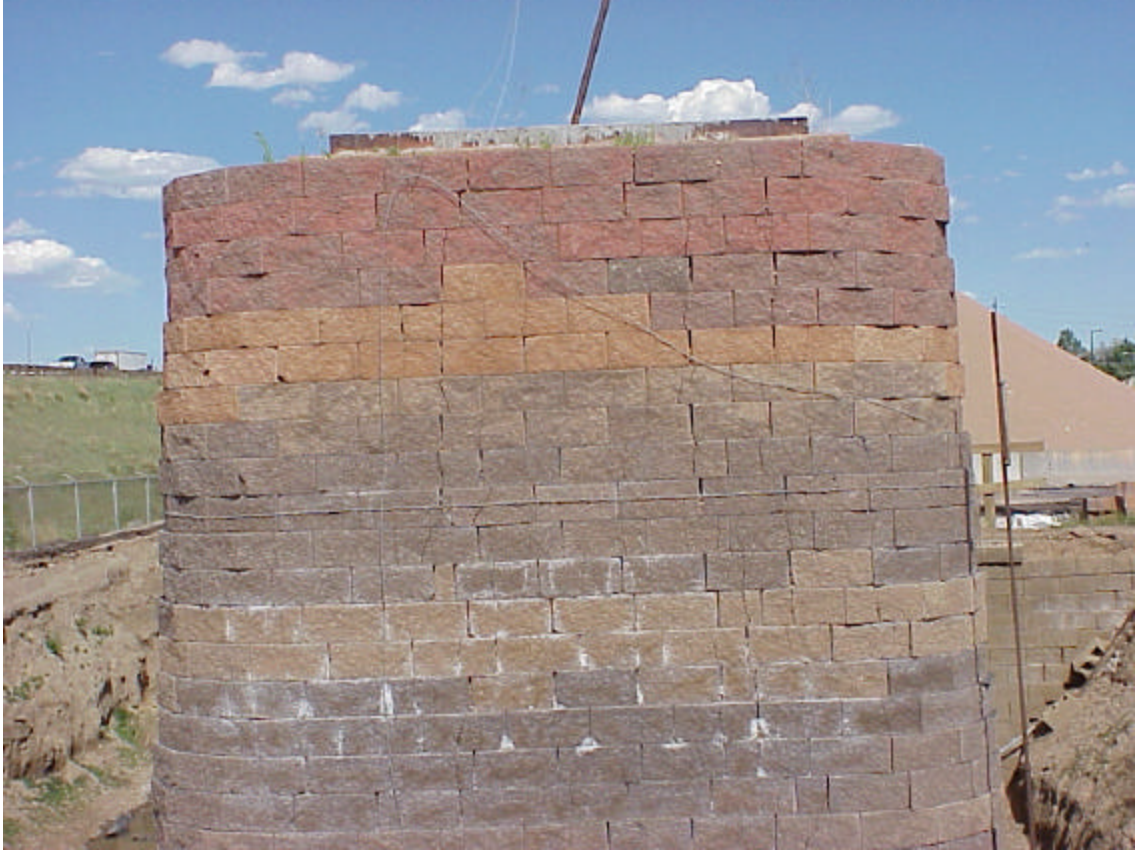
**Photo 5. The Outer Pier Structure.**

Since the blocks of the outer pier structure were severely cracked and the upper four rows showed significant movements (see Photos 5, 6 and 7), the external and internal conditions of blocks were thoroughly examined. The results of this examination are presented in the following subsections.

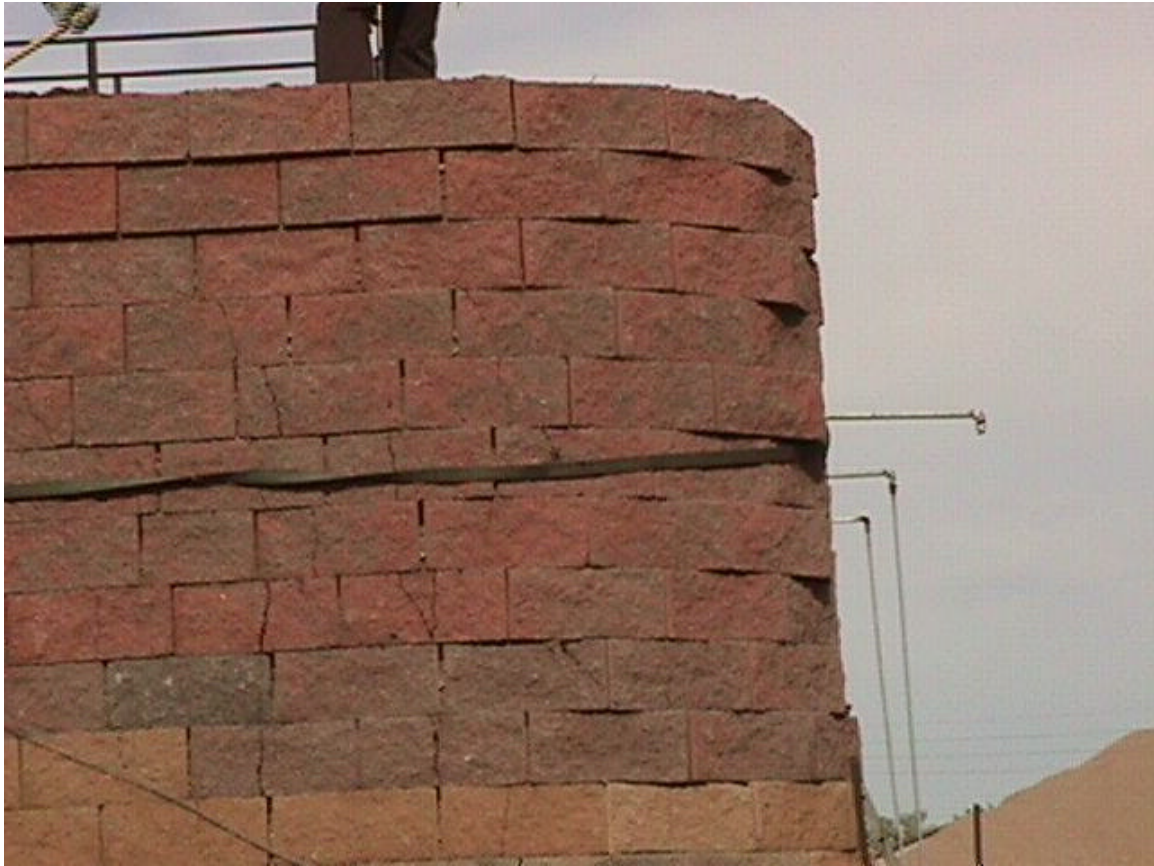
**Photo 6. Excessive Movements of the Top Rows of Blocks on the Outer Pier.**

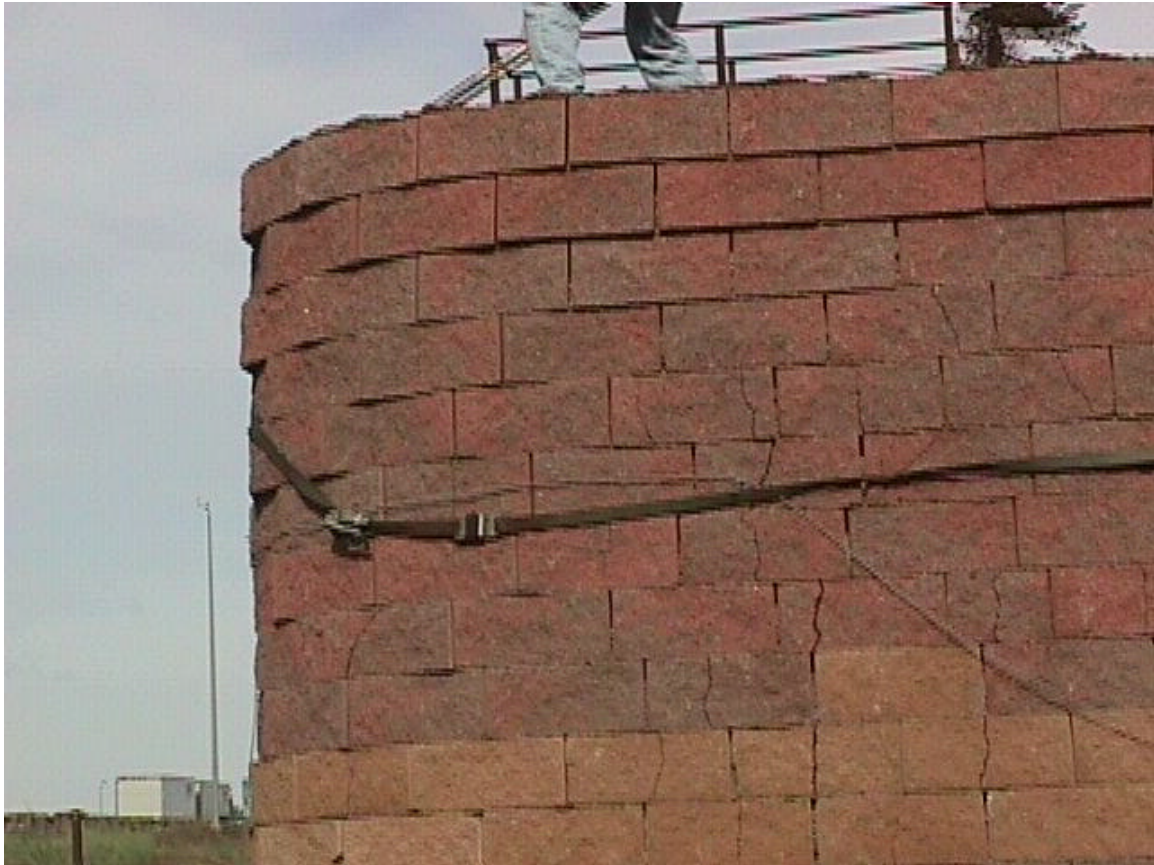
**Photo 7. Excessive Cracking of the Facing of the Outer Pier Note that all cracks are vertical and they are aligned with joints in layers below or above the cracked blocks.**

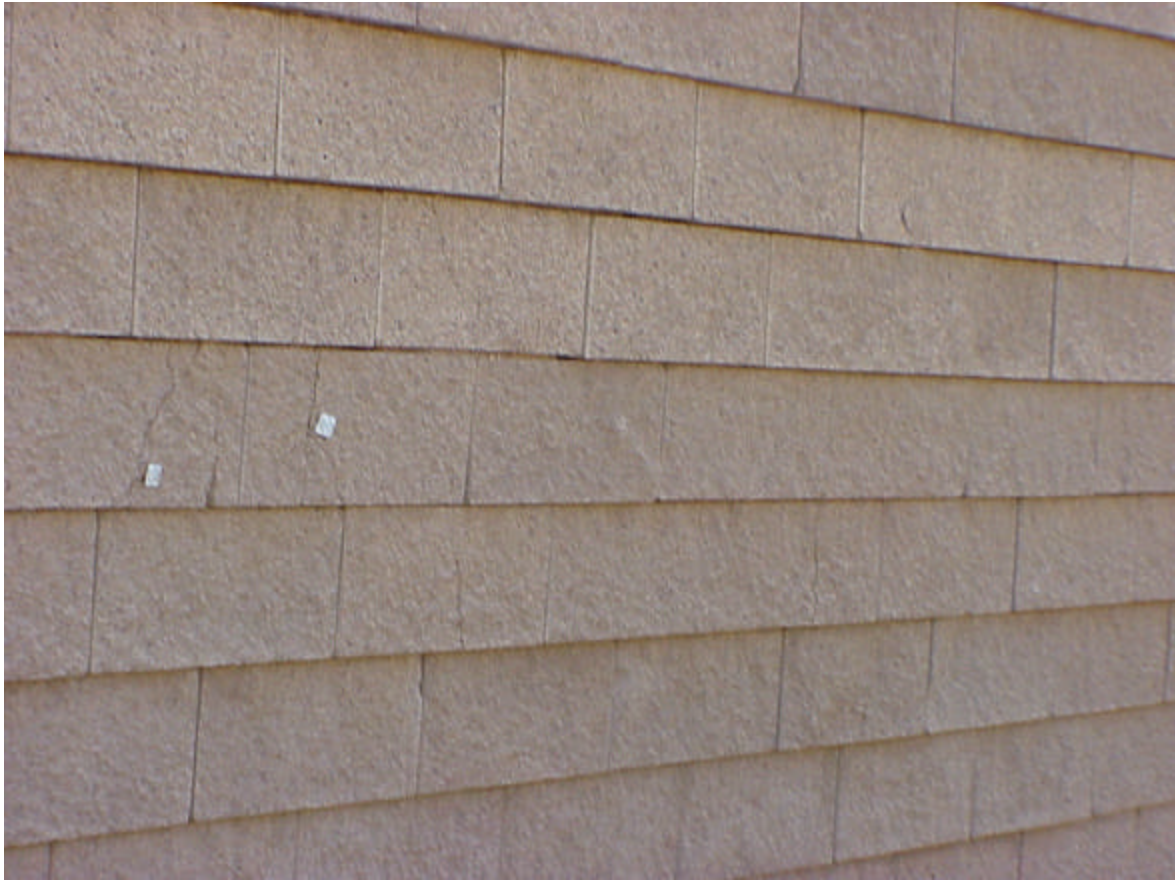
**Photo 8. Cracks in the Lower Part of the Abutment.**

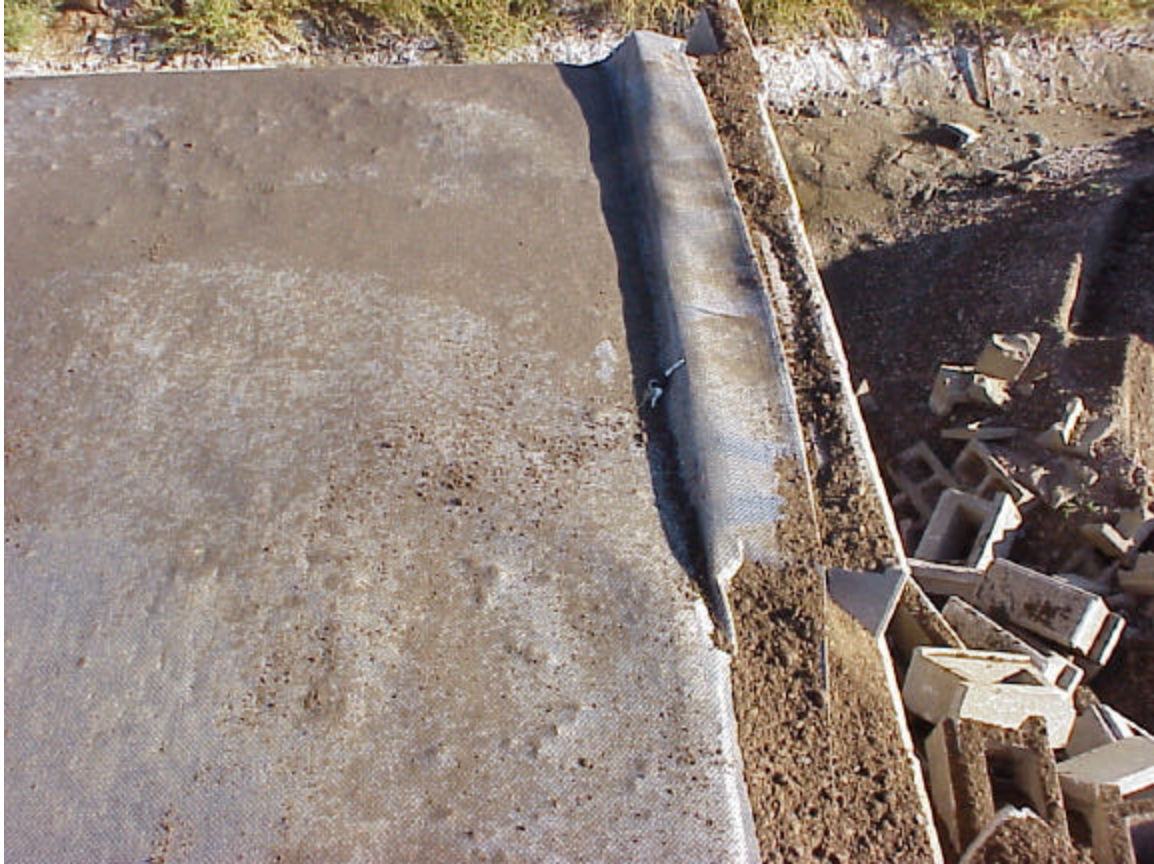
The reinforcement buried in the Havana Yard Structures for three years was a woven polypropylene geotextile designated as Amoco 2044 (Photo 11, 13 and 14 of Appendix A). All collected geotextile sheets were in excellent condition, showing no obvious signs of geotextile distress (e.g., tears or cuts). The survivability and durability of the exhumed geotextiles were evaluated by comparing the measured wide-width tensile strength of the exhumed samples with the strength of the fresh new geotextile samples. The findings were:

**Photo 11. Geotextile Sheet During Dismantling of the Inner Pier. No damage to any of the fabric sheets was observed in any of the structures even at locations where the fill had settled considerably.**

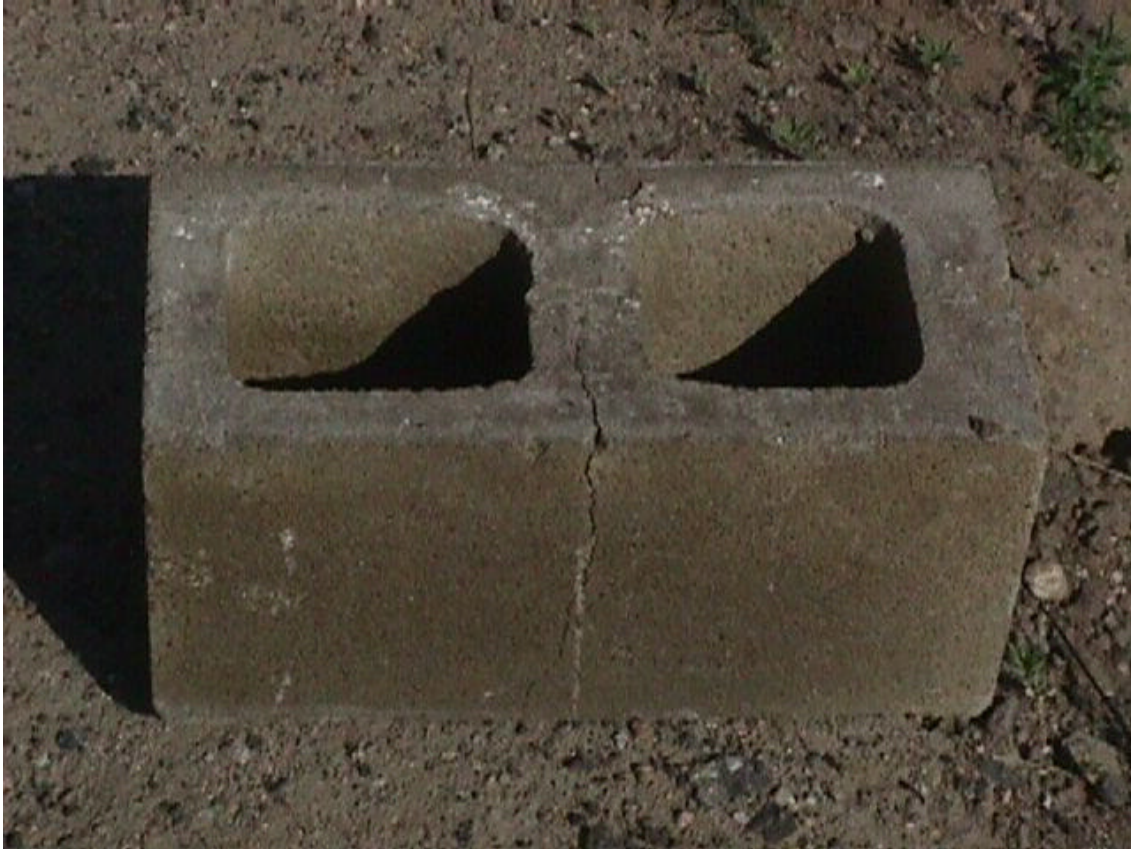
**Photo 12. A Vertical Crack in a Block from the Abutment Structure.**

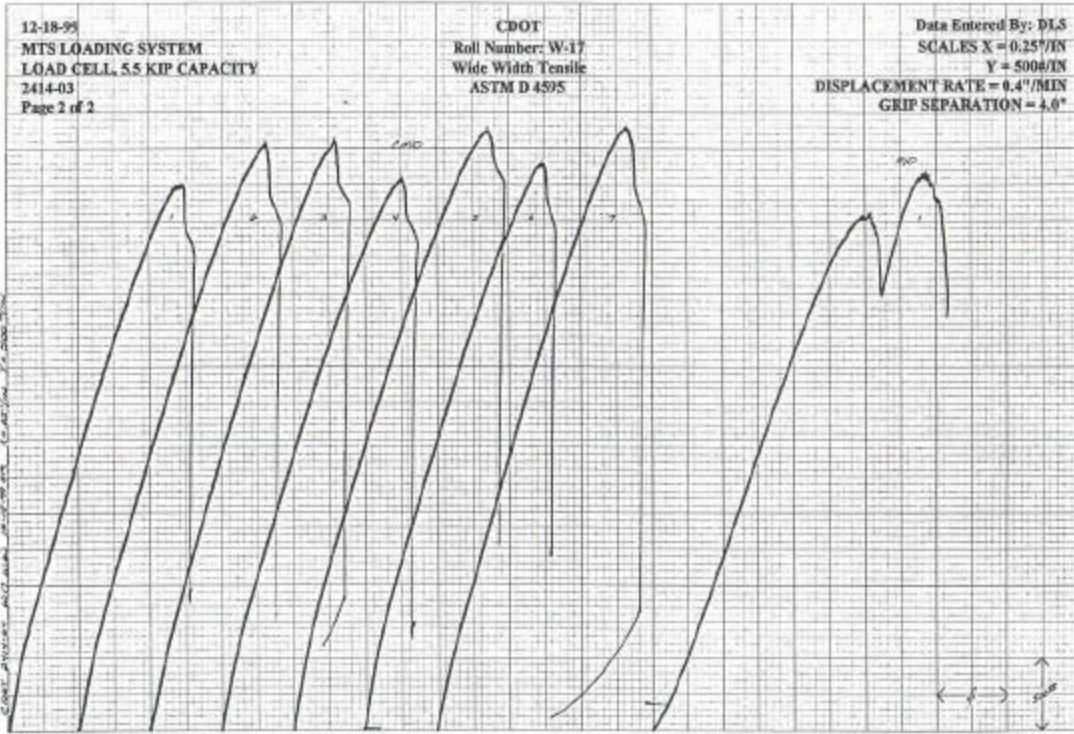
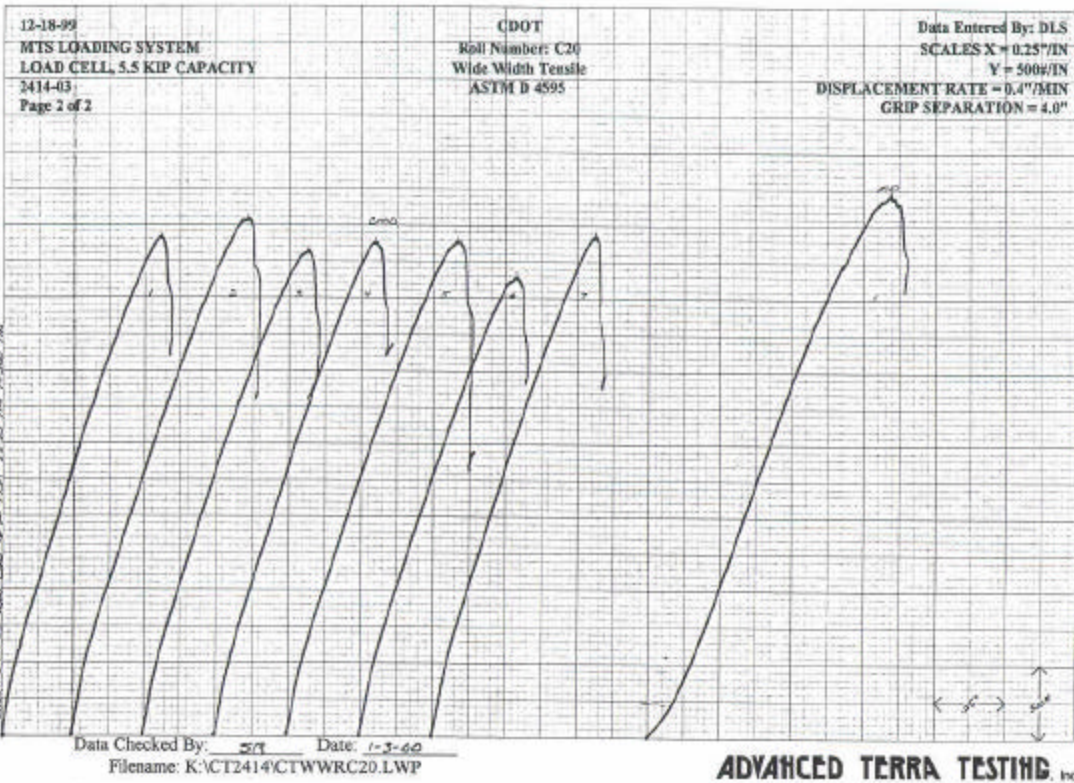
Typical observed responses during testing of sheets W17 and C20 (8 specimens of each sheet) are shown in Photo 17. It was noted that at a point of rupture, the majority of the specimens tended to break violently on one side or the other, resulting in a single peak graph (see Photo 17). In a few instances, rupture initiated near the center of the specimen and radiated outward, resulting in a dual peak graph, and somewhat lower ultimate loads. Typical results in terms of the ultimate strength and strain at break on the 8 specimens of sheet W28 are shown in Table 4. It is clear from Photo 17 and Table 3 that the test results for the 7 CMD specimens were very close with minor variations. The low standard deviation and coefficient of variation of the results of 7 CMD specimens (Table 3) was noticed for specimens of all tested geotextile sheets. Therefore, the results of 7 CMD specimens for each sheet are presented in terms of the average ultimate strength and strain at break as listed in Table 42. Note that the strength results for each structure in Table 42 are listed in order starting from the sheets located in the top. The average geotextile strength and strain at break for each structure (center and outer pier structures) obtained from all sheets and specimens are also listed in Table 42.

**Photo 17. Wide-Width Tensile Test Results on Geotextile Sheets W17 and C20  
 (8 specimens of each sheet).**
