Summary of Recent Activities and Site Locations in TxDOT San Antonio District

March 2018

*Interagency Cooperation Contract: Support to the San Antonio District in
Geotechnical Characterization and Subgrade Stabilization*

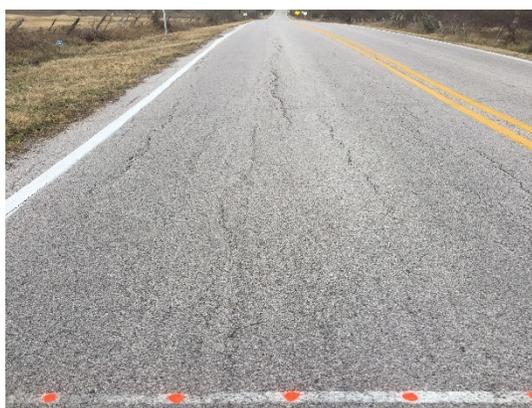
Fig. 1. Example of longitudinal cracks

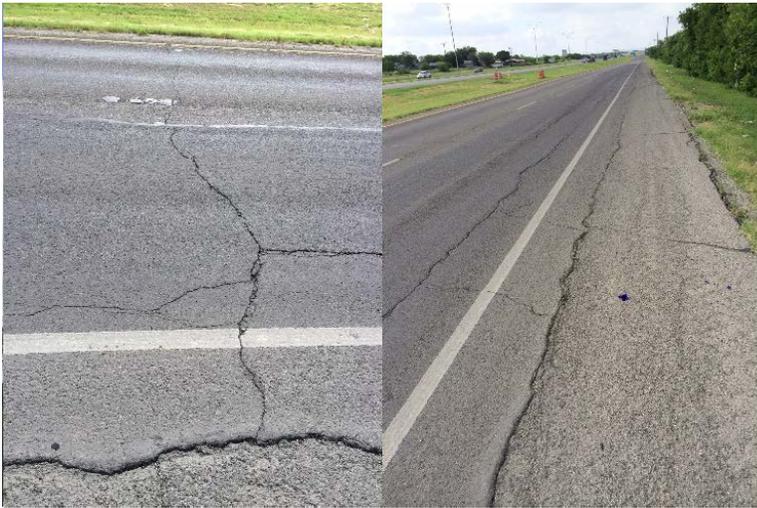
Site 2 is located in Southwest Central San Antonio along the frontage road of SW Loop 410, between Ray Ellison Blvd. and Old Pearsall Road. The pavement at this site showed extensive longitudinal and transverse cracking as well as heaving.

Fig. 21. Damage to pavement

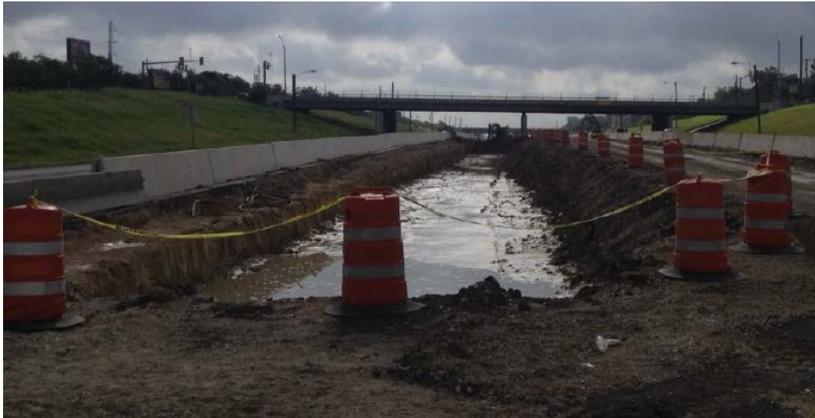
Fig. 23. Excavation pit at Site 3

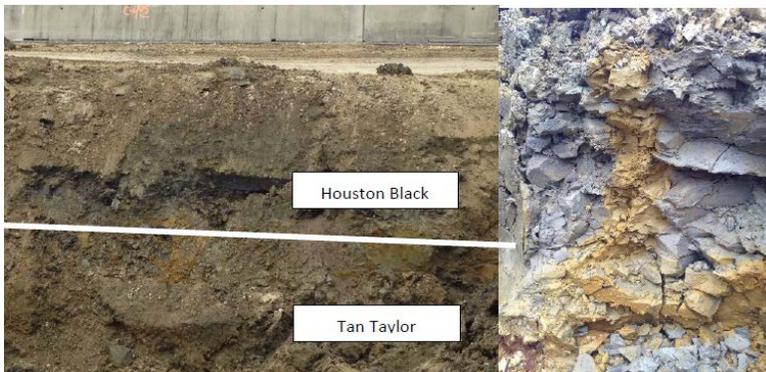
Fig. 25. Soil profile at Site 3

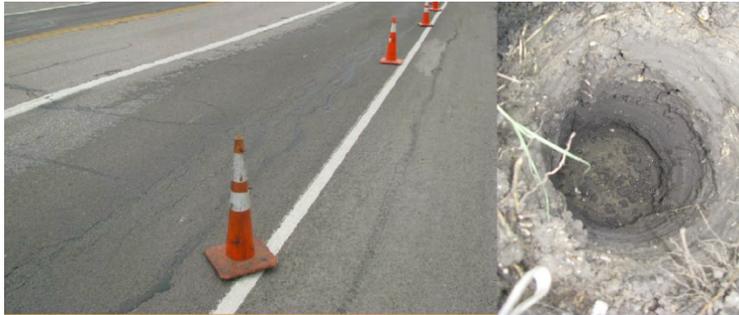
Site 4 corresponds to a section of West Loop 1604 near Pue Rd. and FM 143. Road conditions at this site showed extensive longitudinal and transverse cracking.

Fig. 26. Damage to pavement and clay in borehole

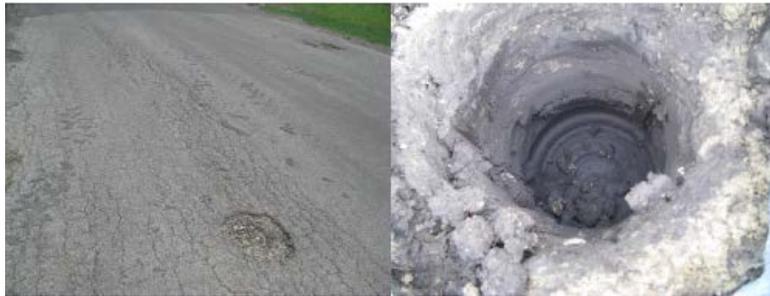
The location of Site 5 is a section of Graytown Road approximately ¼ mile from its intersection with Loop 1604 on the northeast side of San Antonio. The road conditions at the site showed signs of longitudinal cracking as well as major ruts and alligator cracking.

Fig. 28. Damage to pavement and borehole

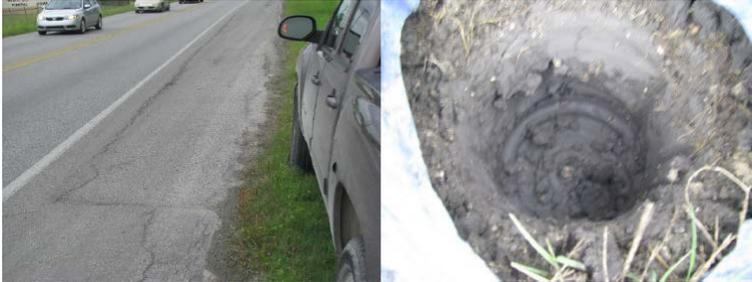
Site 6 lies on FM 1976 just inside Loop 1604 near Miller Road, on the northeast side of San Antonio. Longitudinal cracking was present along the shoulder of the roadway.

Fig. 30. Damage to pavement and borehole

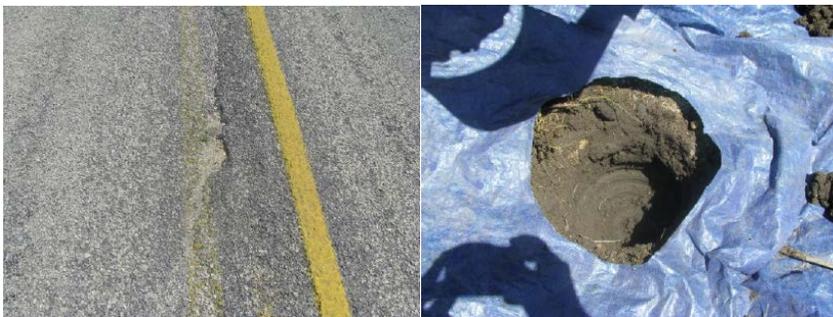
A condition survey showed signs of rutting and differential elevation changes on the road. Soil samples were collected from a boring to 3 feet. Centrifuge swelling tests and soil characterization were utilized to compare the PVR using the DMS-C approach and Tex-124-E.

Fig. 33. Damage to pavement and clay in borehole

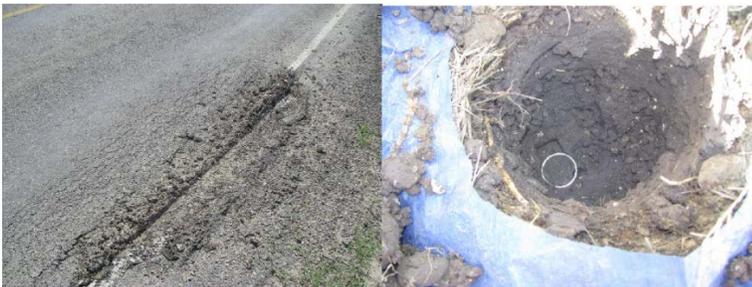
Fig. 35. Damage to pavement and clay in borehole

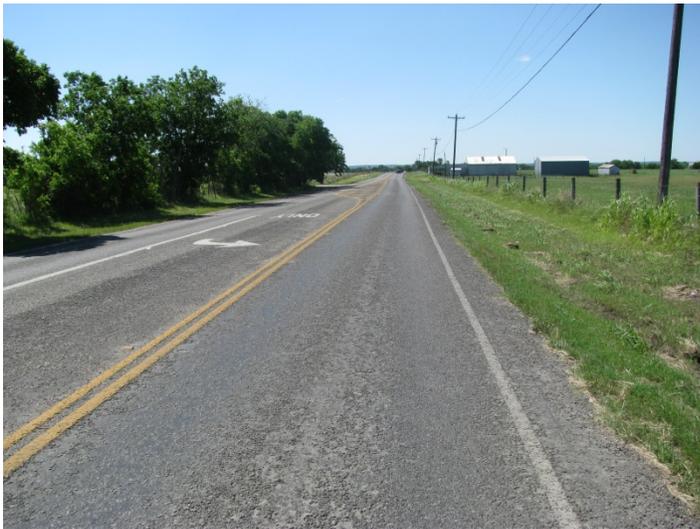
Fig. 37. FM 466 pavement conditions

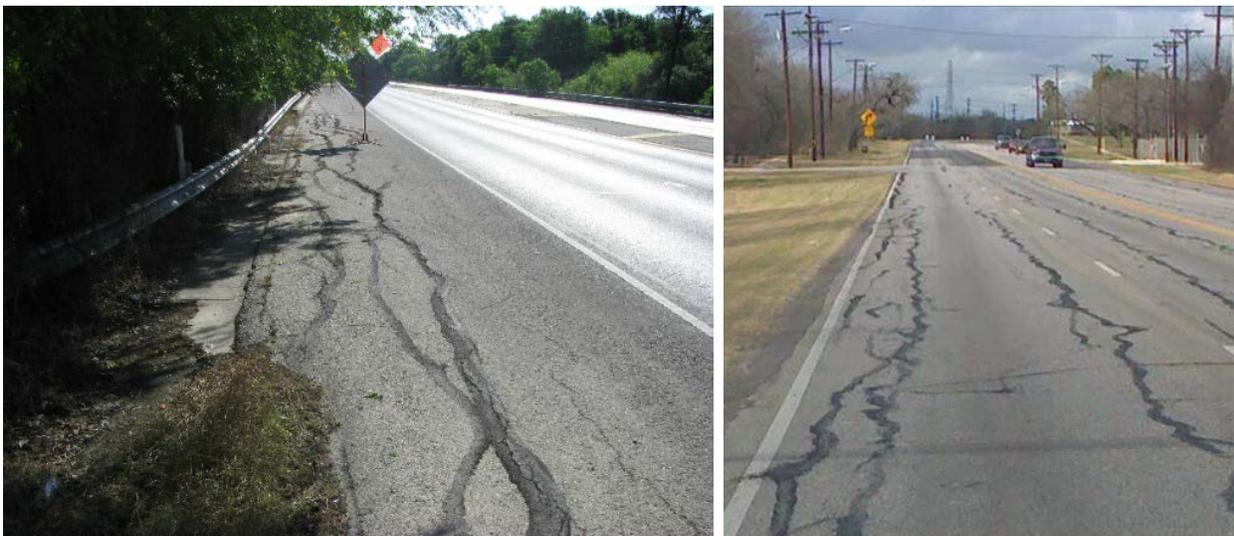
Fig. 39. Pavement distress

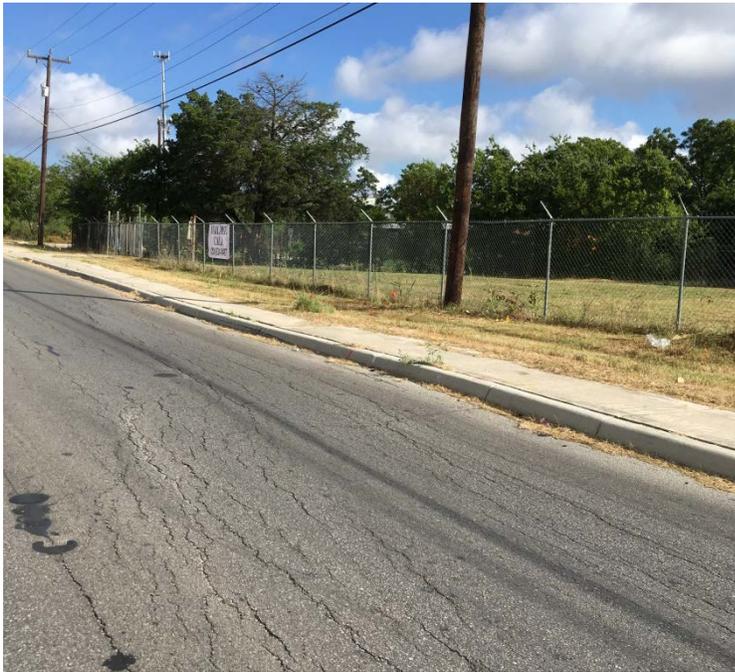
Site 13 corresponds to a roadway rehabilitation project covering a half-mile sloping stretch. The roadway at this site exhibited extensive cracking and heaving.

Fig. 42. Pavement distress on US 87 at Boring #2

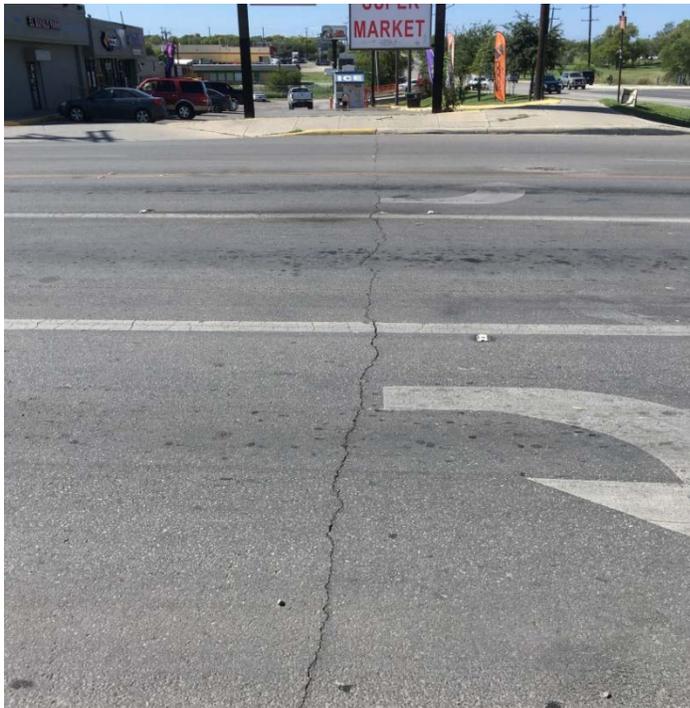
Fig. 44. Pavement distress at Old Pearsall Rd.
