Roodi, G.H., Phillips, J.R., and Zornberg, J.G. (2016). "Evaluation of Vertical Deflections in Geosynthetic Reinforced Pavements Constructed on Expansive Subgrades." Proceedings of the 3rd Pan-American Conference on Geosynthetics, Miami, Florida, 10-13 April, Vol. 2, pp. 1970-1991.

EVALUATION OF VERTICAL DEFLECTIONS IN GEOSYNTHETIC REINFORCED PAVEMENTS CONSTRUCTED ON EXPANSIVE SUBGRADES

G.H. Roodi, J.R. Phillips, and J.G. Zornberg, The University of Texas, Austin, Texas, USA

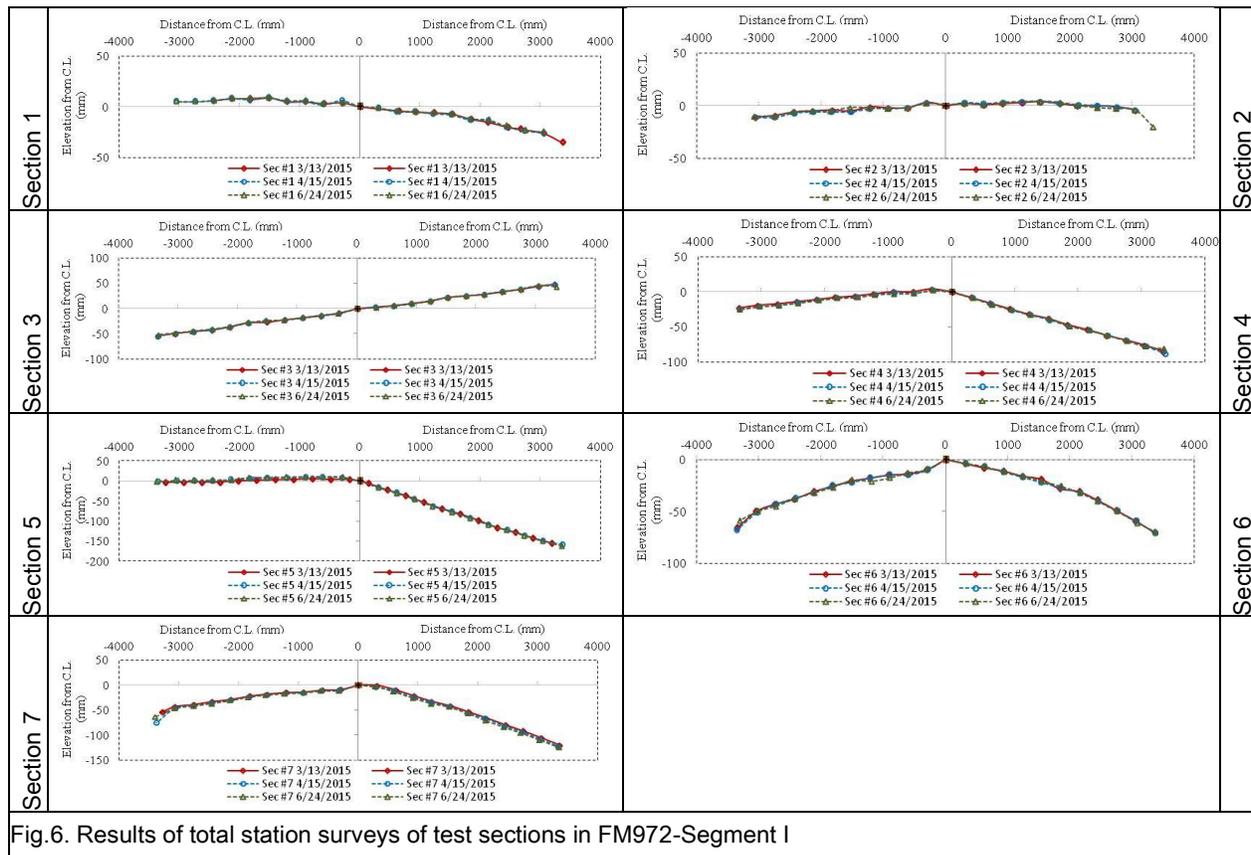
Fig.6. Results of total station surveys of test sections in FM972-Segment I

Transverse profiles resulted from different surveys are illustrated with different colors in Figure 6. Evaluation of the curves presented in this figure reveals that the transverse profiles of the east and west bounds have remained essentially unchanged in all sections. This indicates that in this section of the road the subgrade soil has not imposed significant differential vertical deflection to the road structure, which is consistent with the observed good/fair conditions of the road.

The differential vertical deflection of the road surface has been quantified with the initial slope and change in the slope over time in each transverse section. As summarized in Table 1, although the initial transverse slopes were

very different among the marked sections, all east bound and west bound sections exhibited negligible change in slope.

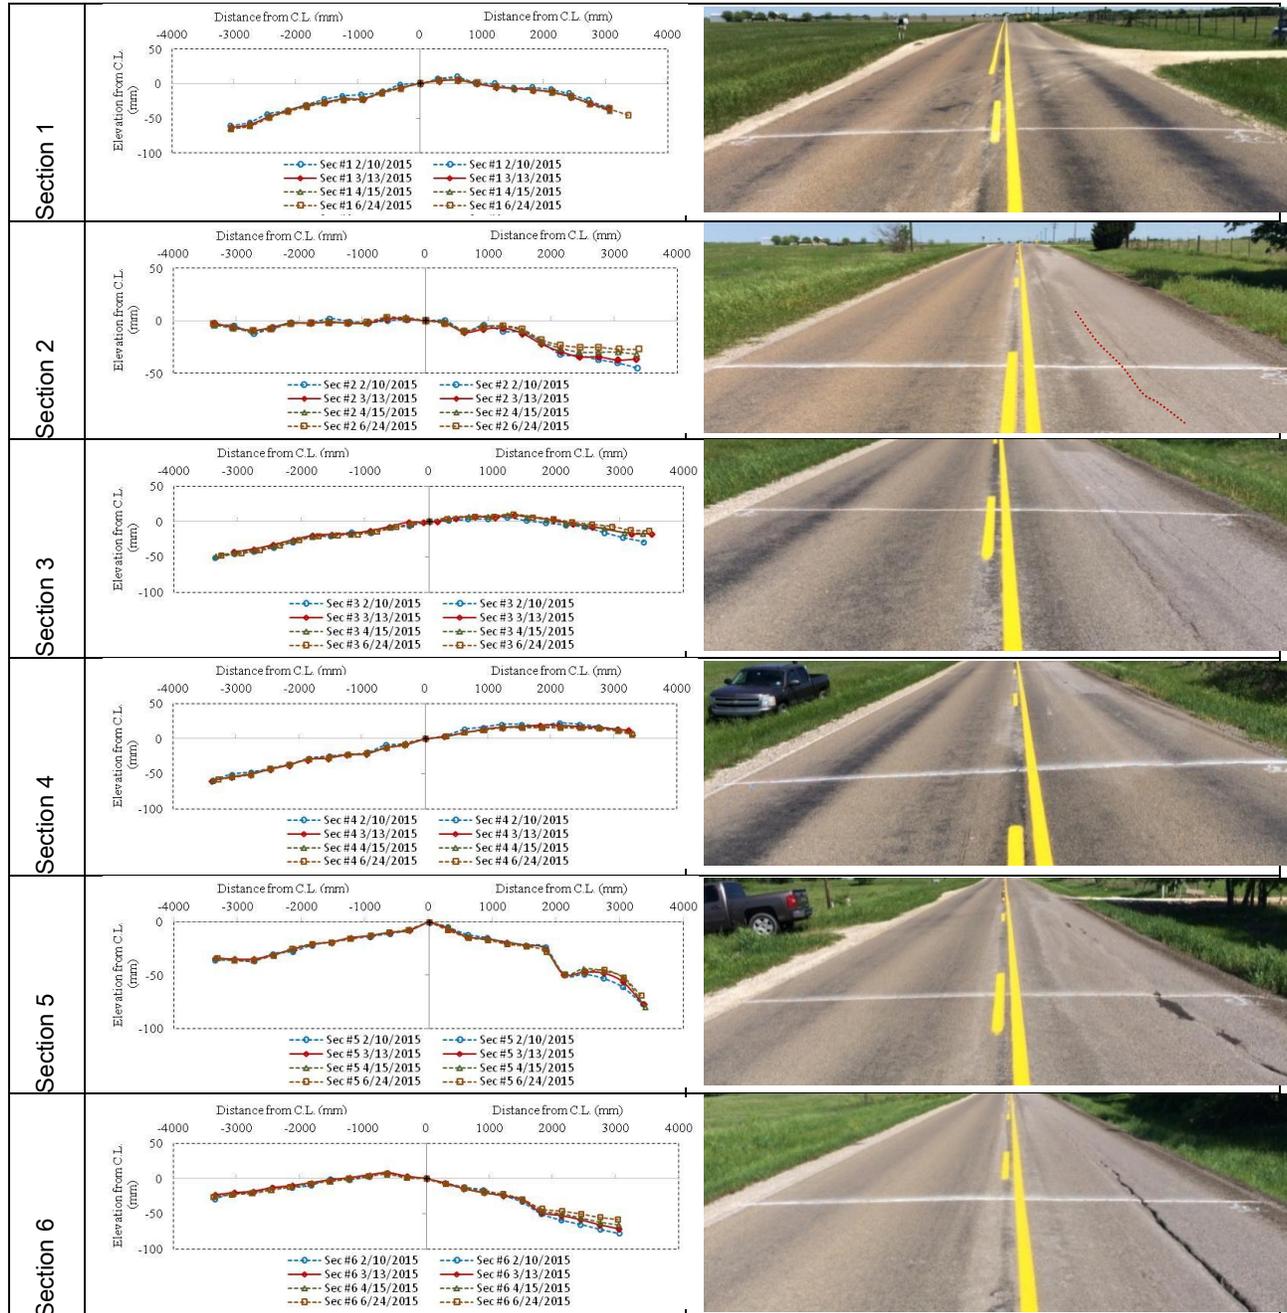
Evaluation of the curves presented in Figure A.1 indicates different vertical deflection behavior in sections with observed good condition as compared to sections with poor condition. Similar to the sections in FM972- Segment I, in FM972- Segment II the transverse profiles of the east and west bounds were found to be essentially unchanged in sections with observed good conditions (Sections #1, #4, and #7). However, in all sections with observed poor performance (i.e. Sections #2, #3, #5, and #6) significant vertical deflections have been recorded. The vertical deflections were found to be positive, i.e. in upward direction, and to be more significant in the edges the pavement. This is consistent with the described conceptual mechanism for pavements constructed on expansive subgrades. According to this mechanism, edges of pavements founded on expansive subgrades tend to heave during wet season, when the subgrade soil expands in the shoulder area, and to settle during dry season, when the subgrade soil tend to shrink. This cycle of upward and downward vertical deflections in the edges leads to the development of longitudinal cracks in pavements, particularly close to the edges. As illustrated in Figure A.1, poor condition of Sections #2, #3, #5, and #6 are attributed to the cracks observed on the edges of the eastbound of the road (i.e. the right lane on the profiles), whereas the westbound lanes are found to be in good condition. Vertical deflections were also found to be significant only in the edge of the eastbound lanes. It can be envisioned that cycles of heave and settlement that have been repeated over time have been the main reason for development of the observed cracks. Maximum positive deflection between first survey on February 10th and last survey on June 24th was found to be 18, 16, 9, and 20 mm, respectively for Sections #2, #3, #5, and #6.

The differential vertical deflections of the test sections were evaluated with the initial slopes and changes in the slopes summarized in Table 2. Although the initial transverse slopes were different among the marked sections, all westbound sections exhibited almost zero change in the slope. This is consistent with the good conditions have been

observed in the westbound sections. The slope of the eastbound sections, however, has changed in the sections with the observed poor condition. The changes were found to be negative indicating reduction in the slope magnitude.

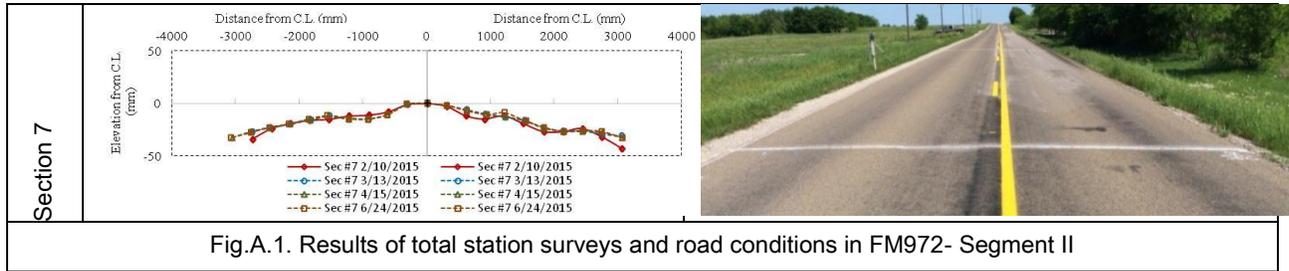
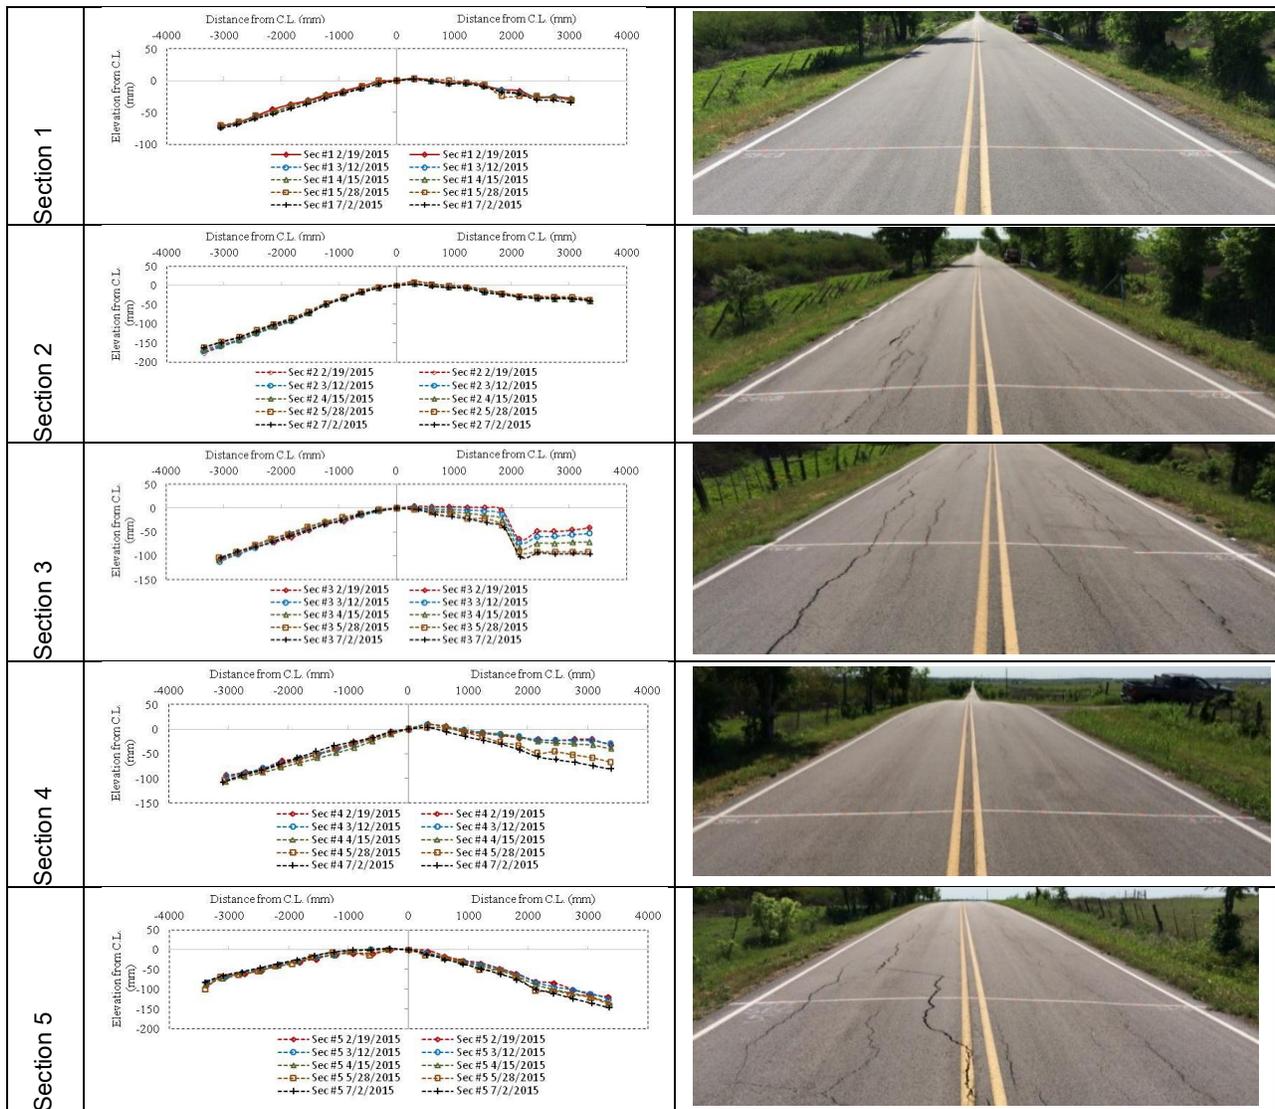
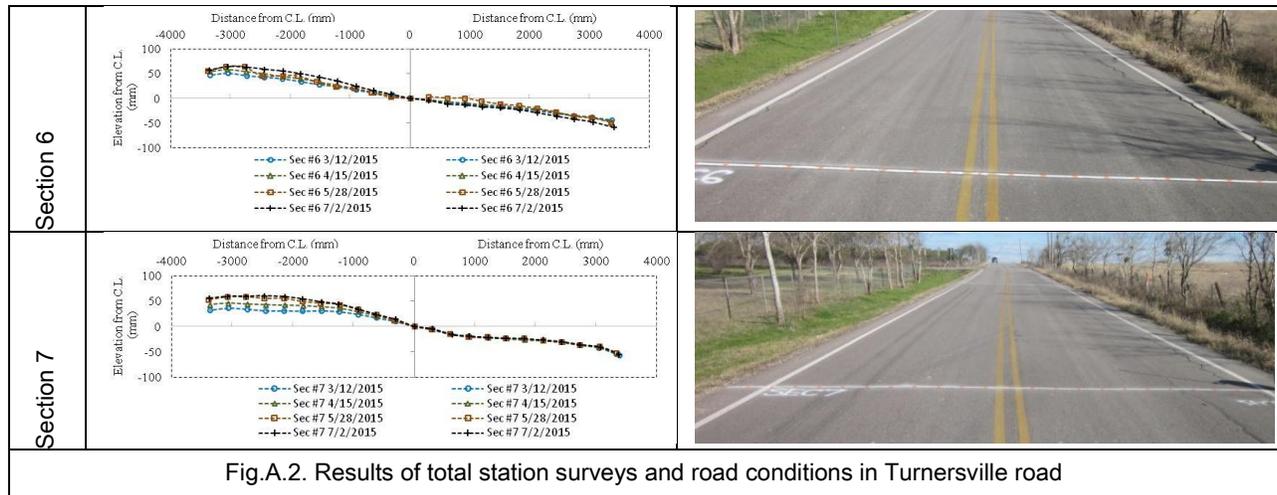
Fig.A.2. Results of total station surveys and road conditions in Turnersville road

Vertical deflections of the road surface were found to be different among the seven transverse sections. Similar to the sections in good condition in FM972, it was found that Section #1 in Turnersville Road has exhibited very limited vertical deflection. As illustrated in Figure A.2 very minor change was measured in the elevation of the painted points in Section #1. The slope of both right and left lanes did not change significantly in this section (Table 3). Transverse slopes in Section #2 were also found to remain essentially unchanged.

Sections #3, #4, and #5 exhibited significant drops in the elevation of their right lanes. This settlement can be attributed to the shrinkage of the expansive subgrade during the period of this study. The maximum settlement was found to be at the edges of the pavement, which is consistent with the described conceptual mechanism for pavements constructed on expansive subgrades. The maximum settlements were measured as 55, 49, and 28 mm in Sections #3, #4, and #5, respectively. As presented in Table 3, as a result of the settlements, significant increase was measured in the right lane transverse slopes. The increase was found to be as large as +2 and +1.7 % for Sections #3 and #4, respectively. It should be noted that the wide crack on the right lane of Section #3 could potentially provide a faster and easier access to water for pavement base and subbase layers as well as for the expansive subgrade. This could impose slope stability issues as well as exacerbating impact from the expansive subgrade.

In contrast with the settlements observed in other sections, left lanes in Sections #6 and #7 exhibited positive vertical deflections, which indicate swelling of the expansive subgrade in this area (Figure A.2). Maximum vertical deflection was recorded as +18 and +30 mm in Sections #6 and #7, respectively, which has led to reduction of -0.5 and -1 % in the slope of the left lanes. However, the right lanes of Sections #6 and #7 exhibited zero or negative change in the elevation, which is consistent with the shrinkage observed in other sections. The expansion of the subgrade soil observed in the left lanes can be attributed to the geographical features in this area. As shown in Figure A.2, left side of the road in Sections #6 and #7 is bound by residential areas that created a natural pond for accumulation of rain water or other runoffs. The impact of this natural pond can clearly be seen in the difference in the vegetation of the right side of the road as compared to the left side. Accumulation of water in the pond could potentially provide additional access to water for the subgrade soil, which has led to the observed expansion.

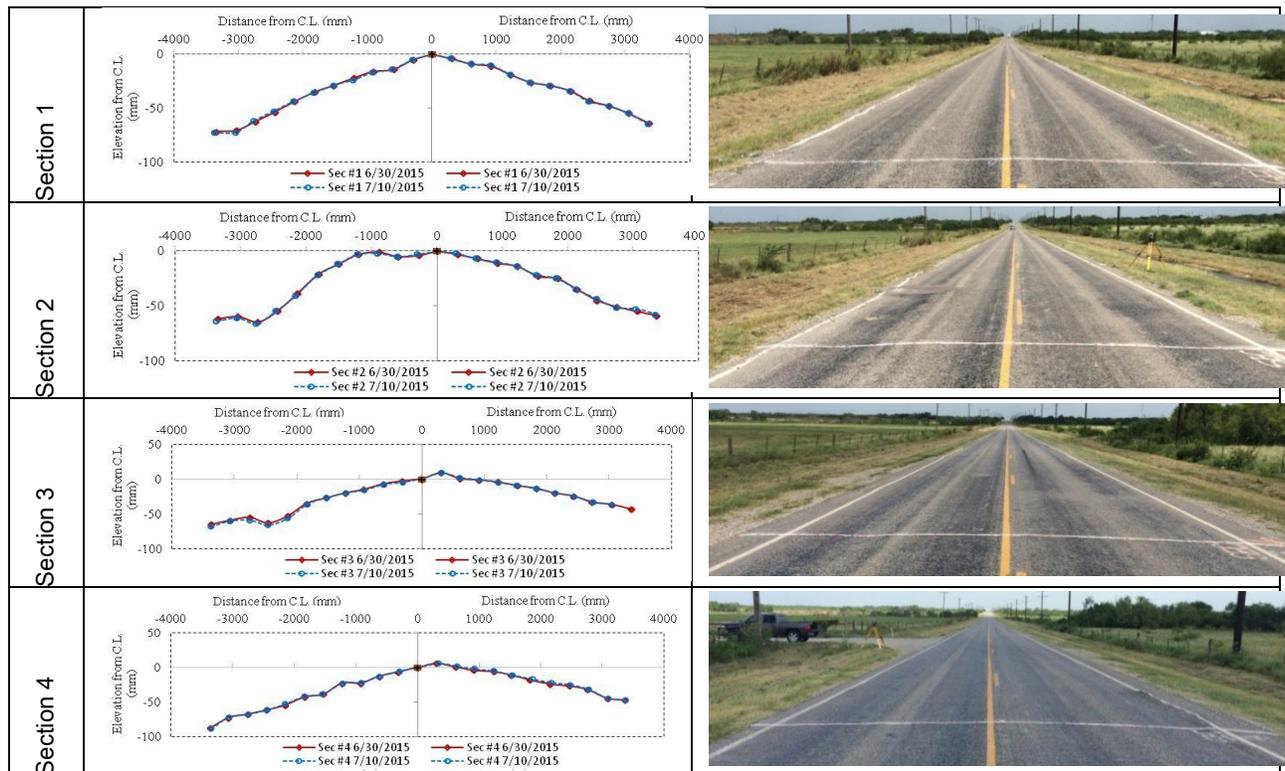
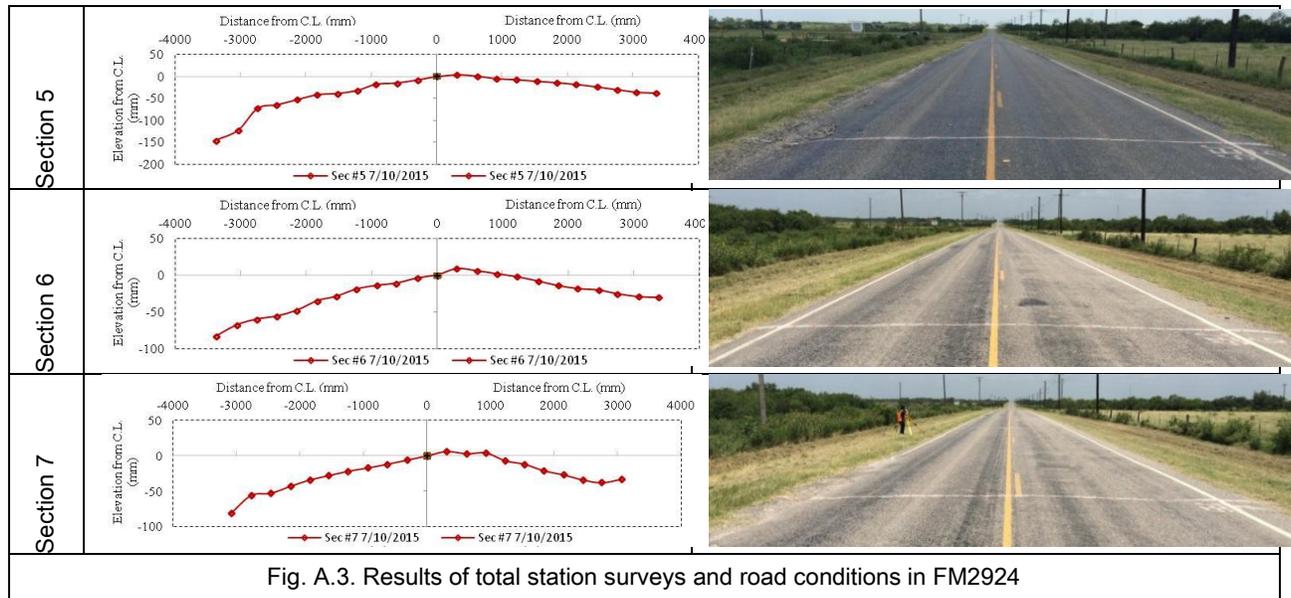
Fig. A.3. Results of total station surveys and road conditions in FM2924

Total Station Readings: As listed in Table 4, since the transverse test sections in FM2924 were marked recently, only a single or two total station surveys have been conducted at the time of writing this paper. Therefore, the findings of this section should be treated with caution, but the significance of using geosynthetic reinforcement, which is a major focus in this study, is further underlined by these data.

Comparative evaluation of the test sections conditions in FM2924, FM972, and Turnersville Road, highlights the significance of geosynthetic reinforcement layer in the performance of the pavements constructed on expansive clays. While the test sections in all three locations have been founded on similar subgrade soil and have been exposed to similar environmental conditions and traffic loads, the test sections in FM2924 were found to be in significantly better condition. As demonstrated in Figure A.3, in contrast to the wide and deep cracks have been observed in the test sections in FM972 and Turnersville road, zero or very minor environmental longitudinal cracks were found in the test sections in FM2924. This indicates that the geosynthetic reinforcement was effective in mitigating the main distress associated with the expansive subgrade. The geosynthetic reinforcement was able to reduce the severity or delay opening of environmental longitudinal cracks in FM2924 test sections.

Application of geosynthetic reinforcements in FM2924 could minimize change in the design transverse slopes. As presented in Table 4, slopes measured for marked transverse sections in FM2924 were found to range from 1.4 to 2.6 %. This indicates very minor change as compared to the design slopes, which highlights significance of geosynthetic reinforcement in mitigation of the differential vertical deflections and accompanied longitudinal cracks.
