Brown, A.C., Ellis, T., Dellinger, G.F., El-Mohtar, C., Zornberg, J.G., and Gilbert, R.B. (2011). "Long-Term Monitoring of a Drilled Shaft Retaining Wall in Expansive Clay: Behavior Before and During Excavation." Proceedings of the *GeoFrontiers 2011 Conference*, Geo-Institute of ASCE, Dallas, Texas, March 13-16, pp. 3516-3525.

Long-Term Monitoring of a Drilled Shaft Retaining Wall in Expansive Clay: Behavior Before and During Excavation

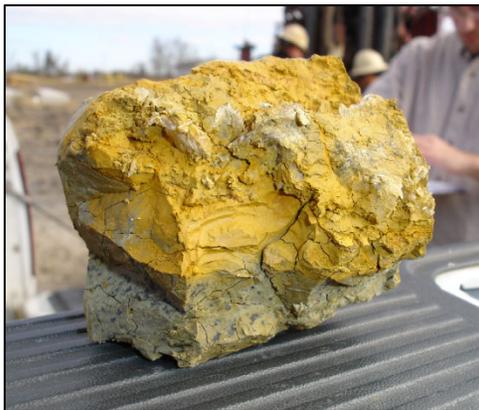
Figure 2: Taylor Clay

The project site is located in Manor, Texas, on a site underlain by approximately 50 feet of the Taylor Formation, a highly expansive and problematic clay. A sample of the Taylor Formation from the project site is pictured in Figure 2. The project site and test wall are pictured in Figure 3 (photograph taken before excavation).

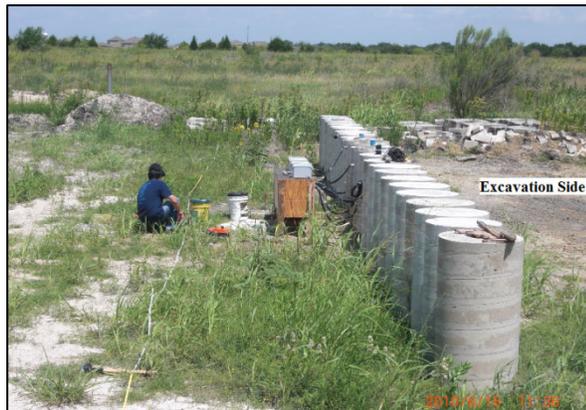
Figure 3: Project Site and Test Wall

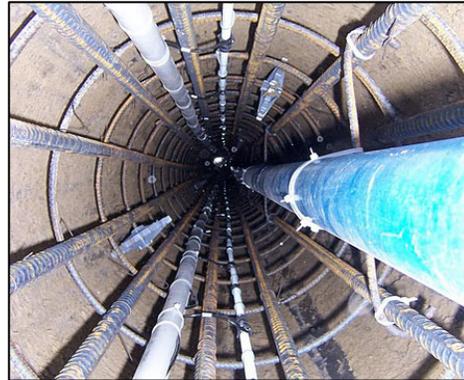
Figure 7: Instrumented Cage During Installation

During construction, the optical cables were protected within a slotted PVC pipe (Figure 7). In order to prevent excessive bending of the rebar cage and damage to the instrumentation, the instrumented cages were lifted with two cranes. To prevent sensor damage during concrete placement, concrete was directed down the center of the rebar cage with shovels. Sensor survivability was excellent, with 89 of 90 strain gauges and all inclinometer casings functional after cage placement and concrete pour.
