A Tale of Two Bridges: Comparison between the Seismic Performance of Flexible and Rigid Abutments

ABSTRACT

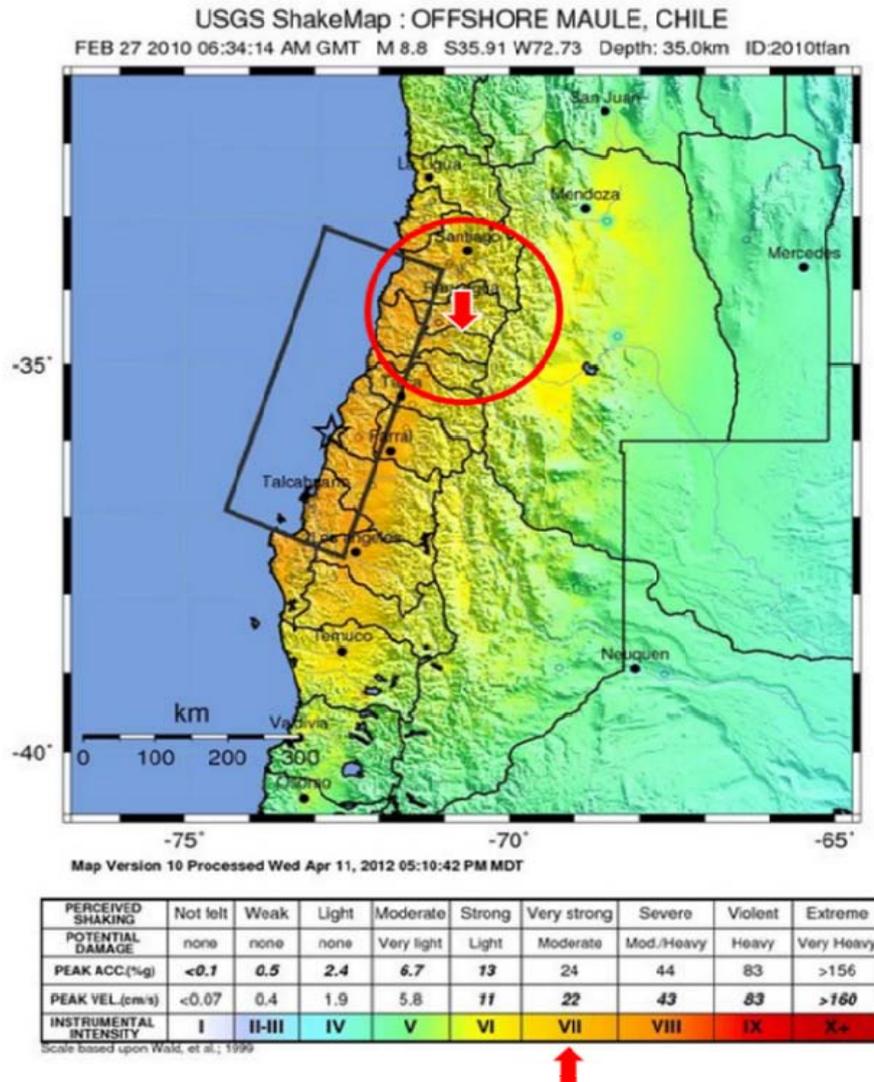
Figure 1. Instrumental intensity map for the main shock (after USGS 2012).

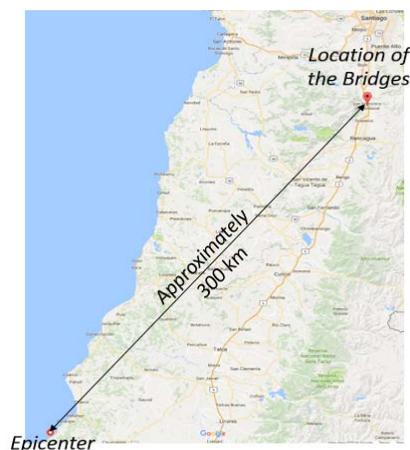
Figure 2. Geographic distance between the earthquake epicentre and the location of the bridges (plotted on Google maps).

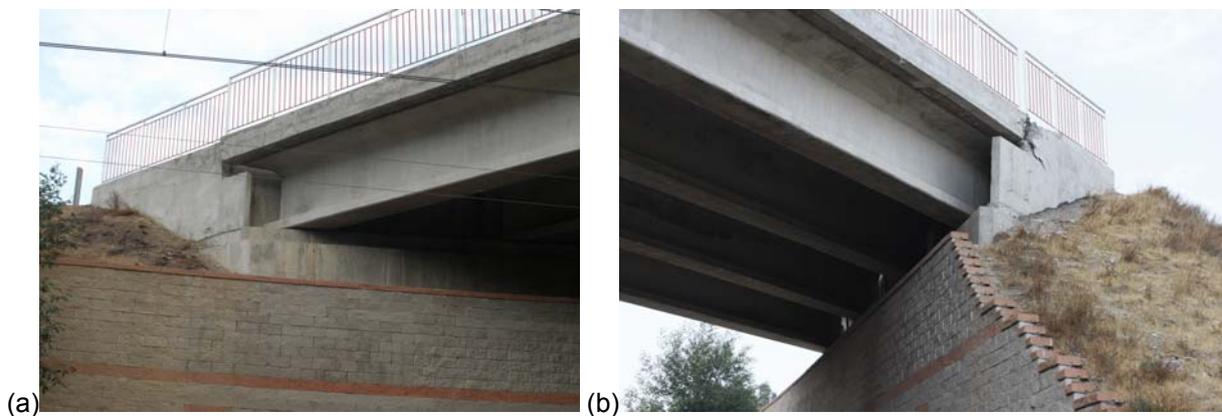
The load on the footings of each abutment is approximately 210 kPa, which is the typical maximum allowed footing load in AASHTO design specifications (Allen 2012). The abutments were designed using the 2002 AASHTO Standard Specifications (Tensar Earth Technologies 2003). The acceleration coefficient used in seismic design was 0.3g. Note that the actual peak ground acceleration (PGA) measured near the bridge during the 2010 Maule earthquake ranged from 0.3g to 0.5g. However, the abutments performed very well, exhibiting no signs of lateral or vertical movement due to the earthquake. The bridge superstructure suffered some relatively minor damage, as shown in Figure 4 (Yen et al. 2011), but was still functional. The damage was probably due to the large skew angle of the superstructure and longitudinal downward slope. This combination of the large skew and slope caused the bridge superstructure to move downslope toward the acute angle in the bridge skew, resulting in the damage (Allen 2012). Yen et al (2011) reported similar observations of other skewed bridges investigated in Chile after the same earthquake event. In addition, they suggested that the damage could also have been caused by the bridge's tendency to slide downhill, as the bridge was located on a downhill roadway grade.

Figure 4. Damages observed at the San Francisco Bridge: (a) displacement in west abutment; (b) cracks in east abutment (courtesy of Daniel Alzamora).

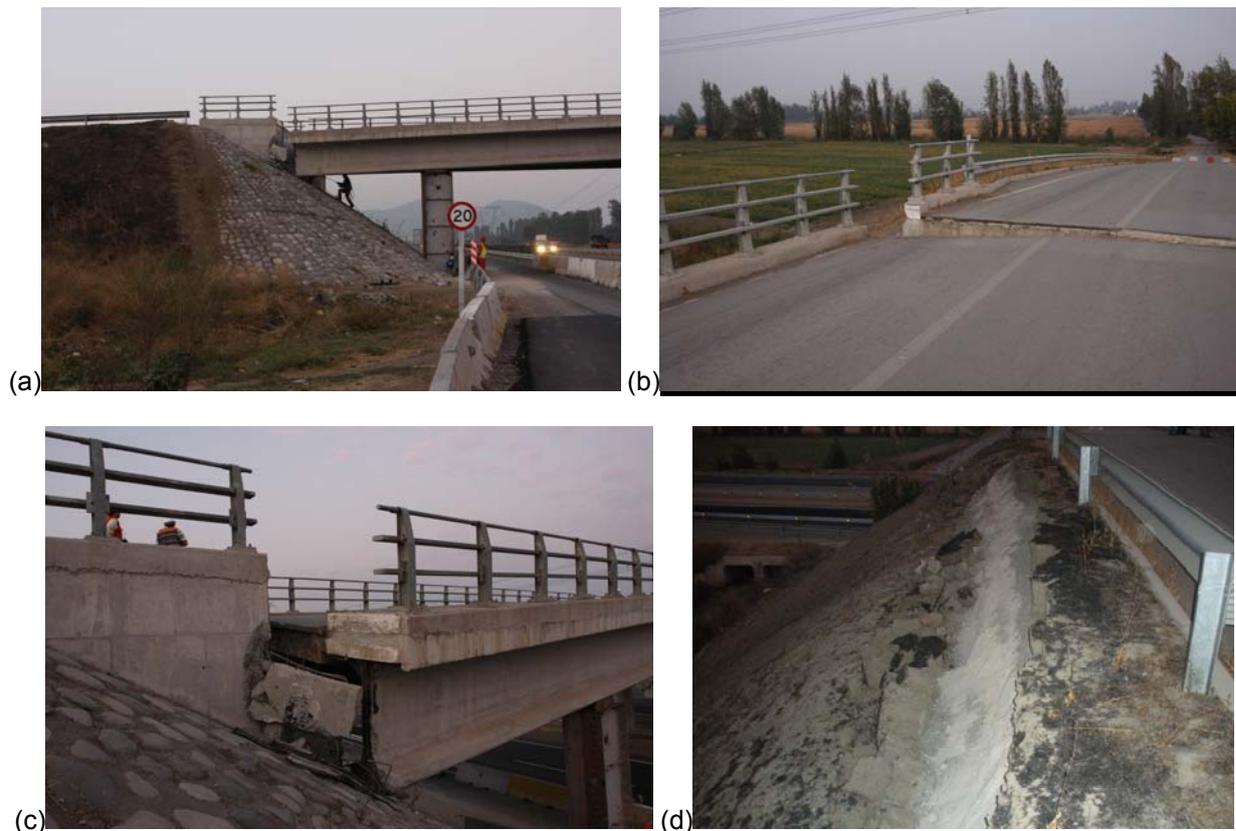
Figure 5. Damages observed at Las Mercedes Bridge: (a) side view looking north showing unseating at west abutment; (b) west abutment unseating to the south; (c) damage due to lack of side stoppers and diaphragms; (d) surface cracks at the embankment (courtesy of Daniel Alzamora).

Las Mercedes Bridge twisted significantly in a counter-clockwise direction during the earthquake. This caused the exterior girders to displace significantly off their bearing seats at both ends as seen in Figure 5. Specifically, the superstructure was displaced transversely by approximately 1.0 to 1.4 m at both ends (Unjoh 2011). The exterior girders rotated off the abutment seats at both ends, which resulted in a longitudinal crack between the exterior and interior girders in the deck slab. A single transverse crack also occurred in the deck slab above the intermediate pier (Yen et al. 2011, Buckle et al. 2012). Side curtain walls were damaged when hit by the superstructure (Yen et al. 2011; Unjoh 2011; Buckle et al. 2012), as shown in Figure 5a. The bridge was weakly restrained in both translational and rotational directions due to the absence of lateral restraints (Kawashima et al. 2010; Buckle et al. 2012) as Figures 5b and 5c show. Figure 5d shows minor damage in one of the bridge embankments as reported by Elnashai et al. (2010).

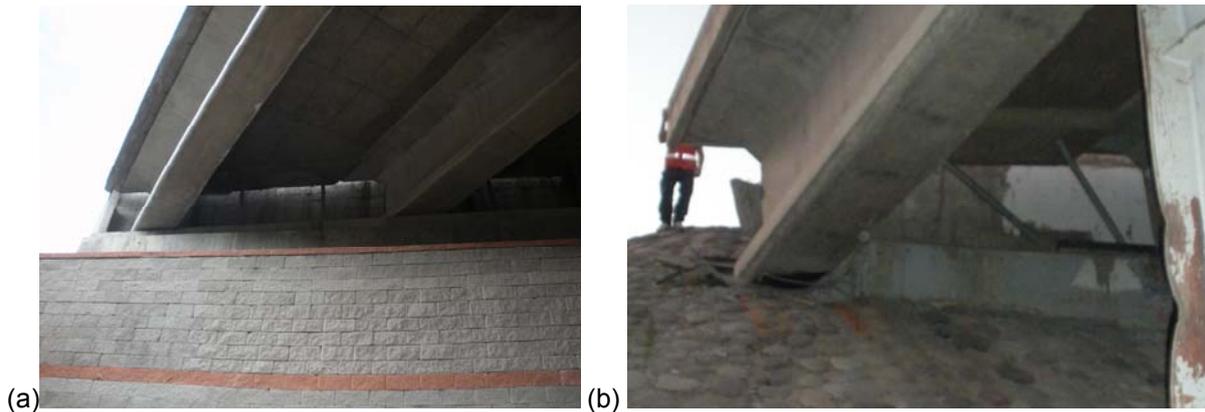
that observed for the San Francisco Bridge superstructure. Figure 6 shows a comparison between the lateral deformations of the seismic bars of both bridges. Note that neither bridge had lateral restraints (e.g. shear keys, diaphragms).

Figure 6. Condition of seismic bars: (a) San Francisco Bridge; and (b) Las Mercedes Bridge (courtesy of Daniel Alzamora) (note that diaphragms were not used in either bridge).
