Report No. CDOT-DTD-R-2000-5

PERFORMANCE OF GEOSYNTHETIC- REINFORCED WALLS SUPPORTING THE FOUNDERS/MEADOWS BRIDGE AND APPROACHING ROADWAY STRUCTURES

**REPORT 1: DESIGN, MATERIALS, CONSTRUCTION,
INSTRUMENTATION, AND PRELIMINARY RESULTS**

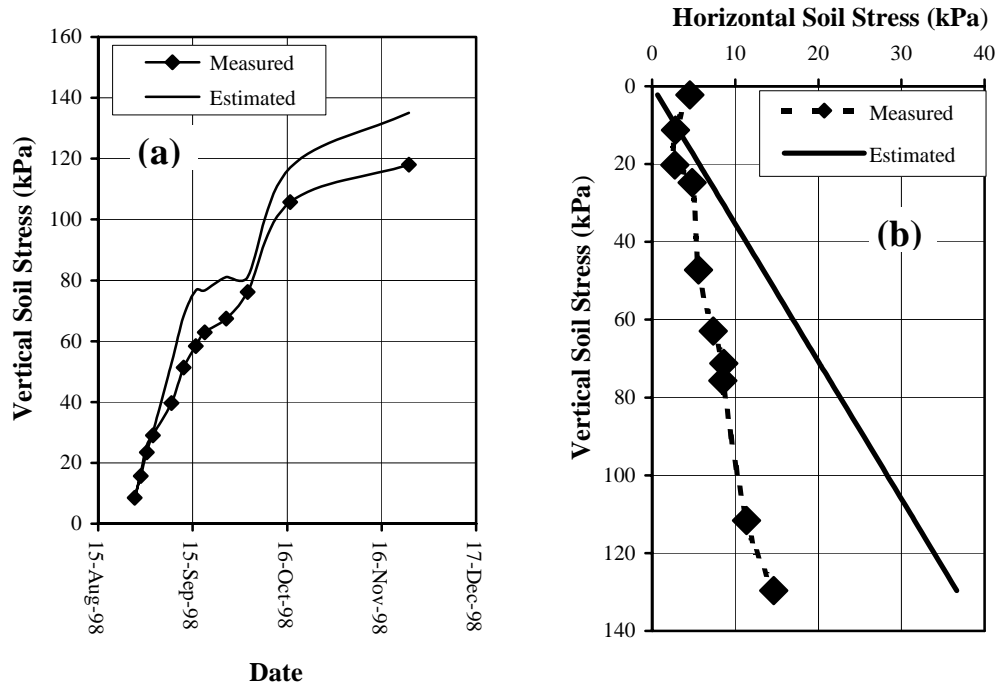
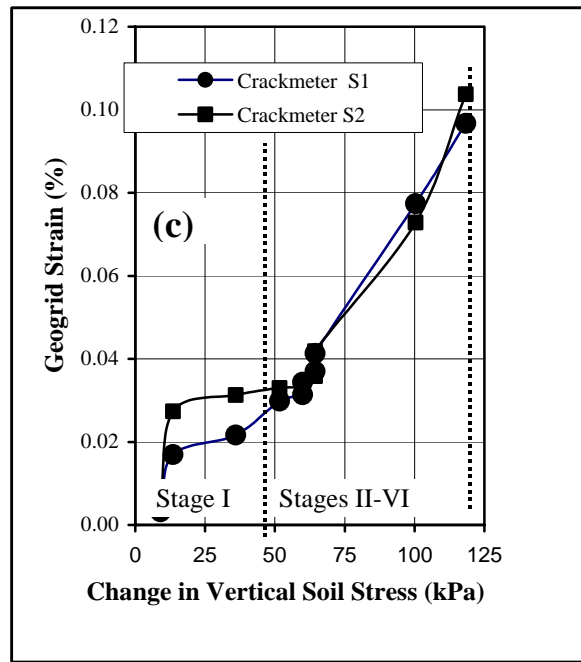
Figure 10. Measured and estimated data on section 400 of the phase I structure: (a) Vertical Stresses, (b) Horizontal Stresses, and (c) Geogrid Strains.

The measured geogrid strains versus the estimated soil vertical stresses at various construction stages are shown in Figure 10c. The Figure indicates that the measured geogrid strains from two crackmeters correlate well with each other. The geogrids experienced very low strains, on the order of 0.1 %. As shown in Figure 10c, sharp increases in geogrid strain developed immediately after the backfill was placed on top of the gauges, possibly influenced by compaction. The rate of strain decreases significantly during the rest of stage I construction and during stage II construction. Finally, the rate of geogrid straining increased steadily during construction stages III through VI.

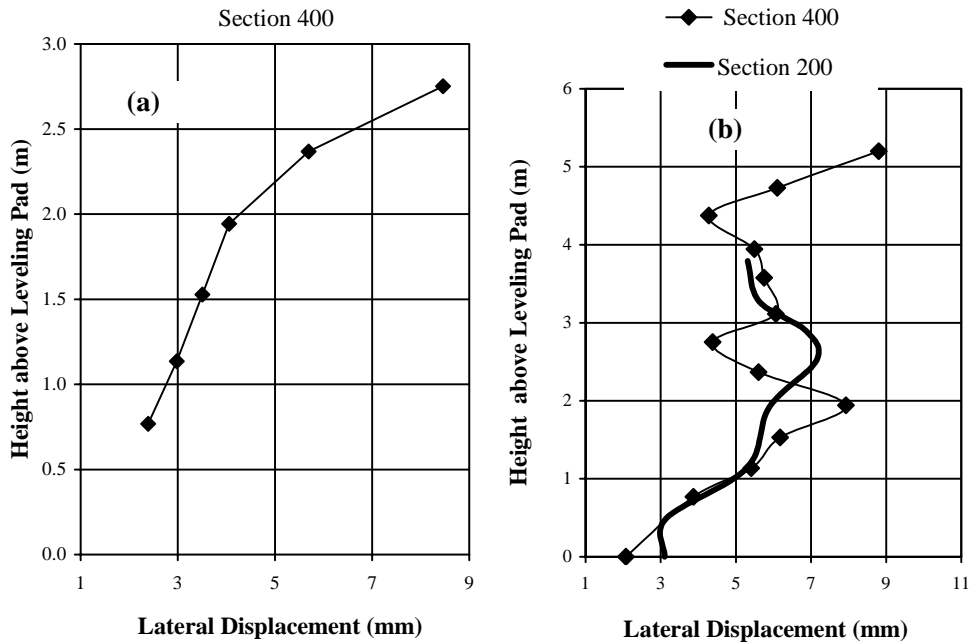
Figure 11. Lateral displacements monitored on phase I structure: (a) during stage I construction, and (b) due to placement of the bridge superstructure.

Figure 11a summarizes the total outward movement of the front MSE wall (section 400) induced during stage 1 construction as the wall height increased from 18 rows (elevation 3.65 m above leveling pad) to 27 rows (elevation 5.48 m). Figure 11b summarizes the total outward movements of the front MSE walls (sections 200 and 400) induced during construction stages II to VI. The following observations can be inferred from the monitored displacement data:

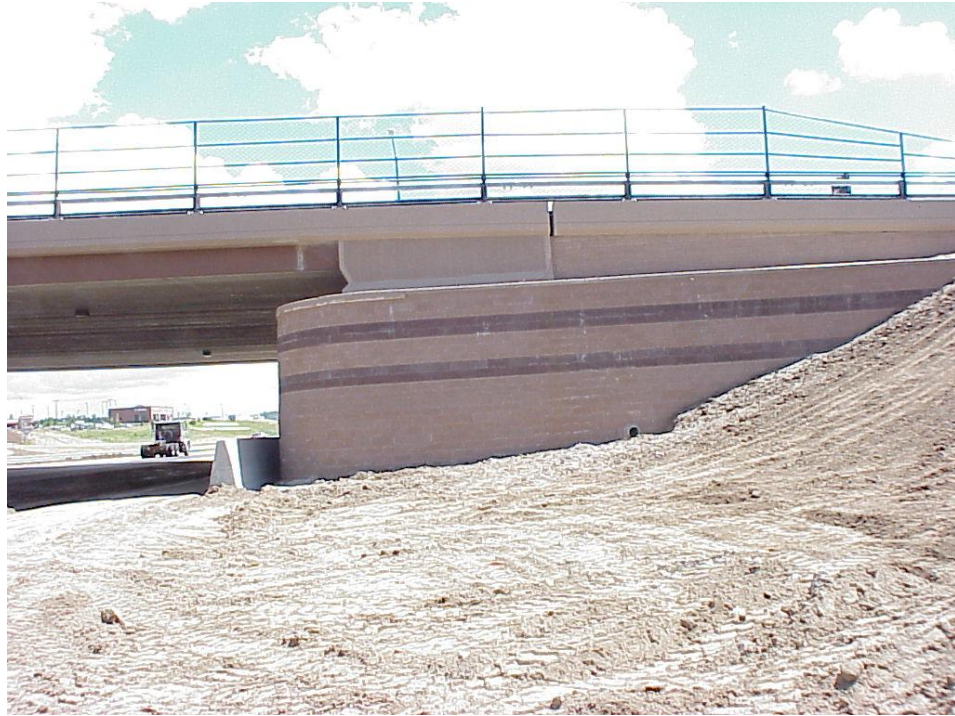
Figure B-1. A view of the northwest side of the completed Founders/Meadows bridge-approaching roadway structure showing lower and upper MSE walls, wing walls, and girders.

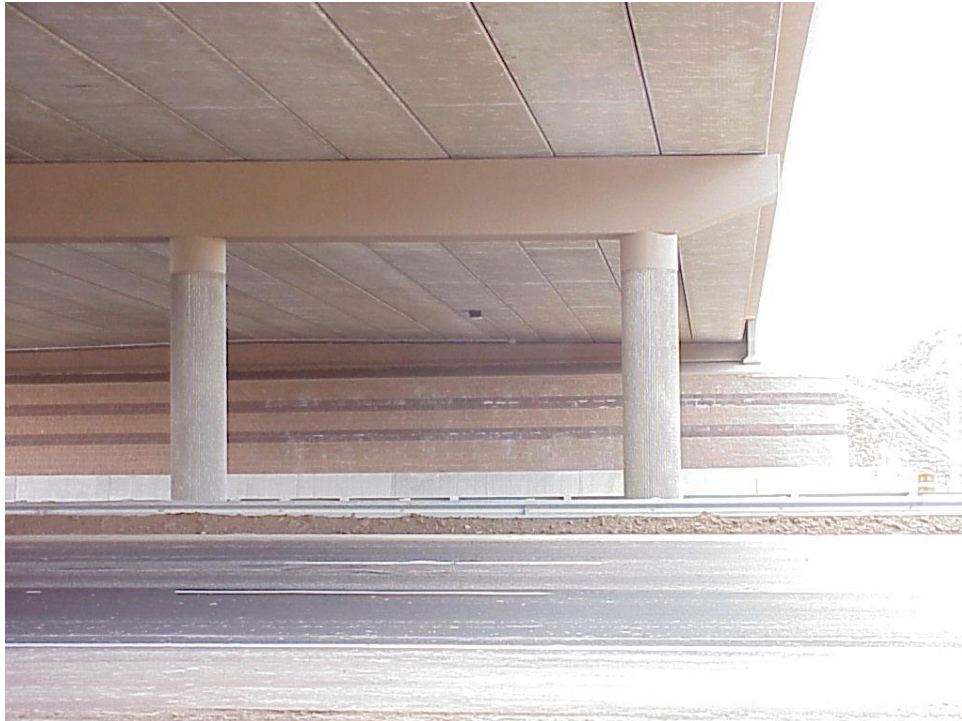
Figure B-2. A view of the east side of the Founders/Meadows Bridge showing front MSE wall, girders and pier columns.

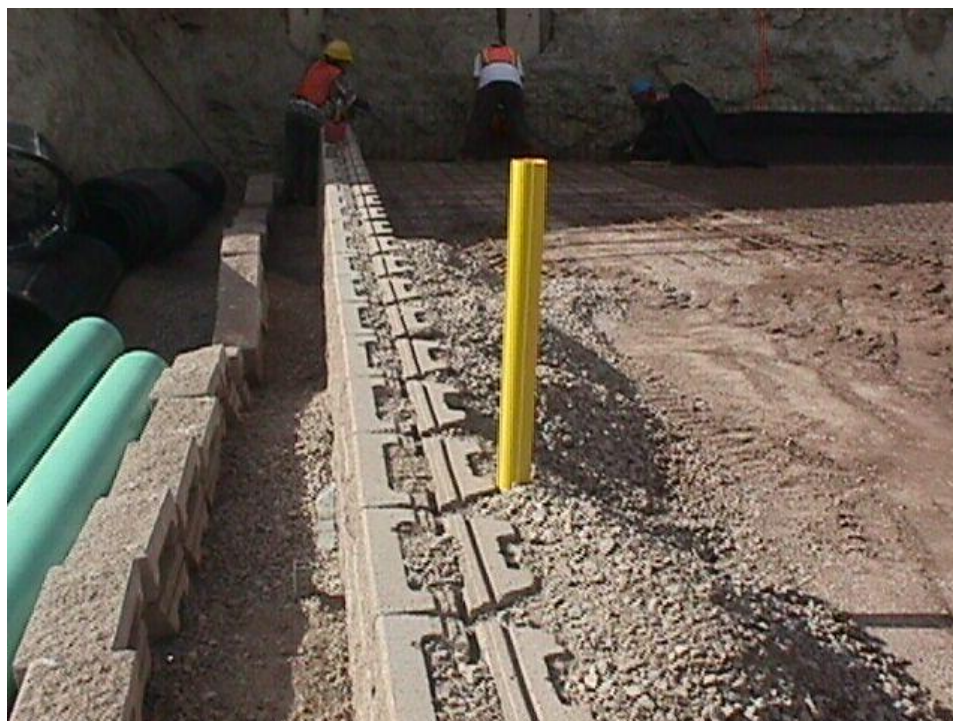
Figure B-4. Picture showing facing blocks, crushed stone used to fill in and 0.3 m behind the blocks, and the compacted CDOT Class 1 backfill. The yellow inclinometer tube was used to measure lateral movement in the structure along Section 400.

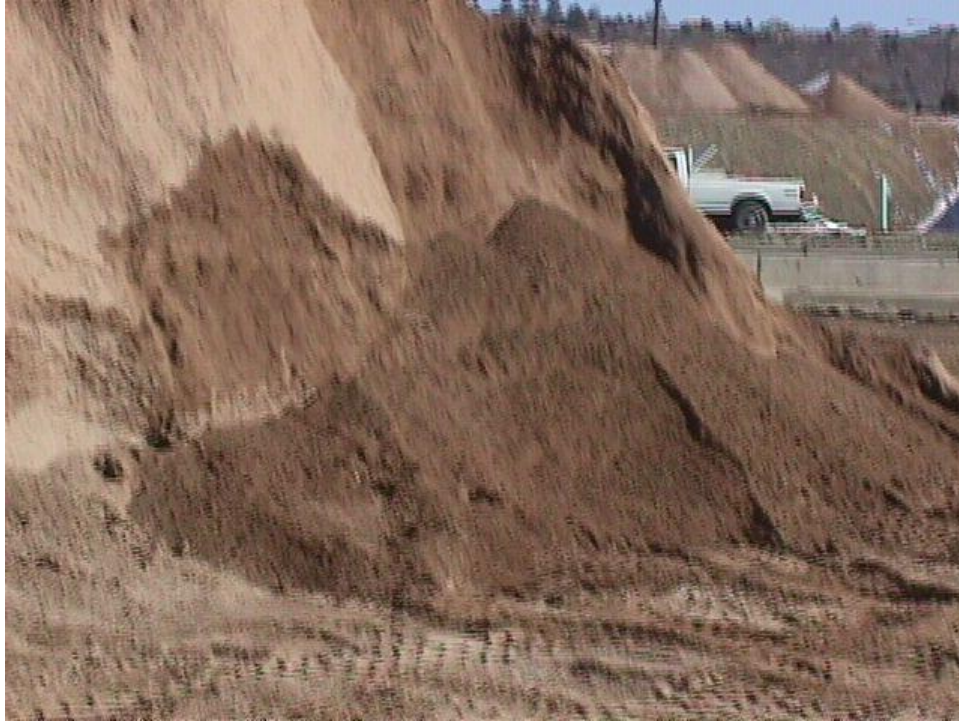
Figure B-5. Backfill material meeting requirements for CDOT Class 1 backfill.

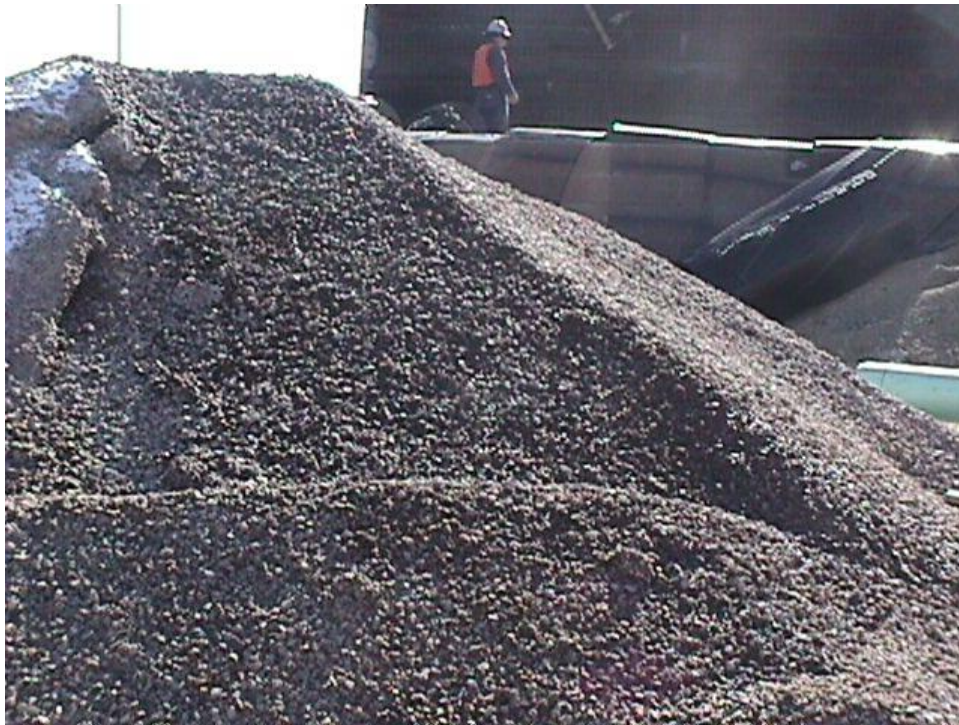
Figure B-6. The 19 mm maximum size crushed stone aggregate used to fill in and for .3 m behind the blocks to facilitate compaction and drainage behind the blocks, prevent washout of the fines in the fill material, and facilitate compaction behind the facing.

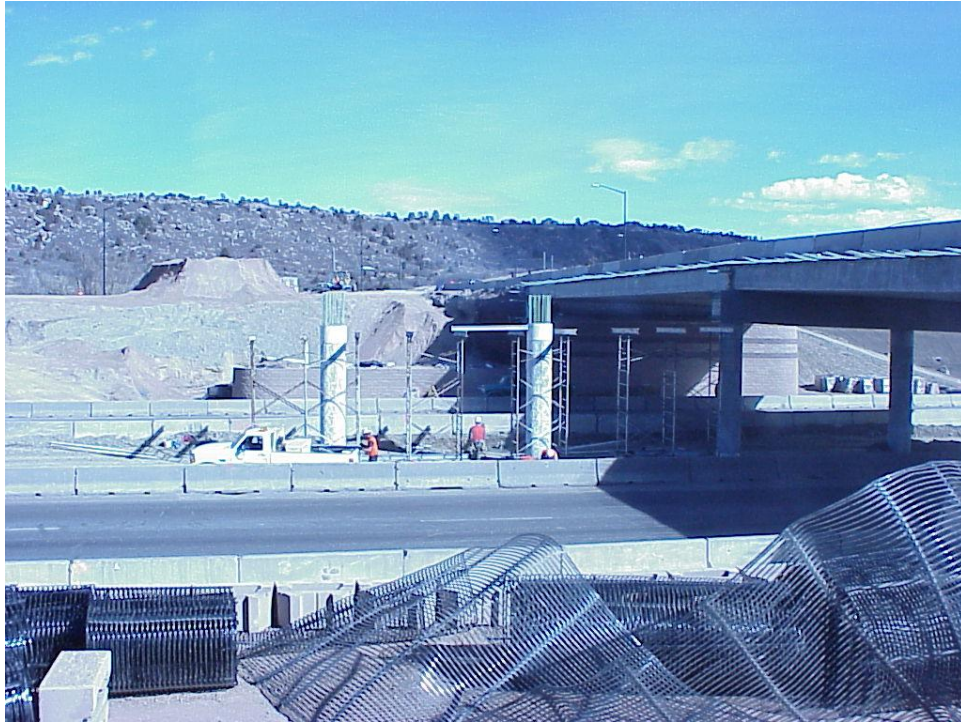
Figure B-7. Rolls of Tensar UX 6 geogrid placed below the bridge foundation.

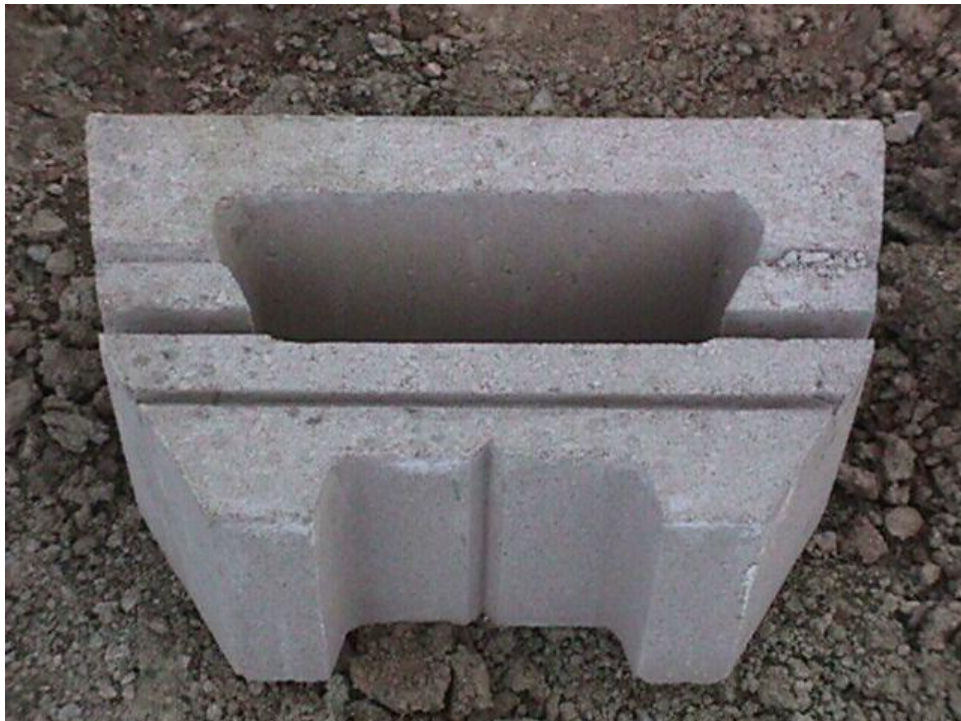
Figure B-8. Top view of the Mesa Block - the outside face of the block is toward the top of the picture.

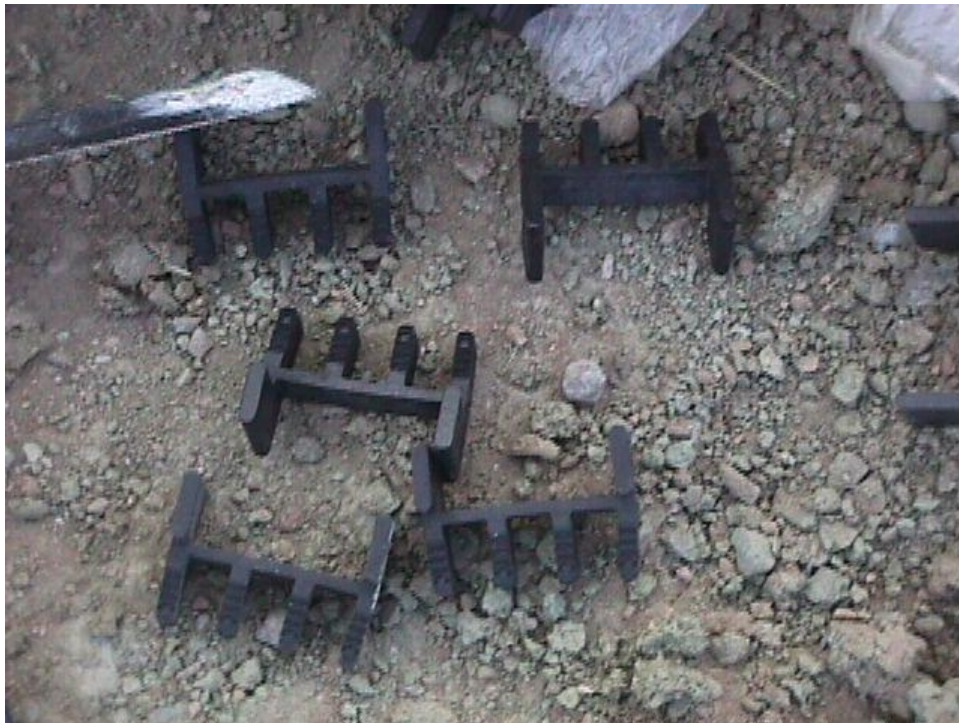
Figure B-10. The Standard Mesa Connectors which provide the positive mechanical connection strength between blocks and between blocks and geogrid. This connector has four “teeth” that fit down into the groove of the block (Fig 8) and two “flags” where the geogrid is hooked. The rear of the cavity of the next row of blocks rests against the two large flags. This provides connection strength between blocks.

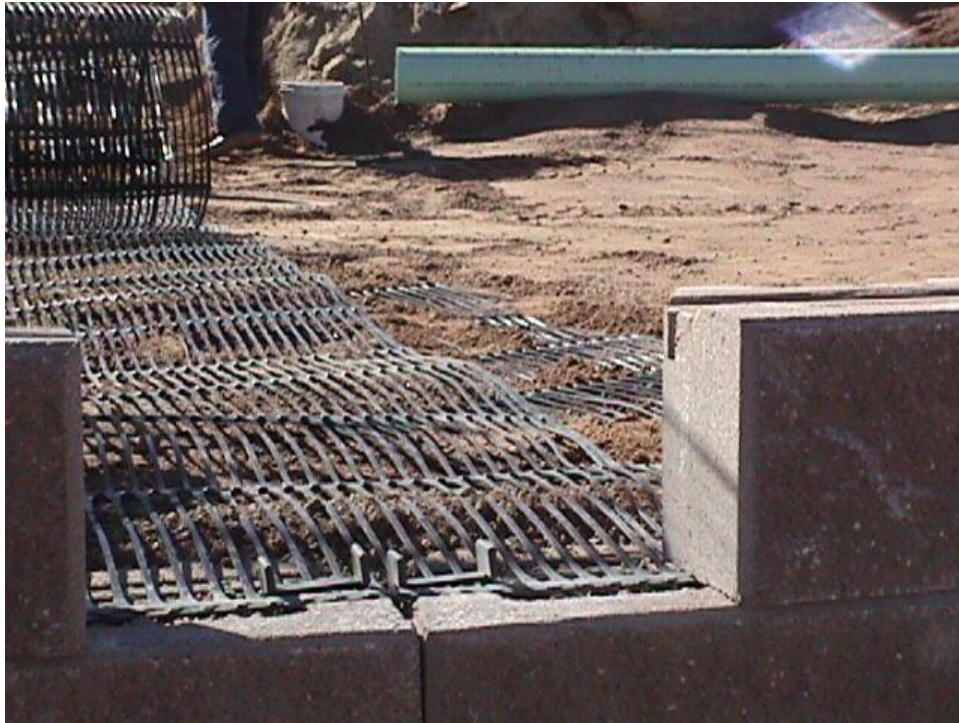
Figure B-11. The facing blocks are fastened to the geogrid by the use of Mesa Standard Connectors which fit into the grooves of the blocks.

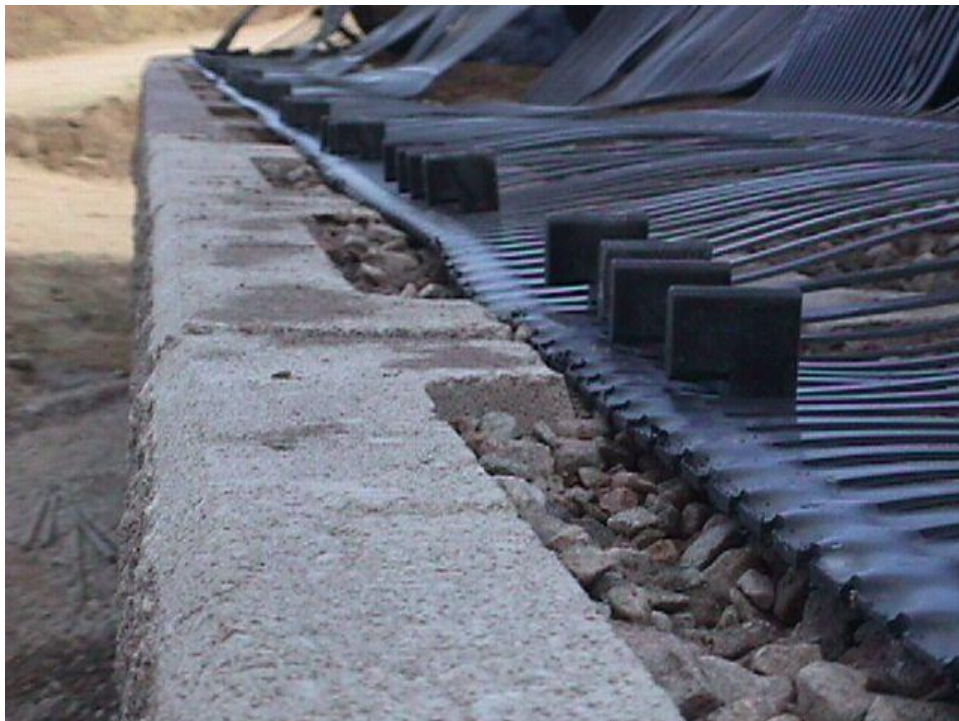
Figure B-12. The rear of the block (to the right of the picture under the geogrid) is lower than than the front to allow for the thickness of the grid.

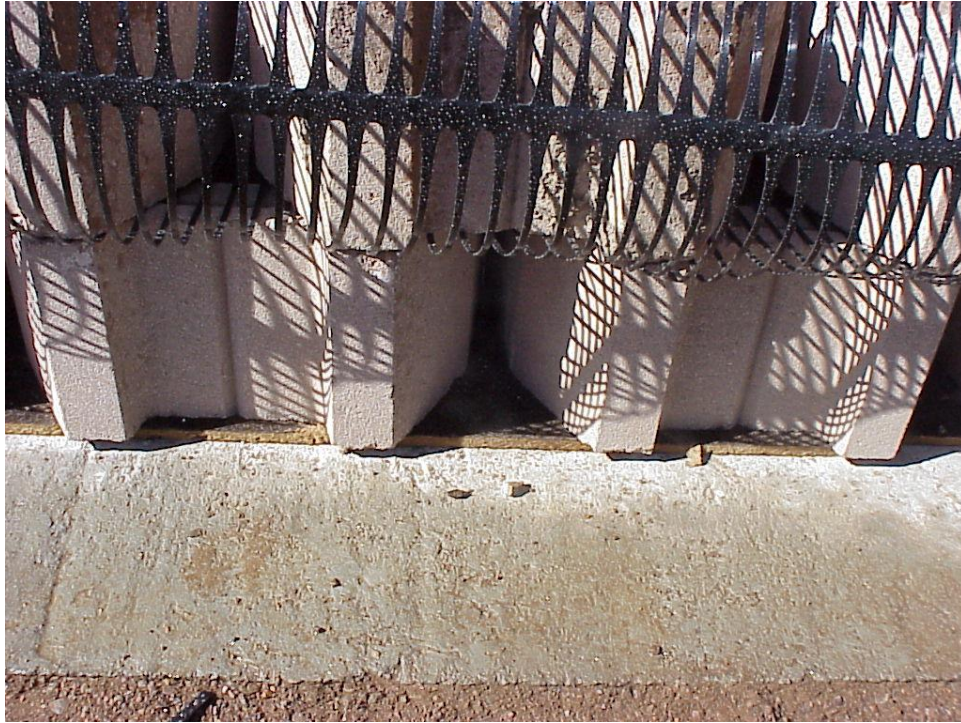
Figure B-13. Expansion joint material was placed between the leveling bed and the first row of blocks.

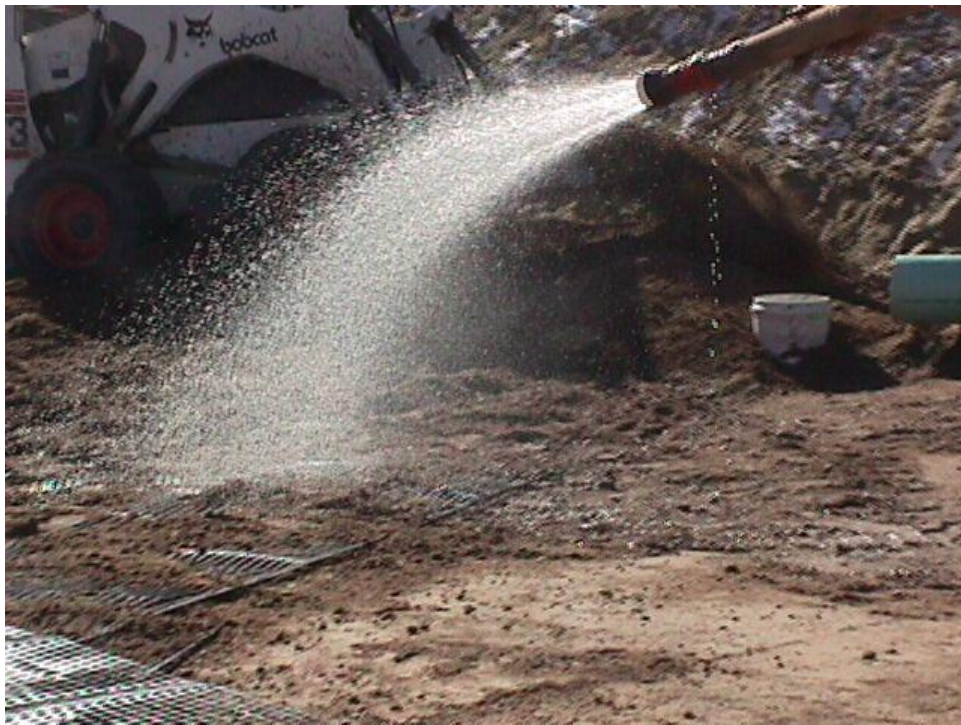
Figure B-14. Water was added before the fill was compacted.

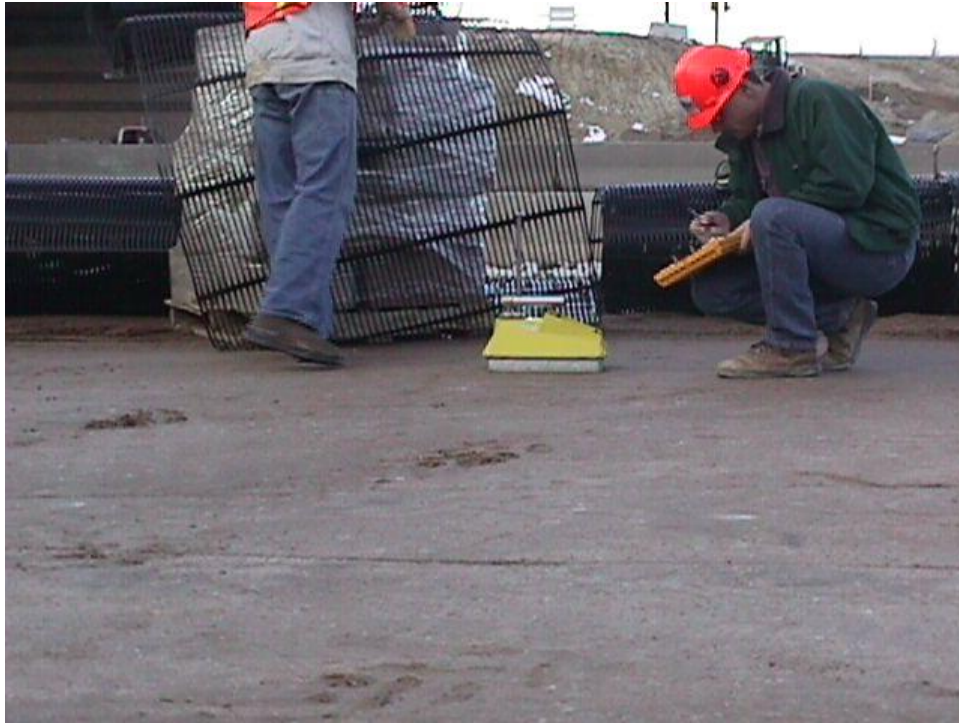
Figure B-15. Backfill levels of compaction were checked with a nuclear gage.

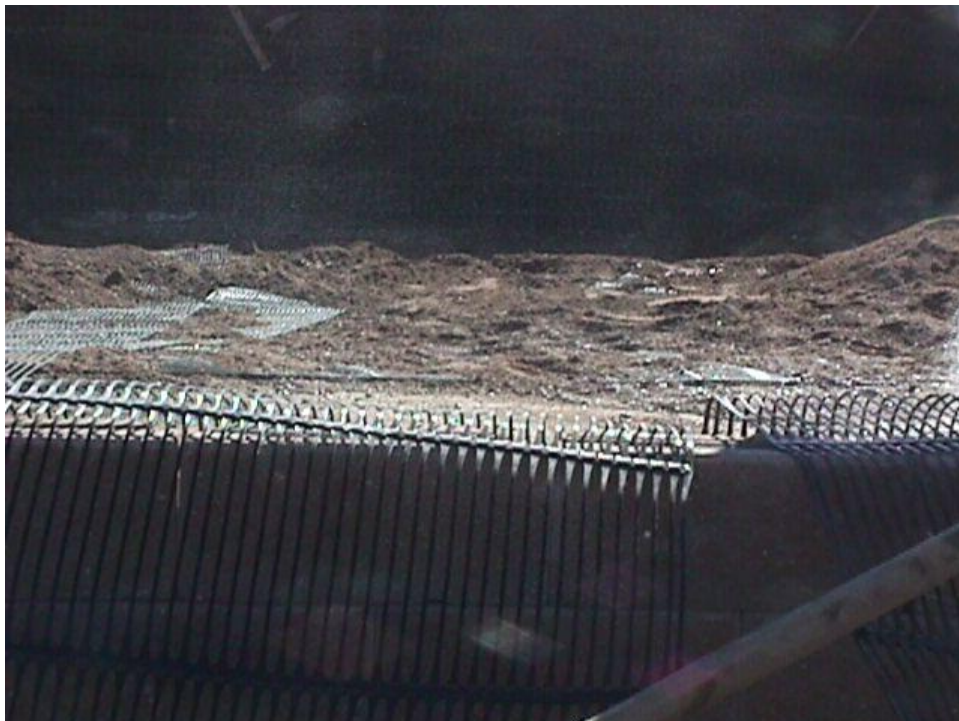
Figure B-16. Around the corners of the lower MSE walls, where geogrid from the front and side of the structure overlapped, a thin layer of fill material was placed between these geogrid layers to provide friction between them.

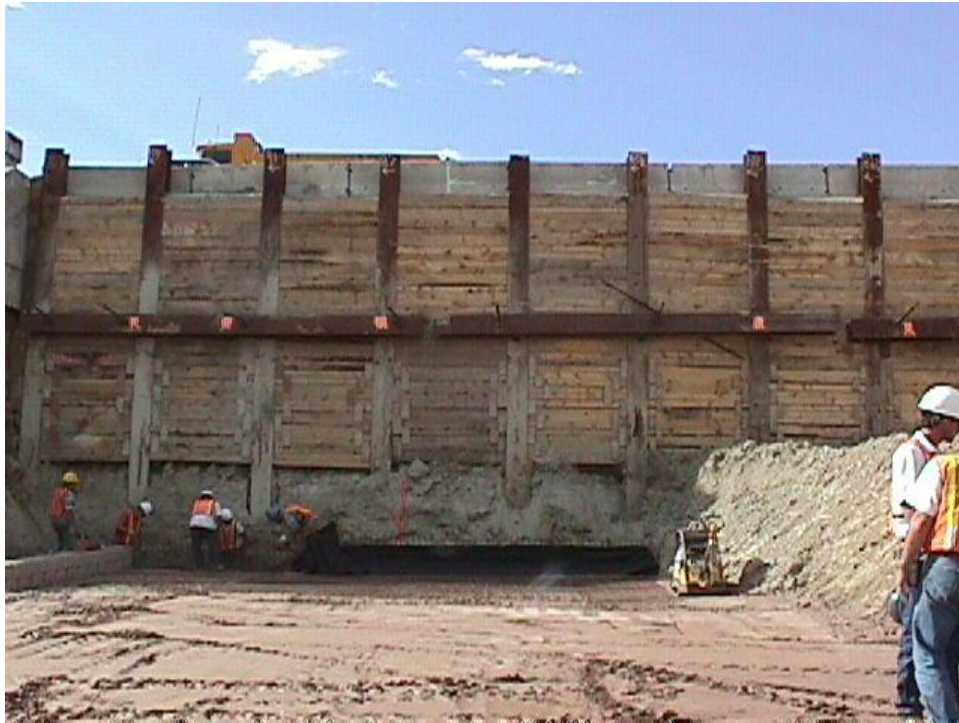
Figure B-17. The first layer of fill material at the east side of the Phase I Structure has been placed. In the background, H-beams and shoring support the approach to the old bridge during the construction of the Phase I Structure.

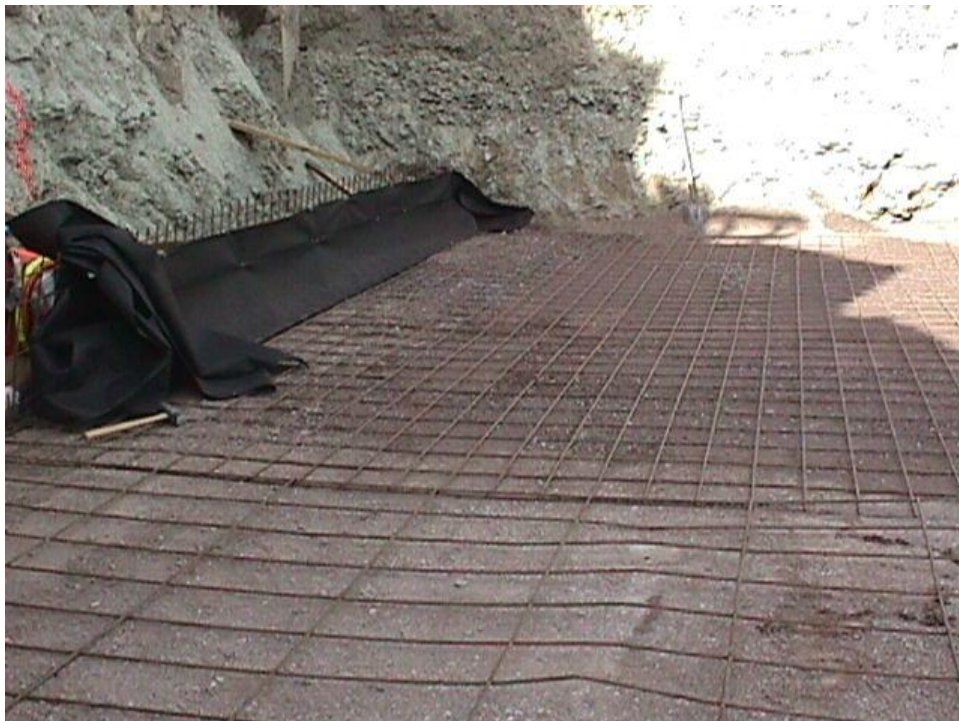
Figure B-18. The northern side of Phase I structure was internally stabilized with steel wire mesh. The steel extended past the edge of the wall and was tied to the geogrid placed to stabilize the front MSE wall.

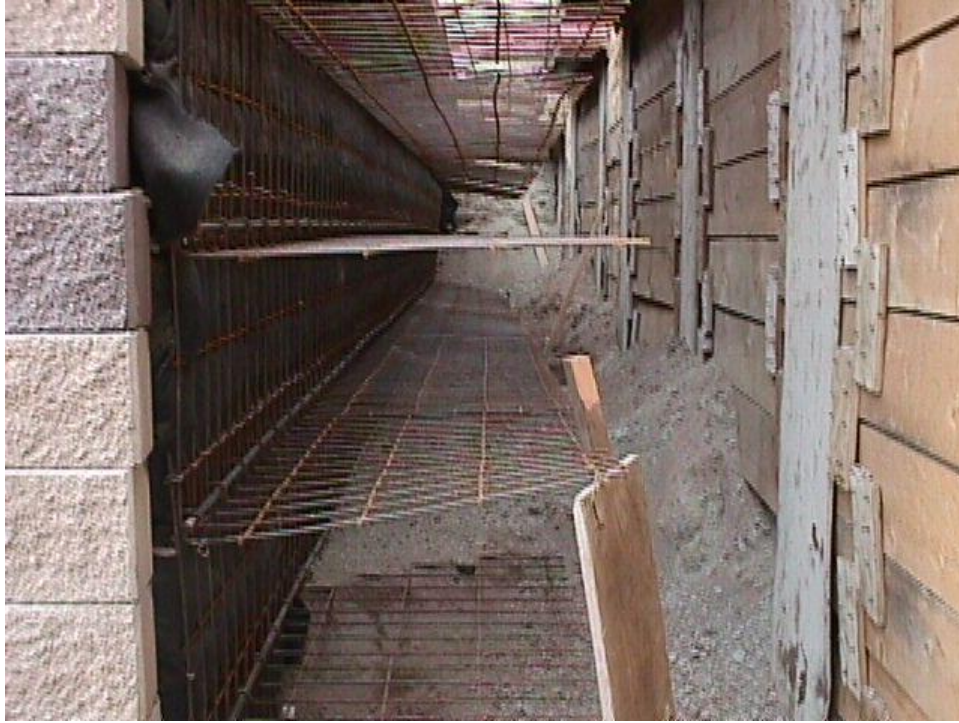
Figure B-19. Temporary wire mesh facing was used to support the northern face of the Phase I structure until the Phase II structure was built and tied to the Phase I structure. The backfill in between the wire mesh reinforcement was contained using wrapped fabric that also facilitated backfill drainage. To the right is a closer look at the shoring supporting the old bridge structure.

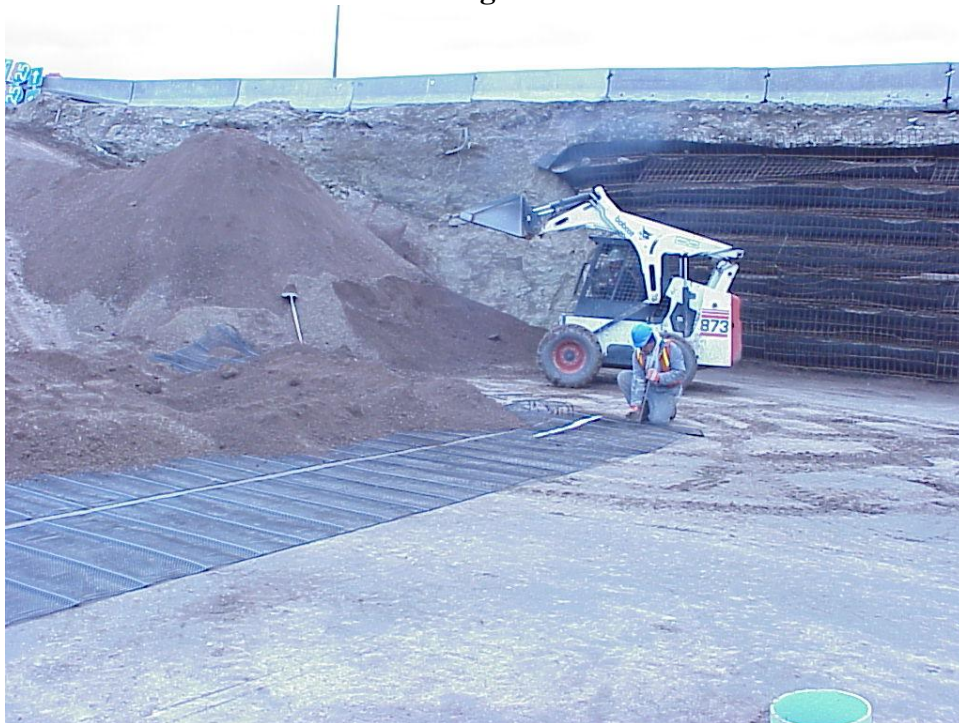
Figure B-20. The geogrid was connected at the wall end, rolled out, and then stretched by hand. The back end was staked to prevent geogrid movement while the fill was placed using a small loader. In the background is the steel reinforcement used to temporarily support the northern face of the Phase I structure.

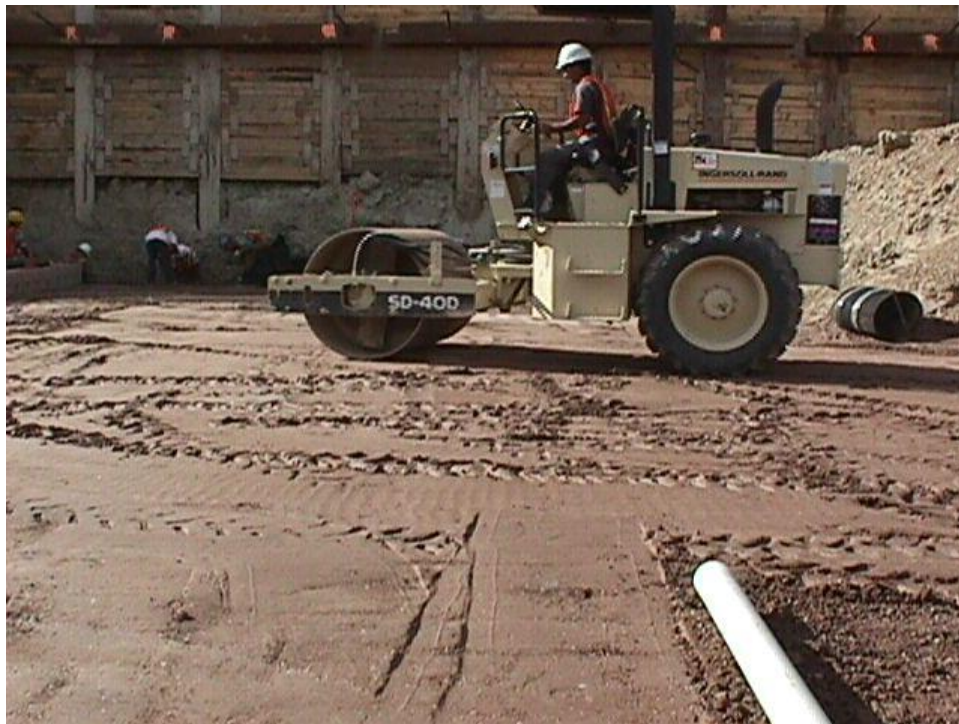
Figure B-21. A vibratory roller was used to compact the fill material.

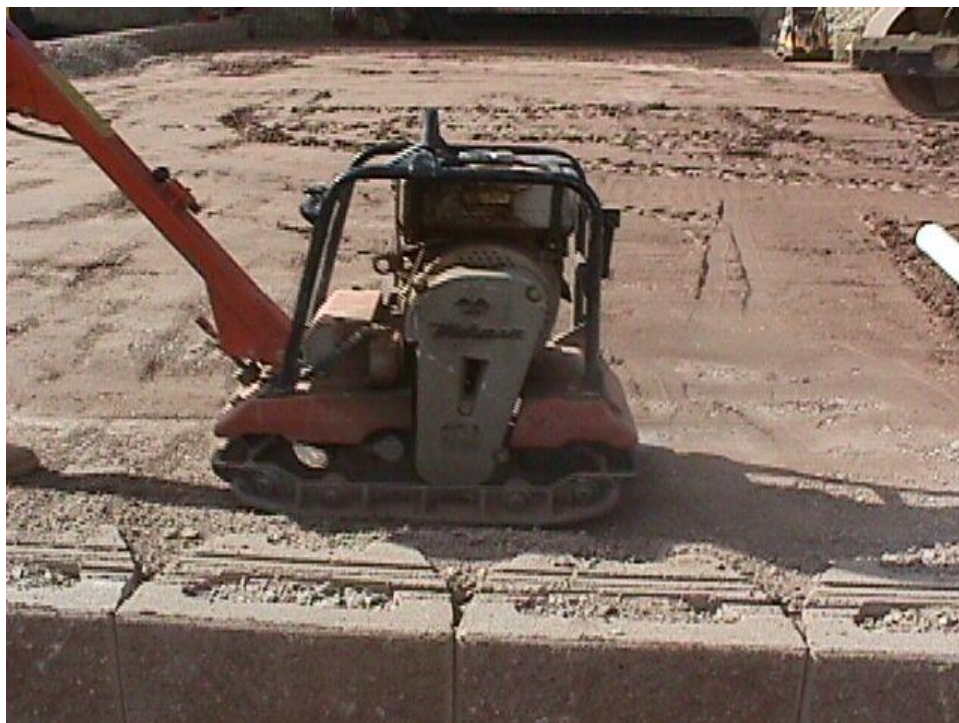
Figure B-22. Near the block facing, a small walk-behind compactor was used to prevent pushing the blocks out of position.

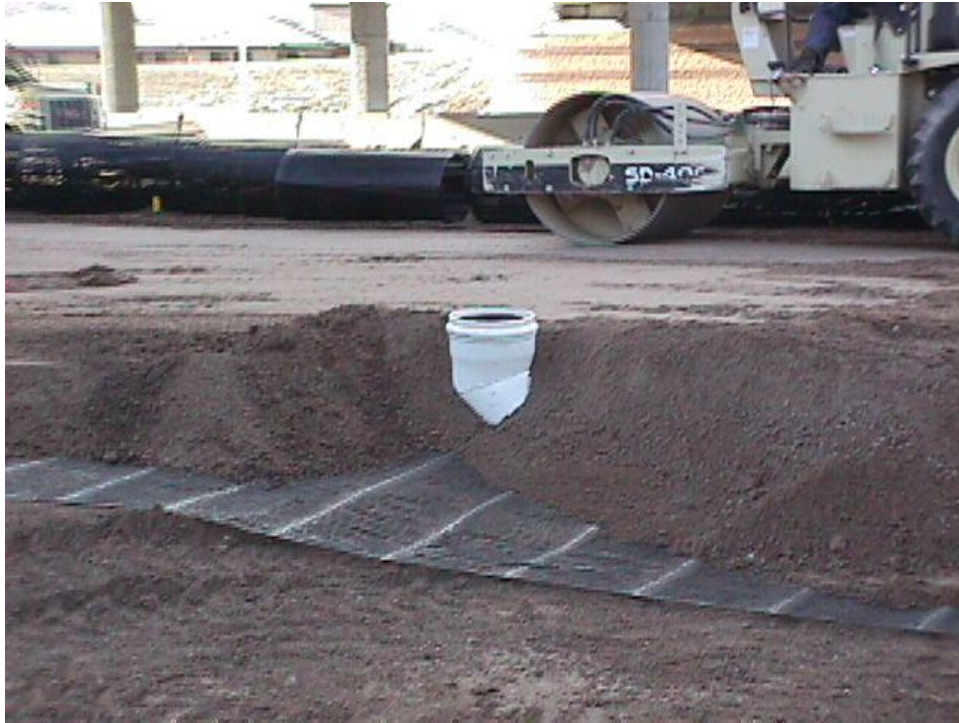
Figure B-23. A vertical drain pipe was installed inside the MSE Walls.

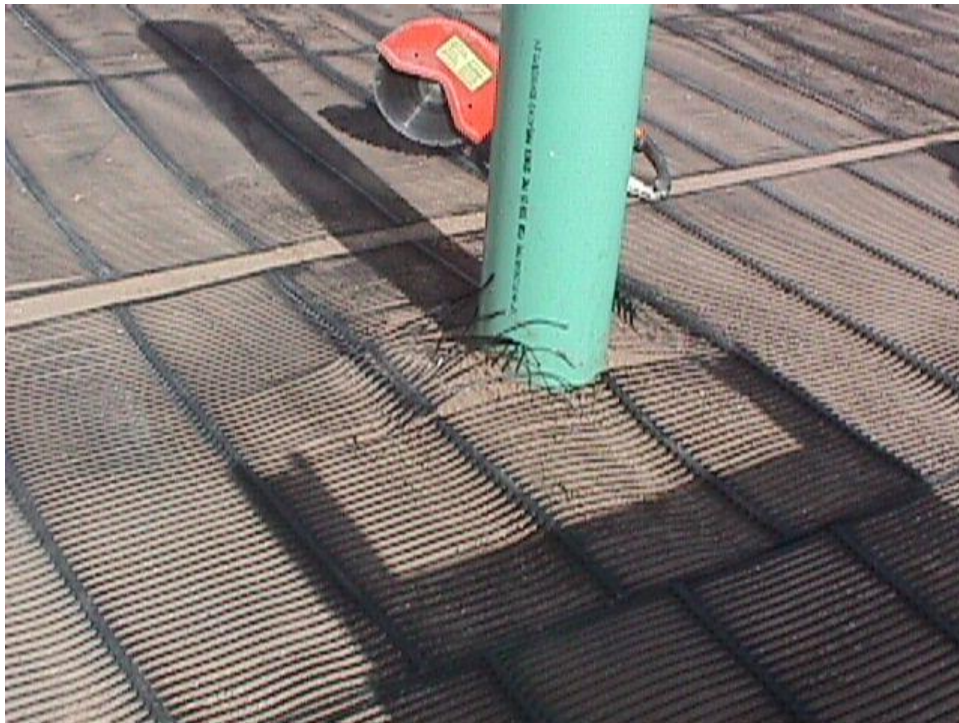
Figure B-24. The geogrid was cut to fit over a drain pipe that went down through the middle of the structure. The pieces of geogrid were offset from one layer to the next so the longitudinal joints did not line up vertically.

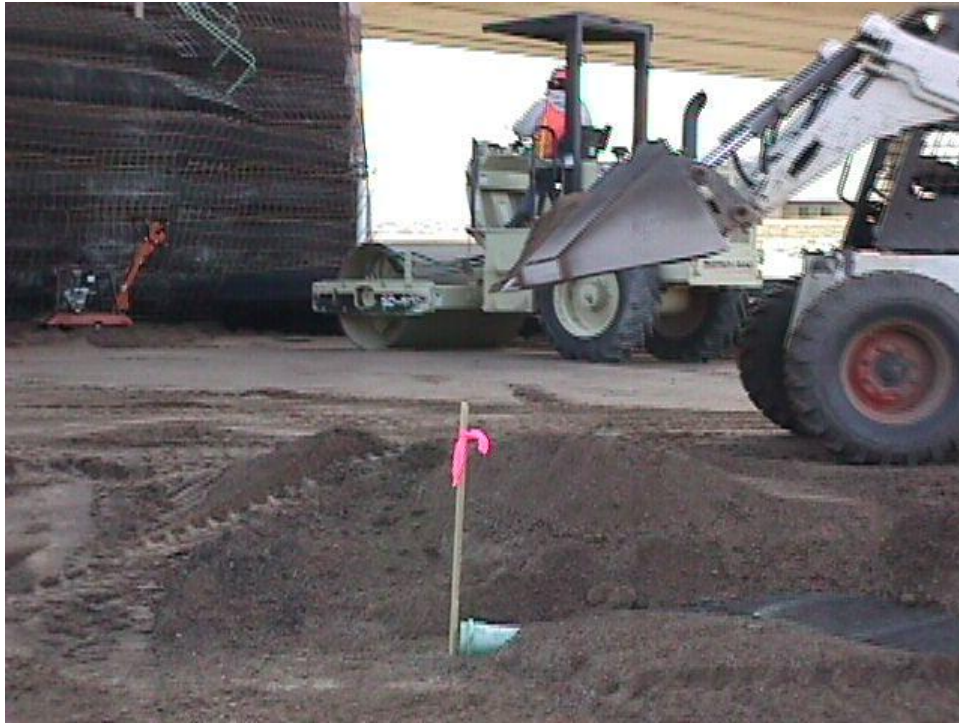
Figure B-25. The pipe used with the drainage blanket placed behind the reinforced backfill.

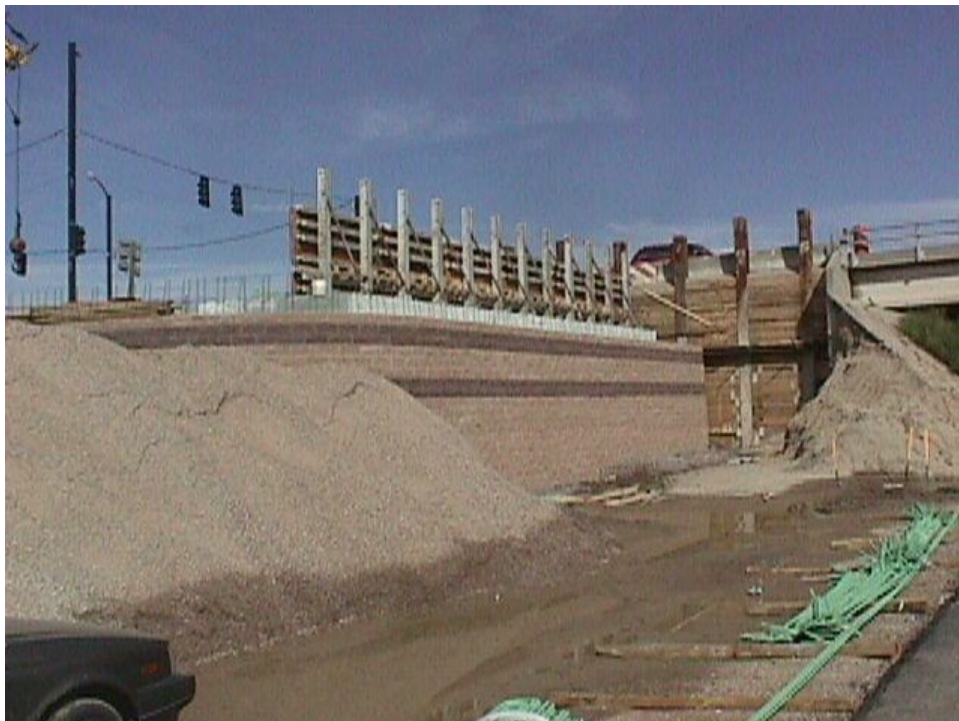
Figure B-26. The abutment wall footing has been poured and the forms are being set for the abutment wall.

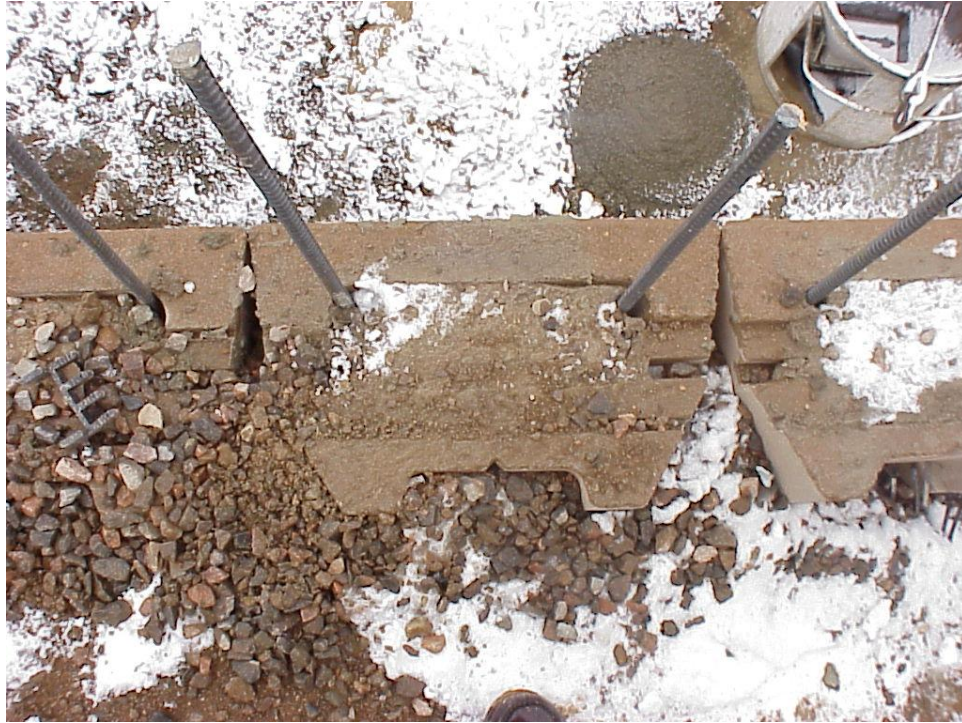
Figure B-27. The top two rows of blocks were filled with concrete. Steel rebar inserted in the plastic concrete were later bent over to tie the concrete cap at the top of the front MSE wall.

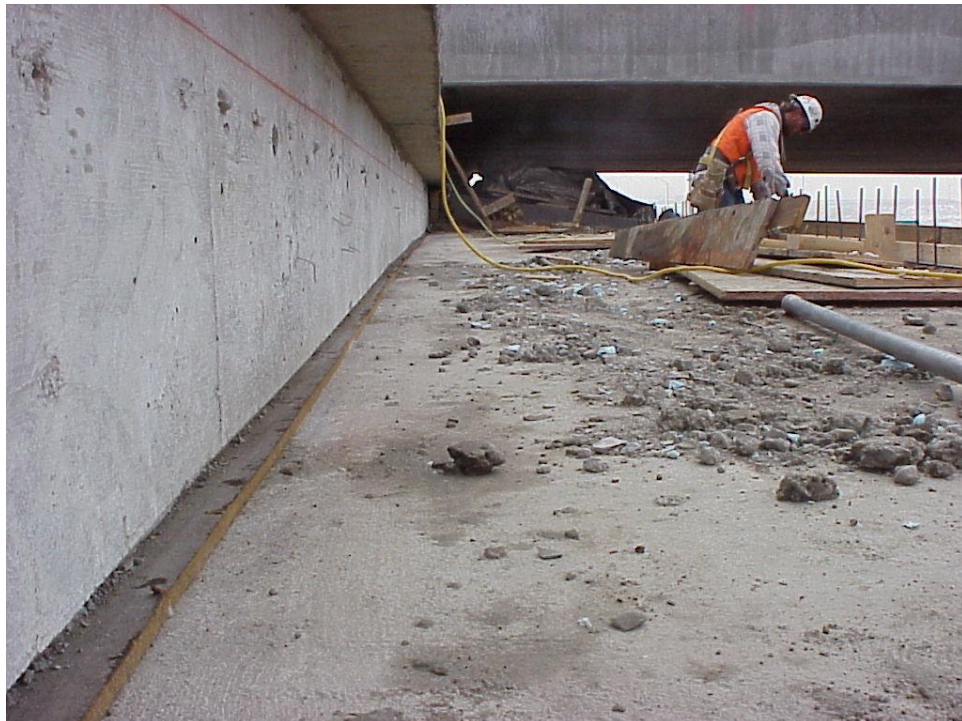
Figure B-28. Expansion joint material was installed below the sides of the abutment wall on top of the footing. In the center zone below the abutment wall on top of the footing, galvanized sheet metal centered on a bearing pad was placed (see figure 29).

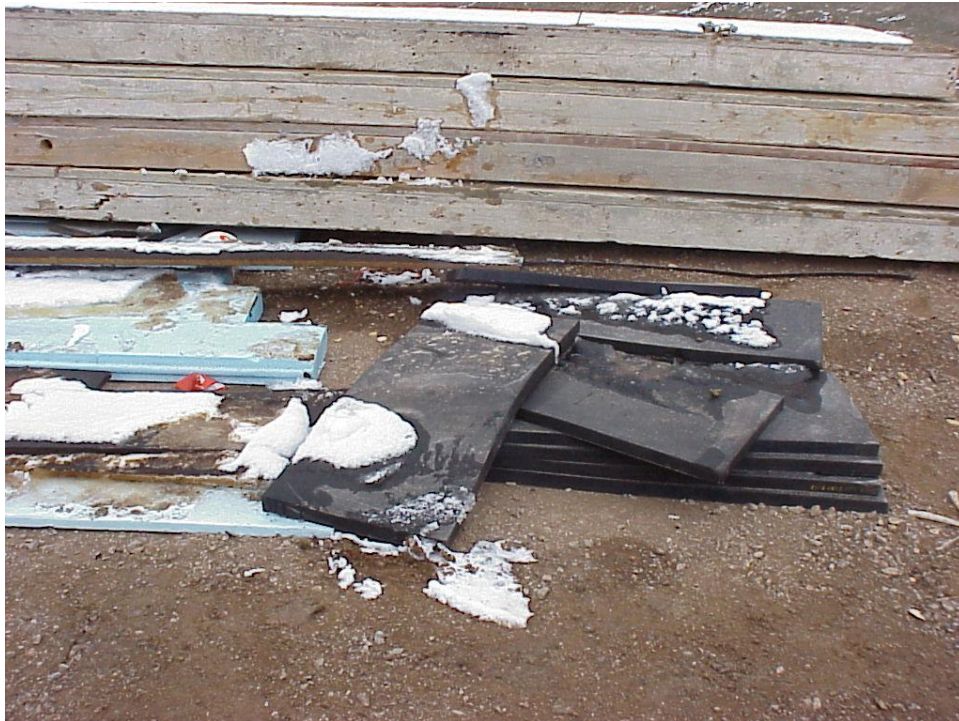
Figure B-30. These elastomeric bearing pads were installed on the abutment wall where the bridge girders are seated.

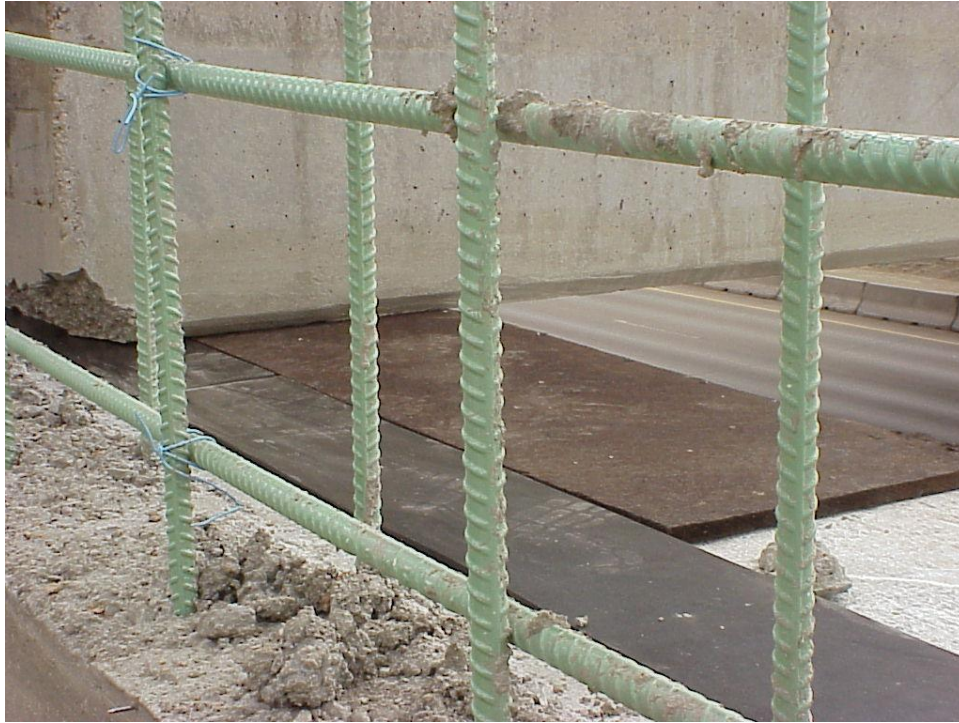
Figure B-31. The elastomeric bearing pad and expansion joints material placed on the abutment wall where girders will be seated.
