Report No. CDOT-DTD-R-2000-5

PERFORMANCE OF GEOSYNTHETIC- REINFORCED WALLS SUPPORTING THE FOUNDERS/MEADOWS BRIDGE AND APPROACHING ROADWAY STRUCTURES

**REPORT 1: DESIGN, MATERIALS, CONSTRUCTION,
INSTRUMENTATION, AND PRELIMINARY RESULTS**

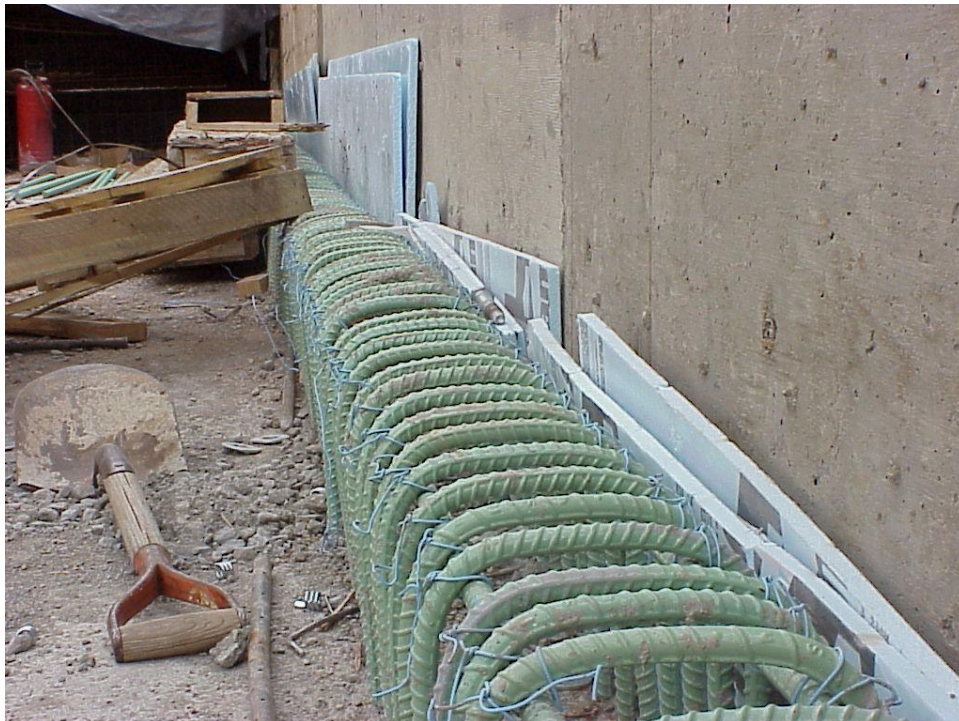
Figure B-32. A reinforced concrete “kicker” strongly attached to the bridge foundation was placed behind the bottom of the abutment wall. This kicker was placed to provide an extra bracing at the top of MSE wall for global stability.

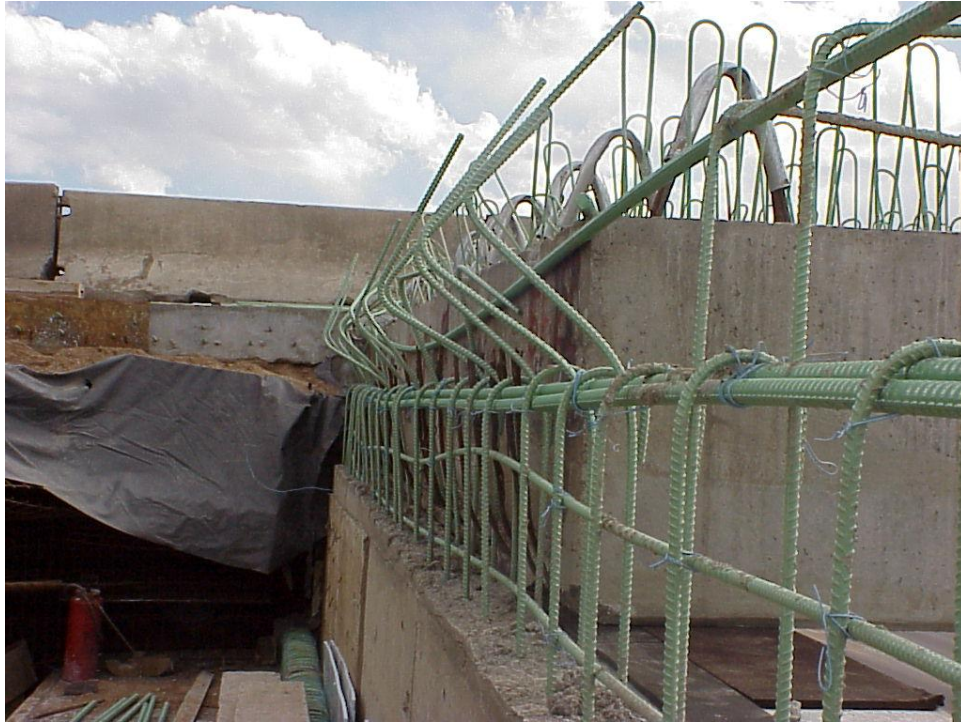
Figure B-33. Abutment wall and some girders. The stage that follows is pouring the concrete for the bridge deck and the rest of the abutment wall and girders. The overlapping steel from girders, abutment wall, and bridge deck will strongly attach the bridge superstructure to the abutment wall without any joint (integral abutment).

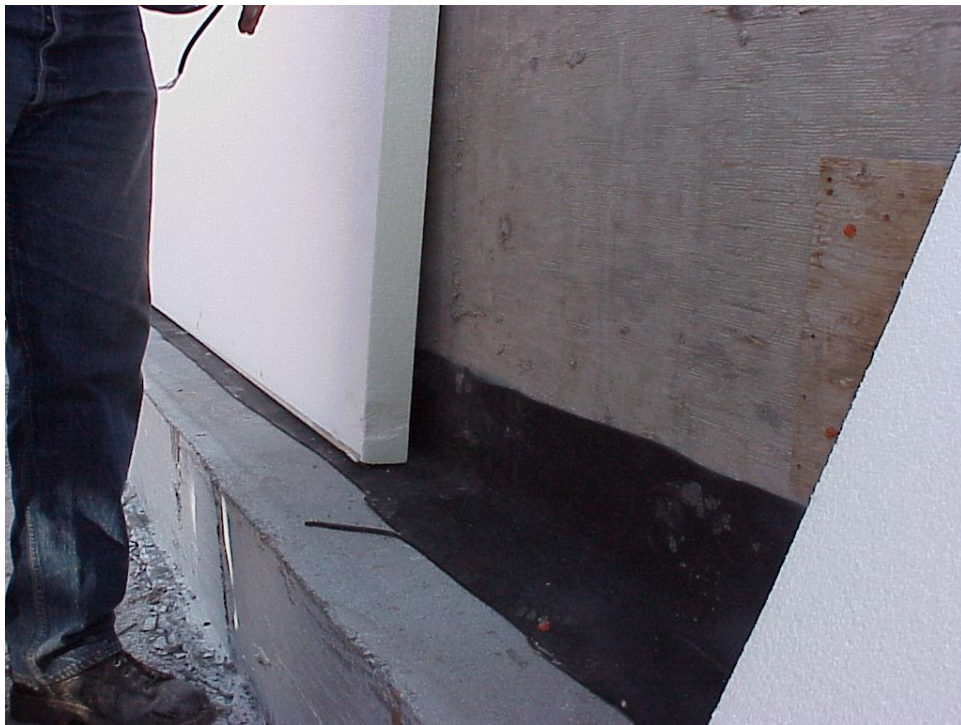
Figure B-34. A plastic sheet was placed between bridge abutment and bridge foundation to facilitate water drainage.

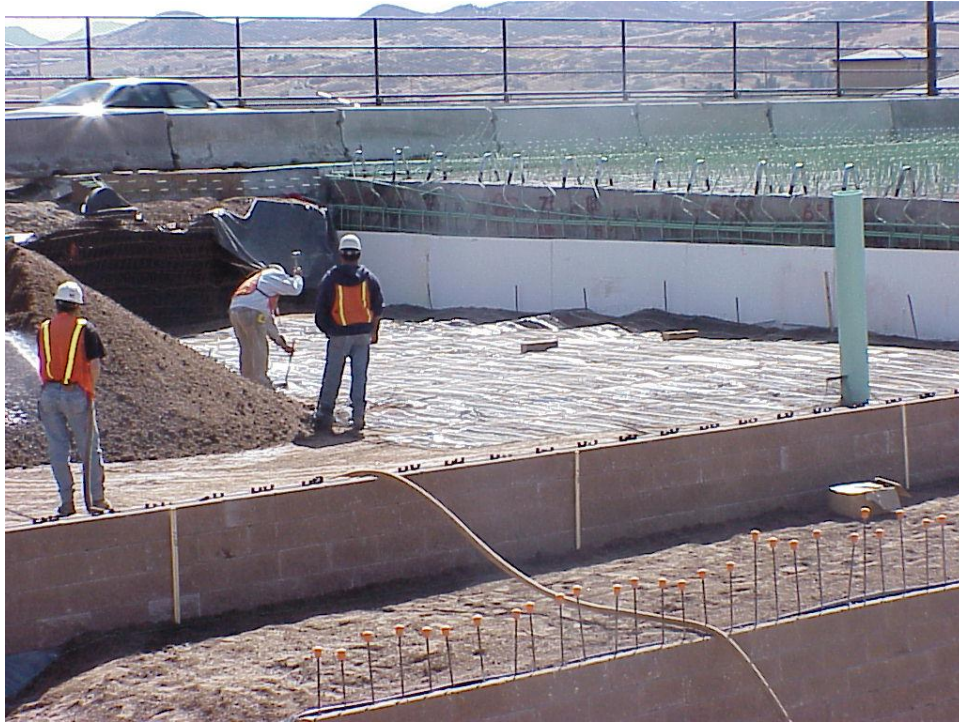
Figure B-35. After the girders were placed, 75 mm sheets of low-density expanded polystyrene were placed against the back of the abutment wall. The area in the foreground between the lower and upper MSE walls will be covered with a membrane and paved with concrete (referred to as slope paving in Fig. 40).

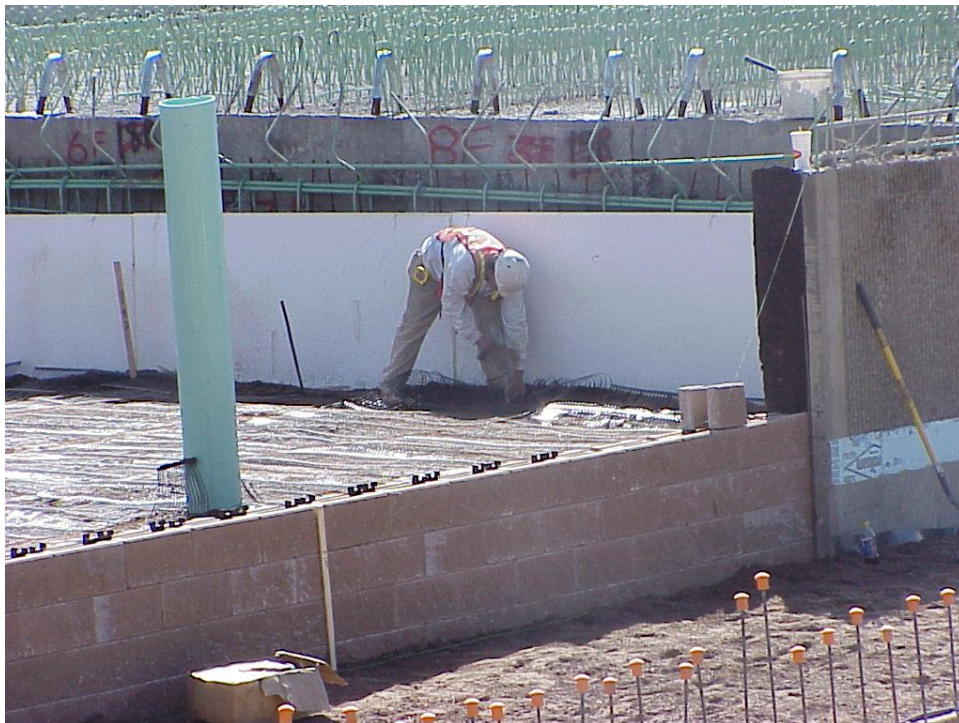
Figure B-36. The wrapped geogrid behind the abutment wall.

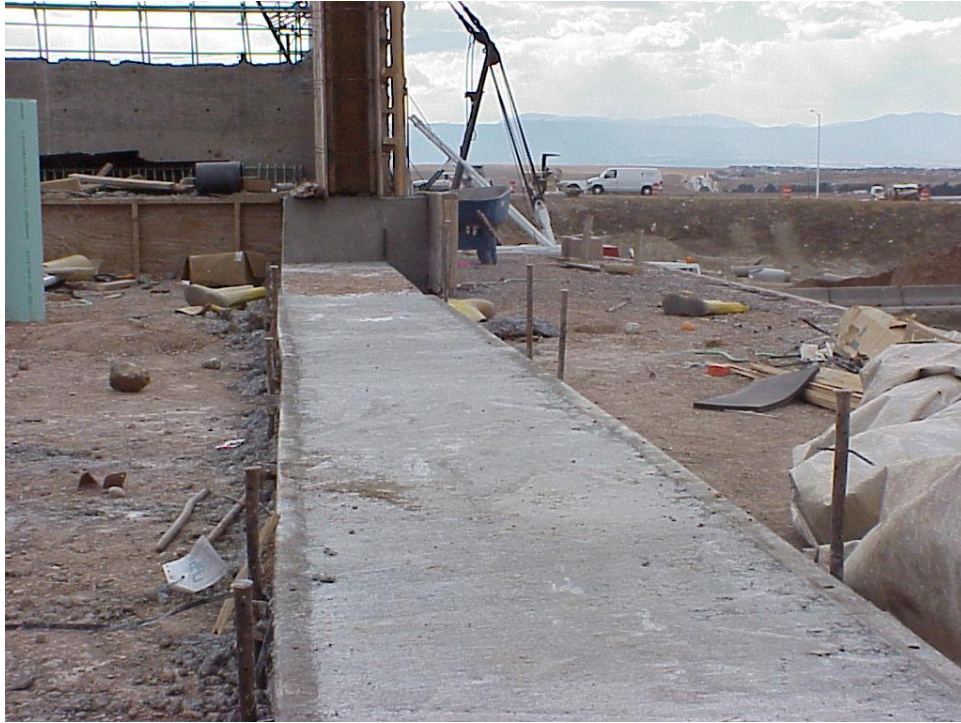
Figure B-37. Leveling pad for the upper MSE wall.

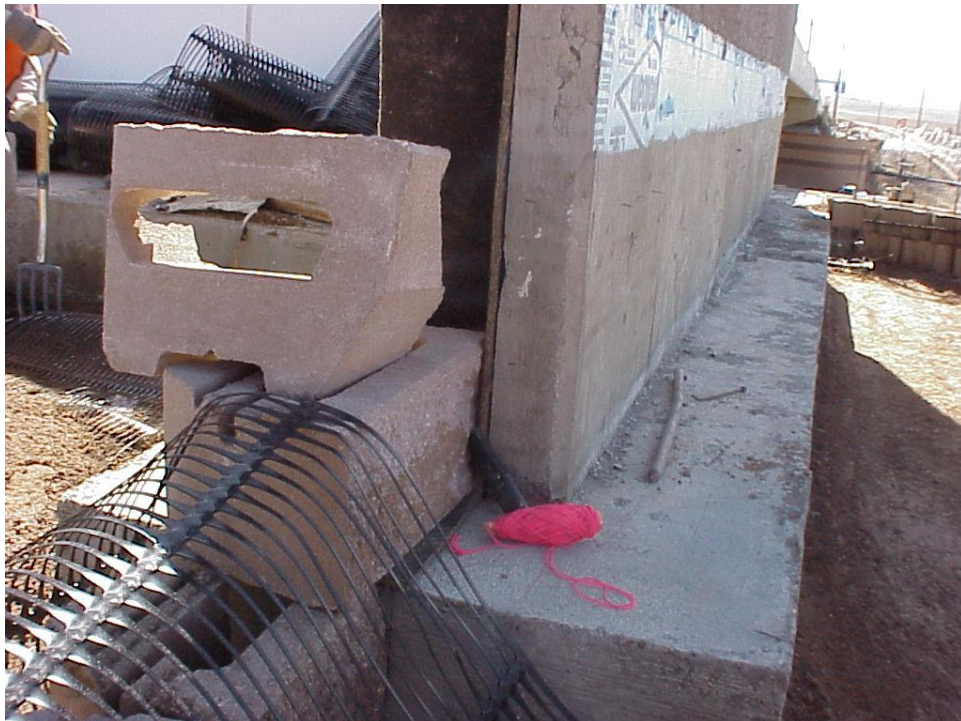
Figure B-38. The edge of the wing wall and upper MSE wall. Expansion joint material was placed between blocks and leveling pad and between blocks and the wing walls.

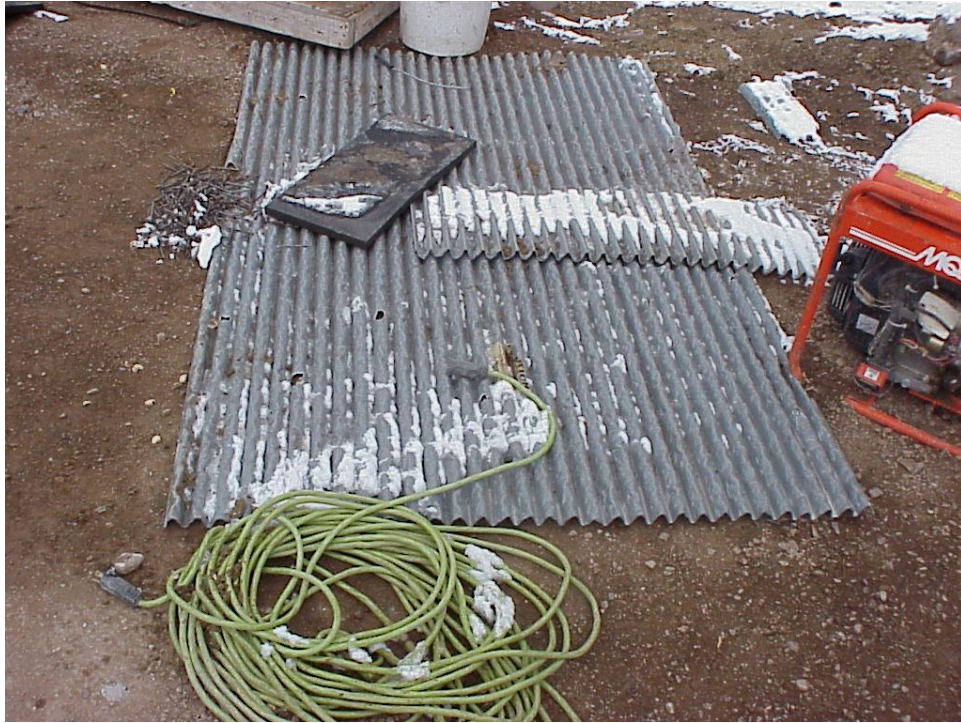
Figure B-39. This panel was used to give texture to the outside of surface of the concrete wing wall.

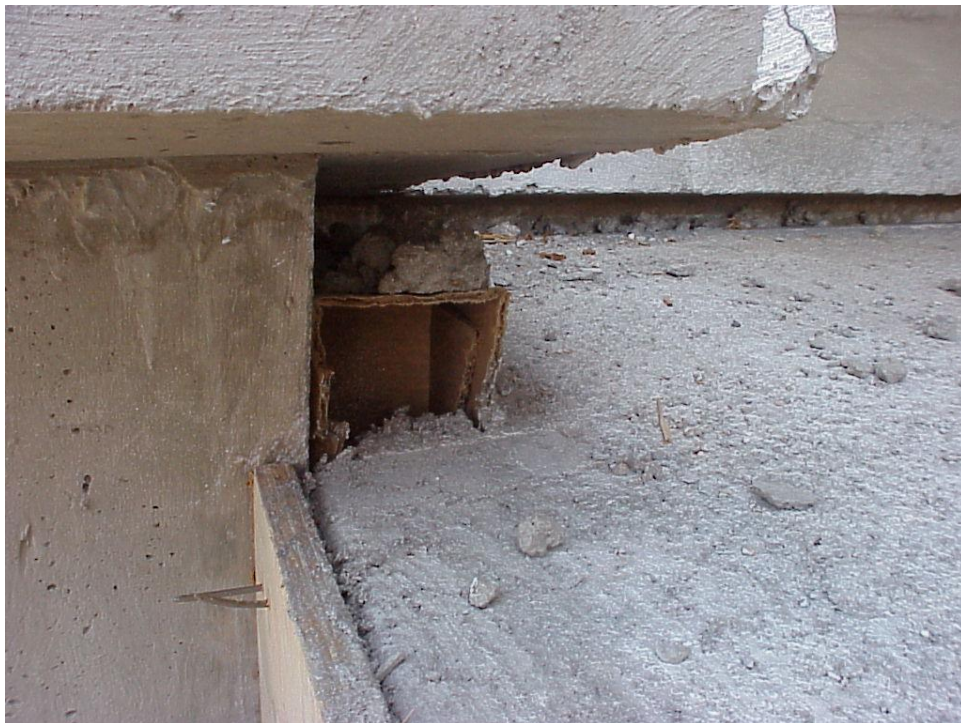
Figure B-40. Collapsible cardboard was placed in front of the bottom portion of the abutment wall behind slope paving (see figures 29 and 35).

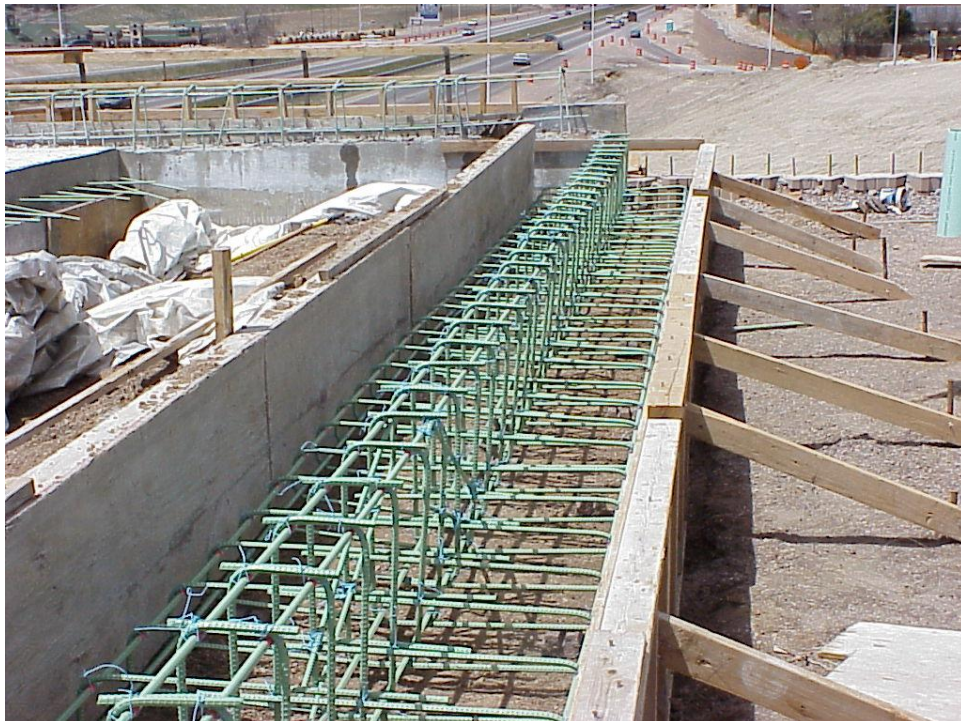
Figure B-42. The forms and reinforcing steel for the sleeper foundation supporting the approach slab.

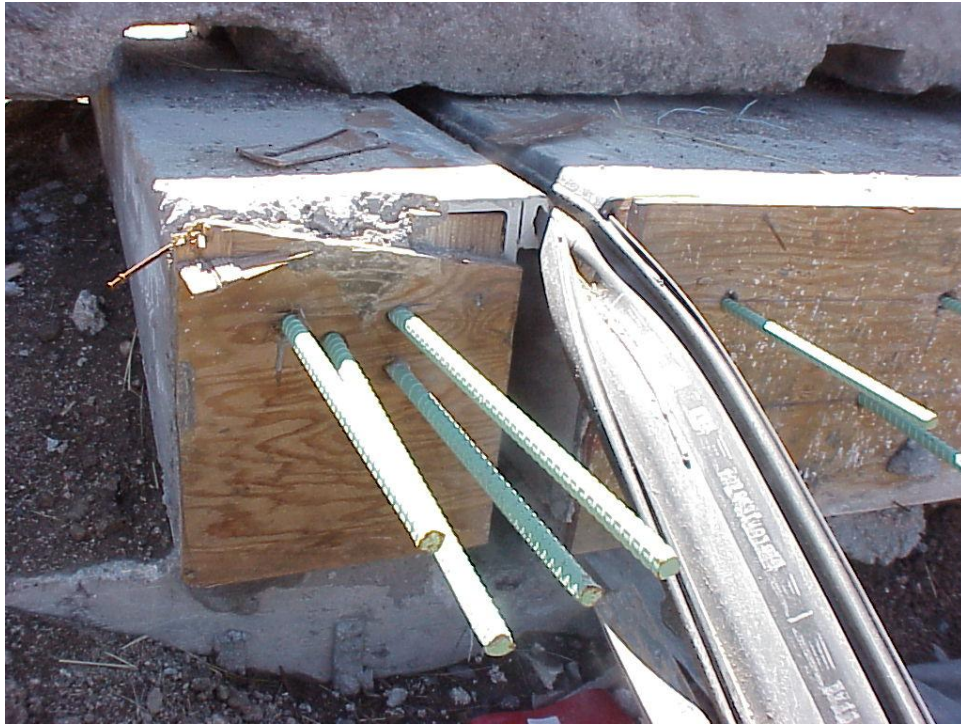
Figure B-43. The approach expansion device placed between the sleeper foundation and approach slab.
