1. Report No. FHWA/TX-07/0-5202-2		2. Government Accession No.		3. Recipient's Catalog No.	
4. Title and Subtitle Field Suction and Effect of Cracking in Highly Plastic Clay			5. Report Date September 2006

Field Suction and Effect of Cracking in Highly Plastic Clay

CTR Technical Report:	0-5202-2
Report Date:	September 2006
Project:	0-5202
Project Title:	Determination of Field Suction Values in High PI Clays for Various Surface Conditions and Drain Installations
Sponsoring Agency:	Texas Department of Transportation
Performing Agency:	Center for Transportation Research at The University of Texas at Austin

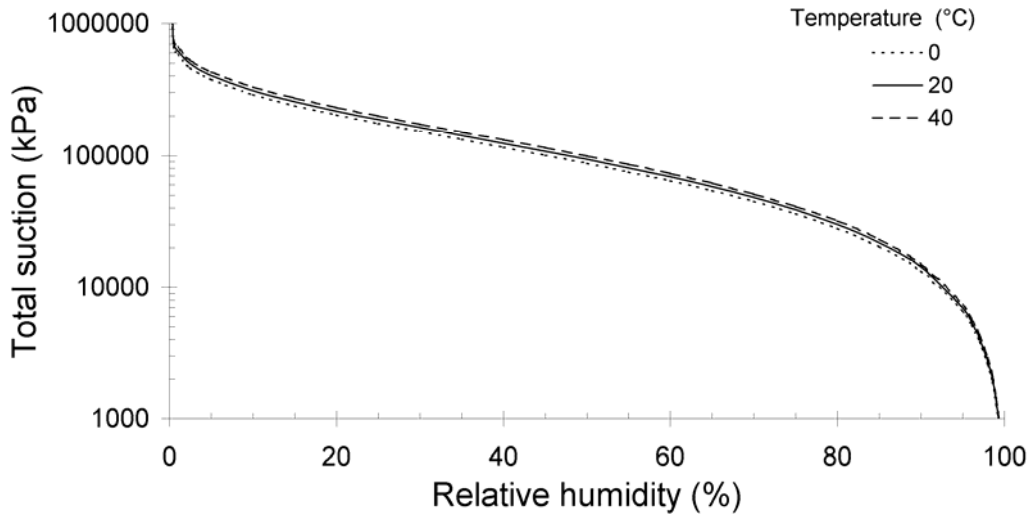
Figure 3.3: Kelvin's equation for total suction plotted for full range of values of relative humidity at various temperatures

The suction, defined using Kelvin's equation, for relative humidity values ranging from 0 to 100% is shown in Figure 3.3 for temperatures of 0, 20, and 40° C. Over the range of temperatures used during this research component, the effect of temperature on total suction was found to be negligible when compared to the effect of relative humidity.

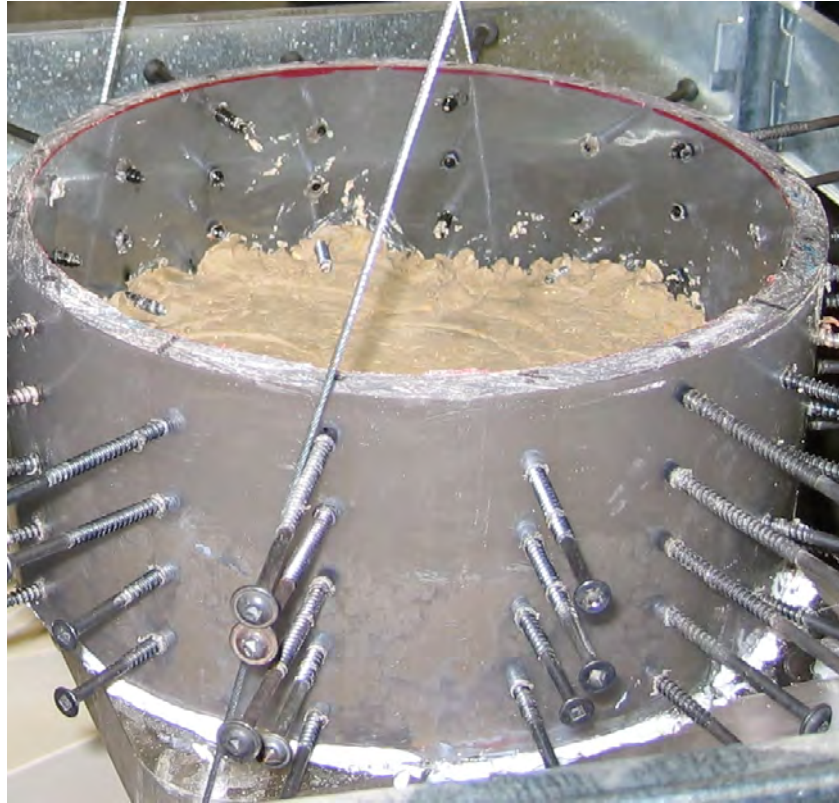
Figure 3.7: Soil Column 2

Soil Column 2 was used to investigate the rate of evaporation from a cracked clay specimen. To avoid separation between the soil and sidewalls (as in Soil Column 1), Soil Column 2 incorporated measures to minimize separation of the soil from the column walls. This soil column was 203 mm in diameter and 40 mm in height. The soil in Soil Column 2 was compacted at 34% gravimetric water content to a dry unit weight of 13.0 kN/m³ (Table 3.2). This corresponds to a degree of saturation of 86% and a volumetric water content of 45%. Sheet metal screws with a 2.9 mm inner diameter and 3.5 mm outer diameter were driven through 2.8 mm diameter pilot holes in the column sidewalls and 20 mm into the soil to minimize separation of the soil from the sidewalls during drying. The screws were placed at intervals of 22.5° around the perimeter of the soil column and at 5 mm intervals of height above the base of the soil column (Figure 3.7). The metal screws provided lateral restraint but were fixed rigidly against vertical movement along the sidewalls. Soil Column 2 is referred to as a “rigid laterally-restrained” soil column. Soil Column 2 is believed to have provided a better representation of field conditions by allowing desiccation cracks to remain open, rather than having cracks close during drying as observed in Soil Column 1.

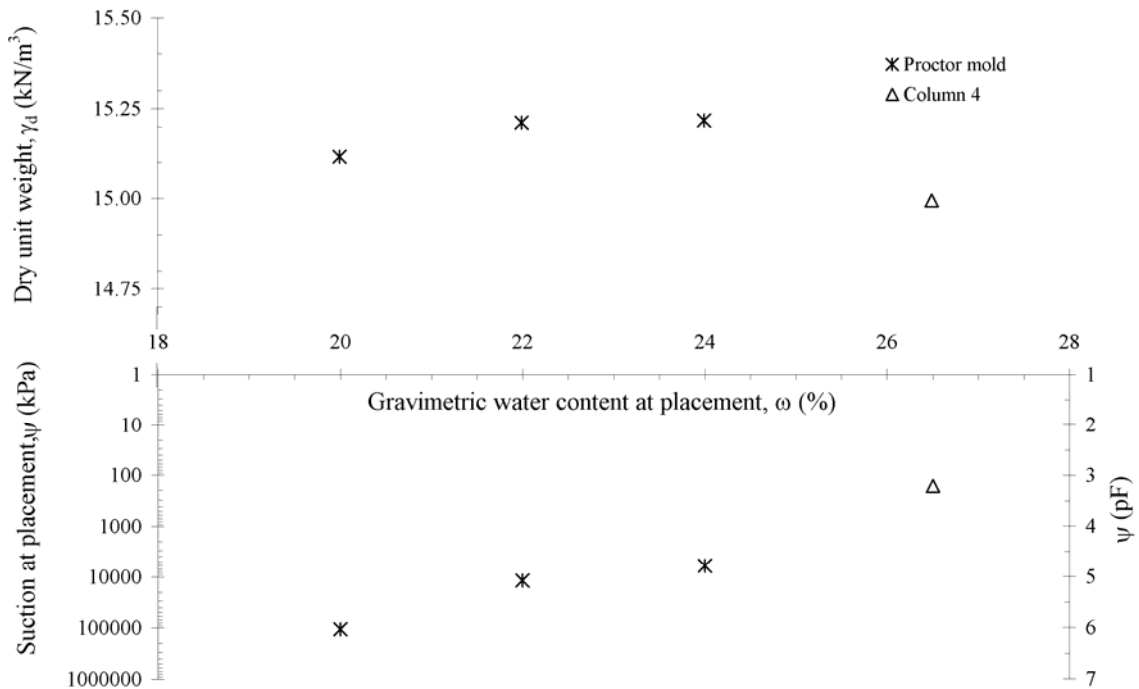
Figure 4.2: Measured suction and dry unit weight for different compaction water contents in Eagle Ford clay

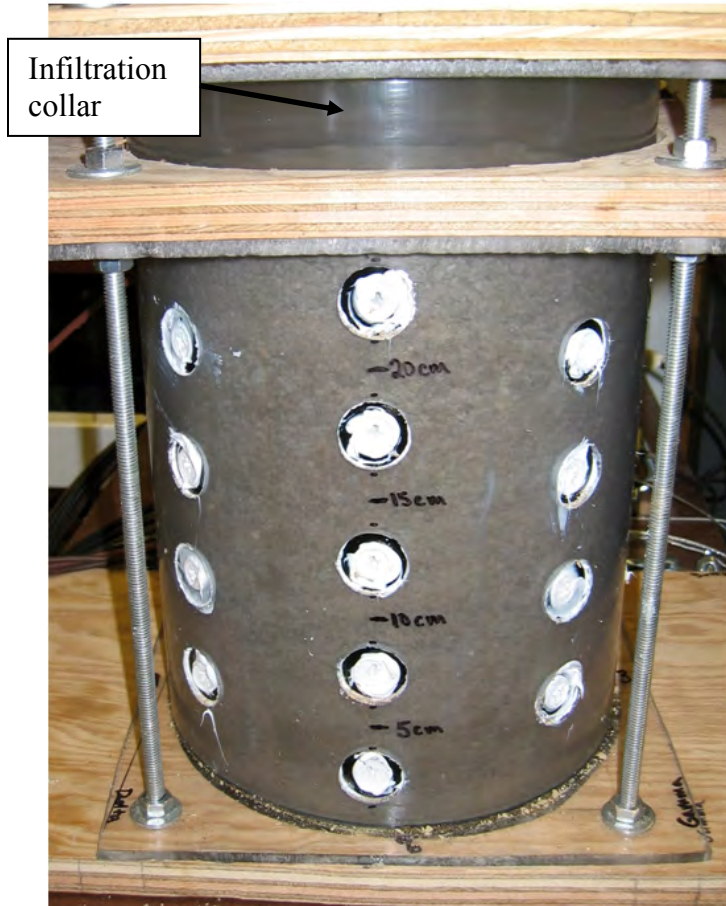
Figure 4.18: Infiltration setup for Soil Column 3

After the measured suction reached steady values during the first evaporation stage, an infiltration stage was initiated by placing a constant head of 25 mm of water on the soil surface. A view of Soil Column 3 with the extension attached for infiltration is shown in Figure 4.18. The infiltration rate as a function of time is shown in Figure 4.19. As shown in this figure, the rate of infiltration into the soil column was initially very high and decreased with time (note that the time scale in the figure is logarithmic). The soil column swelled from 249 mm to 277 mm during the first 18 hours of infiltration (Figure 3.10: Stage III). The high initial infiltration rate indicated on Figure 4.19 was due to the high gradient near the interface of ponded water and the underlying unsaturated soil. The wetting front, identified by a change in soil color, reached the base of the soil column after approximately 100 hours of infiltration. In addition, a second wetting front had reached an elevation of 150 mm after 100 hours of infiltration. The progress of the two wetting fronts, as visually observed by changes in soil color is presented in Figure 4.20. After 260 hours of infiltration, the soil specimen swelled to the top of the infiltration collar at an elevation of 325 mm (Figure 3.10: Stage V). Infiltration was continued until 1,000 hours when no further downward movement of the second wetting front was observed.

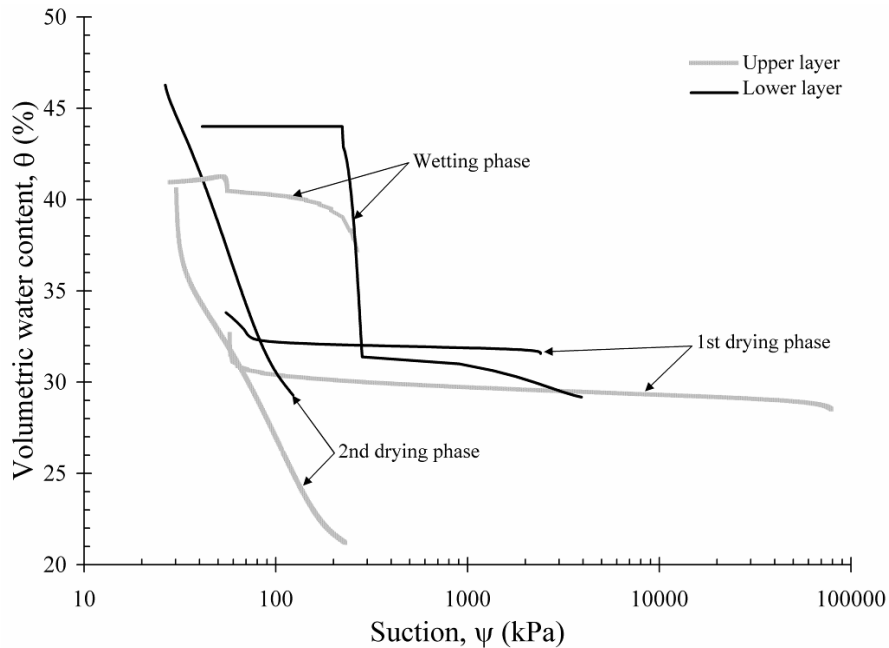
Figure 5.1: Soil water retention curves for Soil Column 3, soil compacted 2% dry of optimum

the SWRC. The SWRC obtained for the wetting phase presents significantly larger values of volumetric water content than observed during the first drying phase. This difference can be attributed to the fact that the soil was initially unsaturated, was compacted 2% dry of optimum, and swelled during the infiltration phase increasing the ratio of soil to water at a given value of suction. The SWRC measured during the second drying phase is different than the SWRC measured during the first infiltration phase and during the wetting phase. While hysteresis of the SWRC may have contributed to the different drying paths observed during wetting, it is also possible that cracks formed during the first stage of evaporation may have changed the water holding characteristics of the soil. When the SWRC from the evaporation stages are compared it may also be noted that there is a significant increase in the slope of the SWRC between phases. Finally, the SWRC measured for the upper layer during the second drying phase indicates lower values of suction at a given value of volumetric water content. This shift in suction values might indicate a greater degree of swelling in the upper layer and may reflect the greater degree of cracking observed in the upper soil layer.

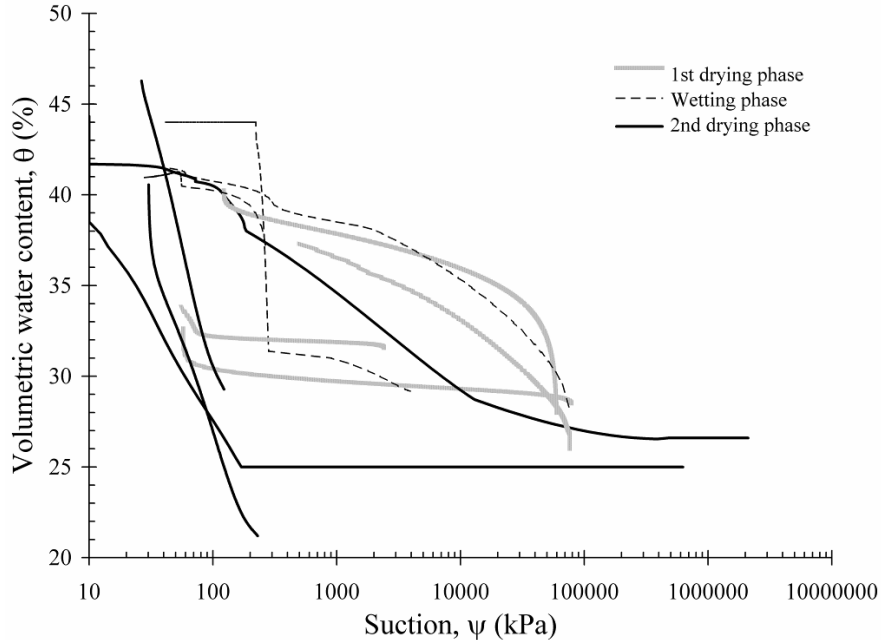
Figure 5.3: Soil water retention curves for the soil specimens, compacted 2% dry and wet of optimum

The SWRCs for Soil Column 3 and 4 are plotted together in Figure 5.3 in order to determine the effect of a drying phase, a wetting phase, and a second drying phase upon the shape of the SWRC. When volumetric water contents for the first evaporation stage and the infiltration stage are compared for low suction values (e.g., lower than 100kPa), the values of volumetric water content measured during the infiltration stage are significantly larger. This increase in volumetric water content was presumably caused by swelling. As noted earlier, this effect was more significant in Soil Column 3 where the soil was prepared at a water content 2% dry of optimum. During the second evaporation stage, the volumetric water content values at suctions higher than 100 kPa are less than the volumetric water content values measured during the first evaporation stage and the infiltration stage. The changes in the SWRC suggest that soil that underwent cracking cannot sustain comparatively high values of suction unless the volumetric water content decreases to a value significantly lower than the volumetric water content measured during the first evaporation stage (e.g., $\theta < 20\%$).

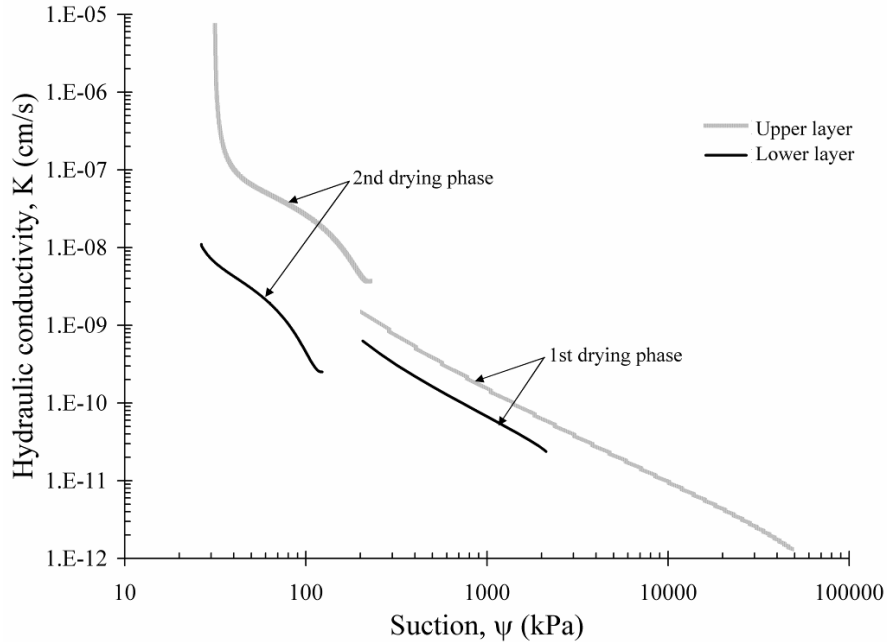
Figure 5.10: Hydraulic conductivity function for the Soil Column 3, compacted 2% dry of optimum

The hydraulic conductivity functions determined for Soil Column 3 are shown in Figure 5.10. It is evident that there is a shift in the hydraulic conductivity function from the first to the second drying phase. During the second drying phase, suction values as high as observed during the first drying phase were not observed until near the close of the experiment. Furthermore, the measured range of hydraulic conductivity increased by approximately three orders of magnitude from the first to the second drying phase. It can, however, be noted that the hydraulic conductivity function measured during the first and second drying phases have approximately the same slope. This may indicate that although the k-function has shifted significantly, the change in hydraulic conductivity with change in suction in a log-log relationship does not change significantly with a cycle of wetting and drying.

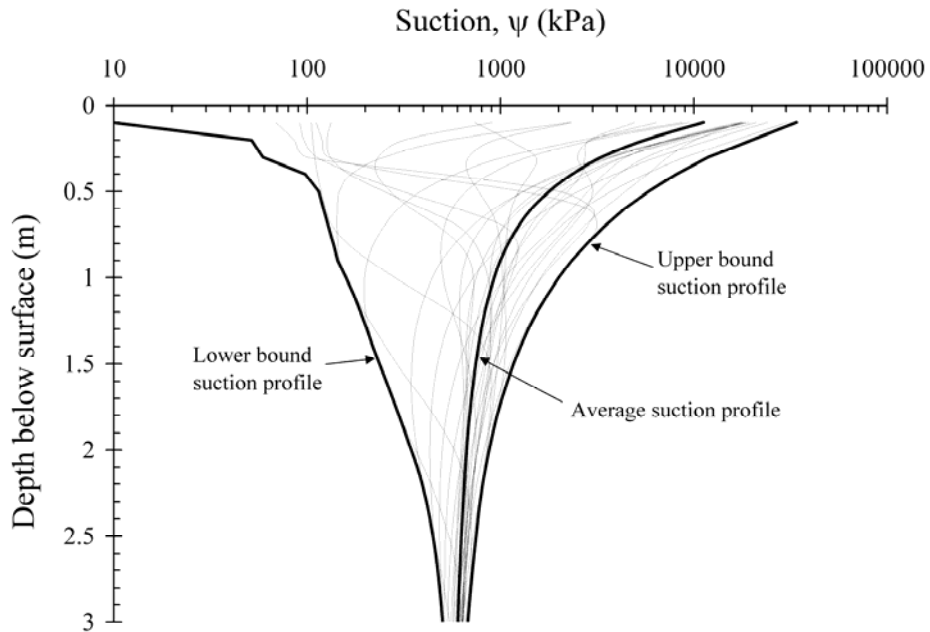
Figure A.10 Predicted variation of suction profile over the course of a year for Eagle Ford clay under Austin, TX weather conditions

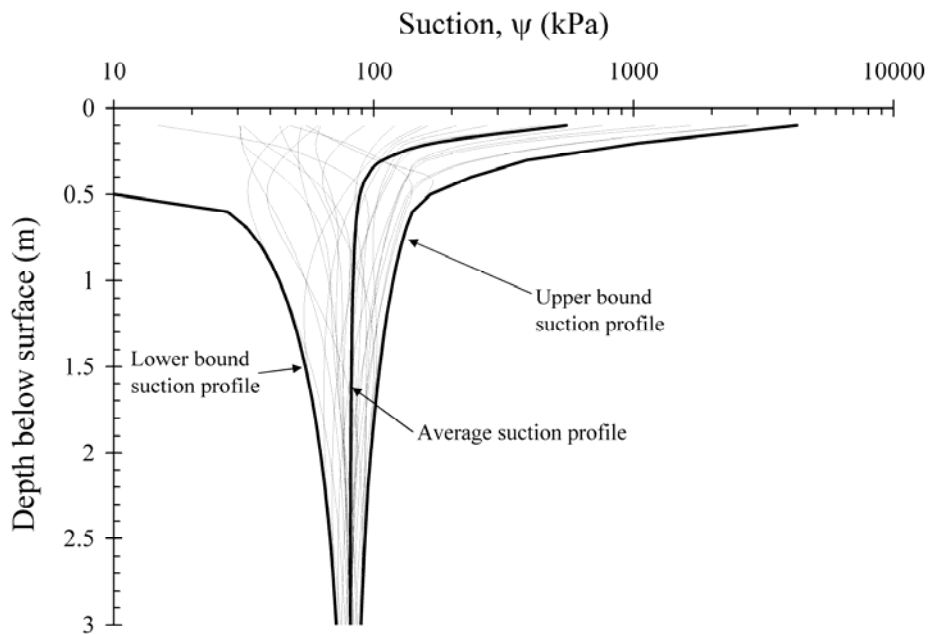
Figure A.12 Predicted variation of suction profile over the course of a year for Eagle Ford clay under Houston, TX weather conditions

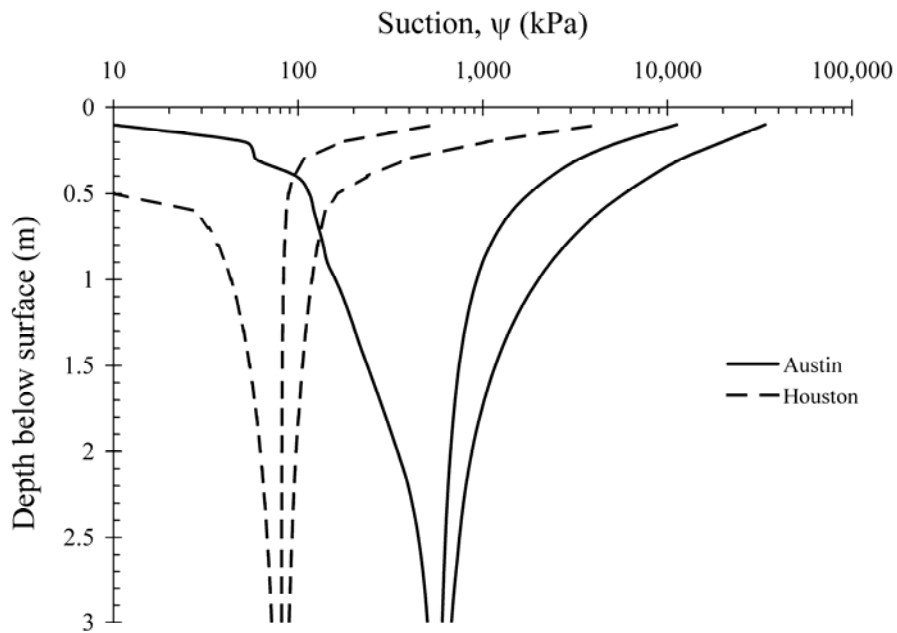
Figure A.16 Predicted range of suction profile over the course of a year for Eagle Ford clay under Austin and Houston, TX weather conditions

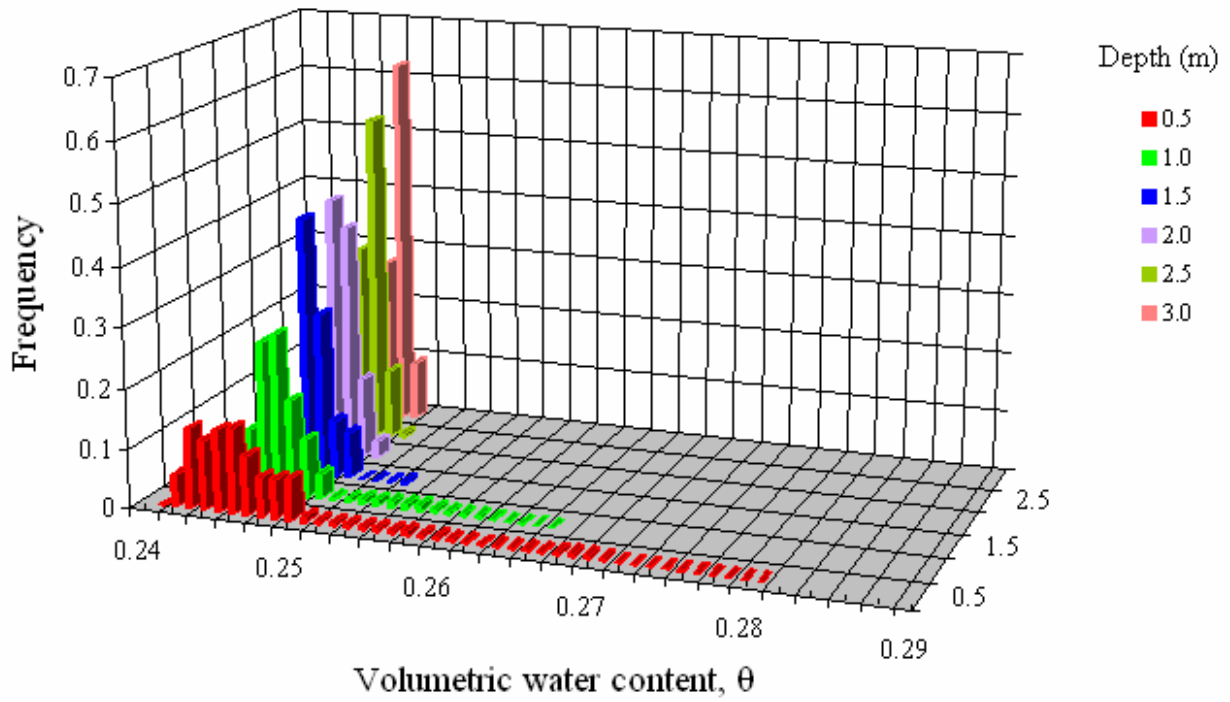
Figure A.19 Histogram and cumulative frequency for predicted changes in water content over the course of a year for Eagle Ford clay under Austin, TX weather conditions

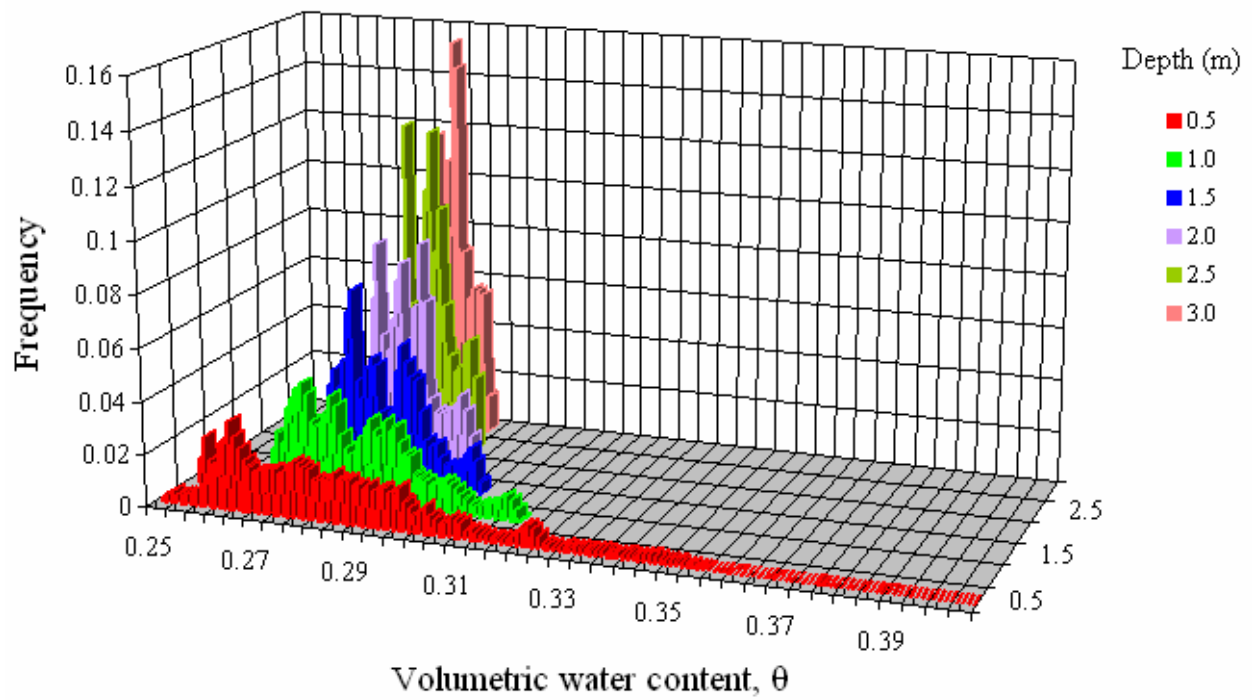
Figure A.20 Histogram and cumulative frequency for predicted changes in water content over the course of a year for Eagle Ford clay under Houston, TX weather conditions

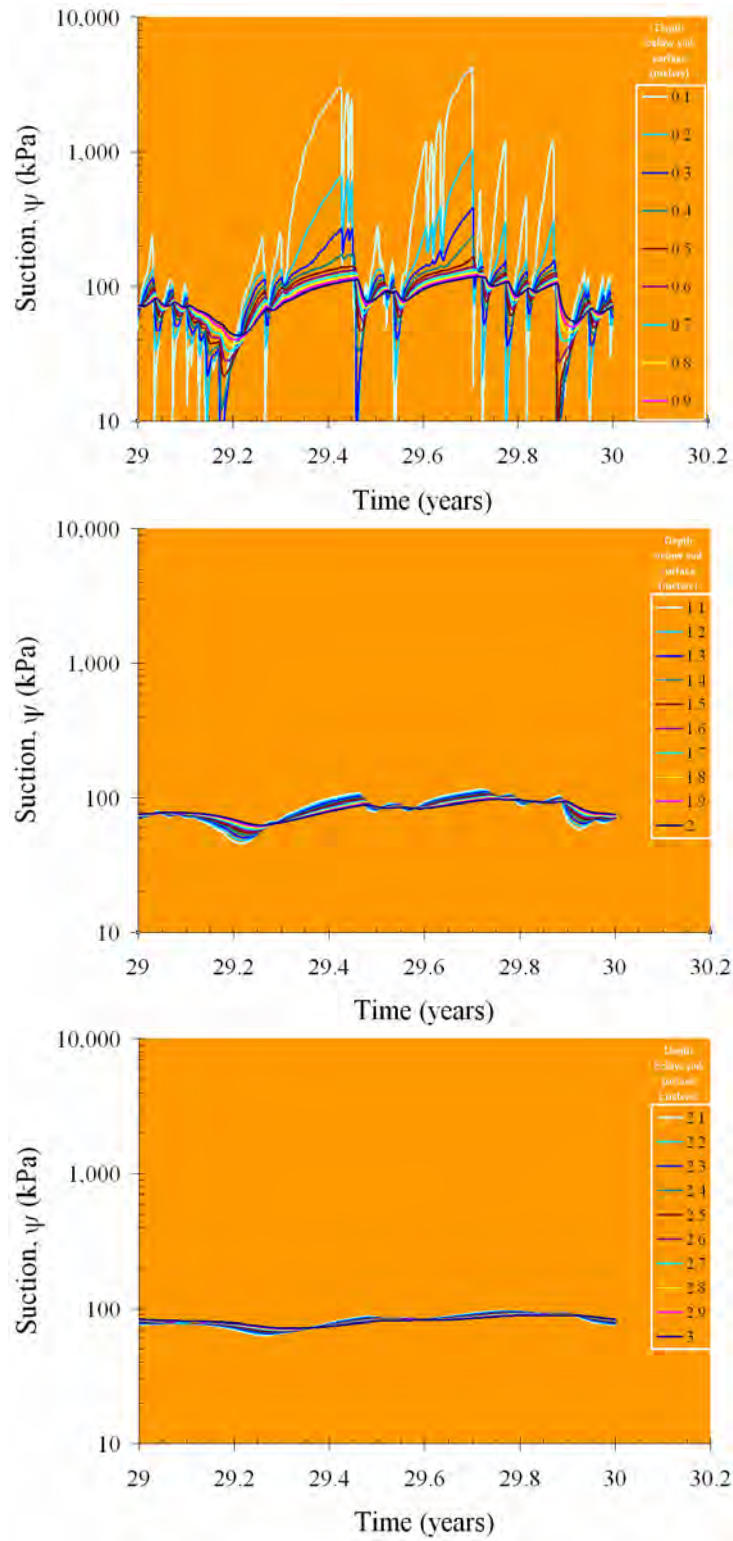
Figure A.23 Predicted changes in suction profile over the course of a year for Eagle Ford clay under Houston, TX weather conditions

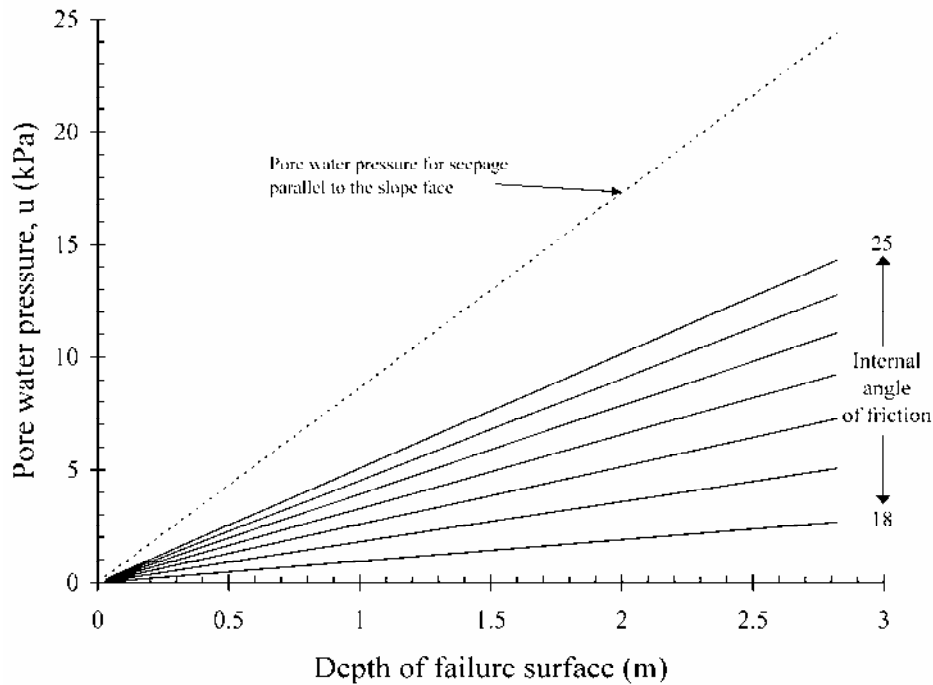
Figure B.1 Back calculated pore water pressure at failure for an 18 degree slope and a range in tangent friction angles for weathered Eagle Ford clay

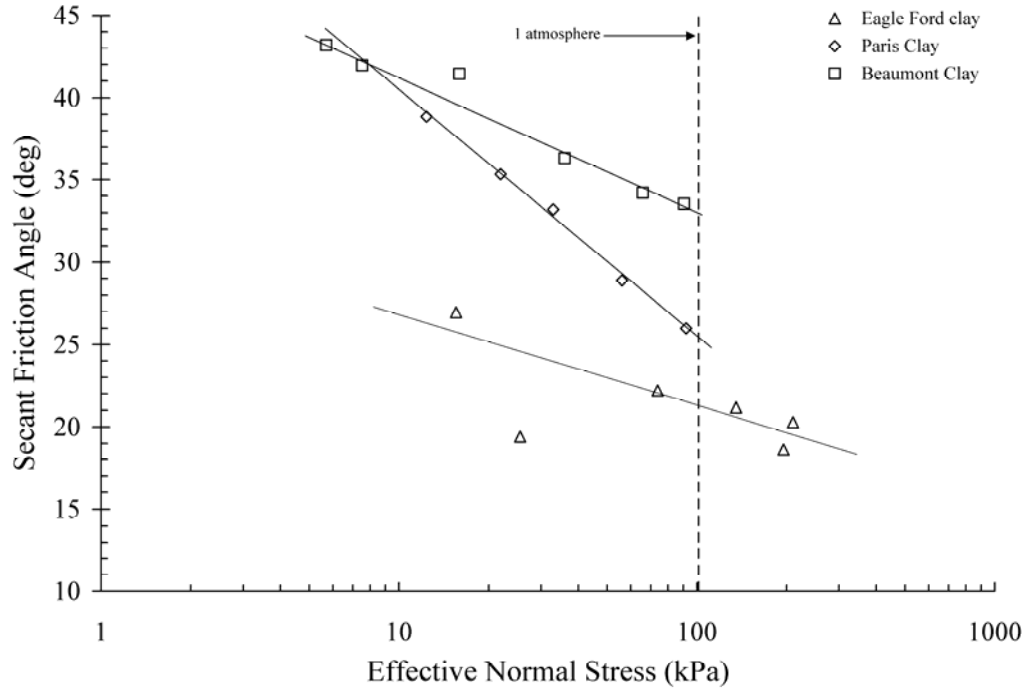
Figure B.2 Secant friction angle as a function of effective normal stress for fully-softened Eagle Ford, Paris, and Beaumont Clays subjected to cyclic wetting and drying

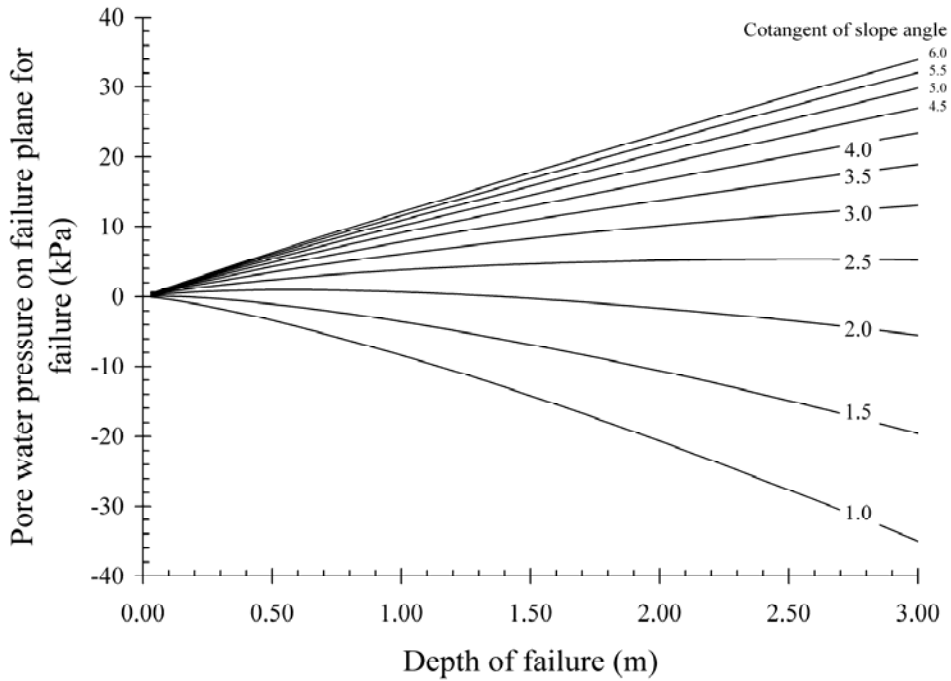
Figure B.3 Back calculated pore water pressure at failure using the secant friction angle for weathered Eagle Ford clay

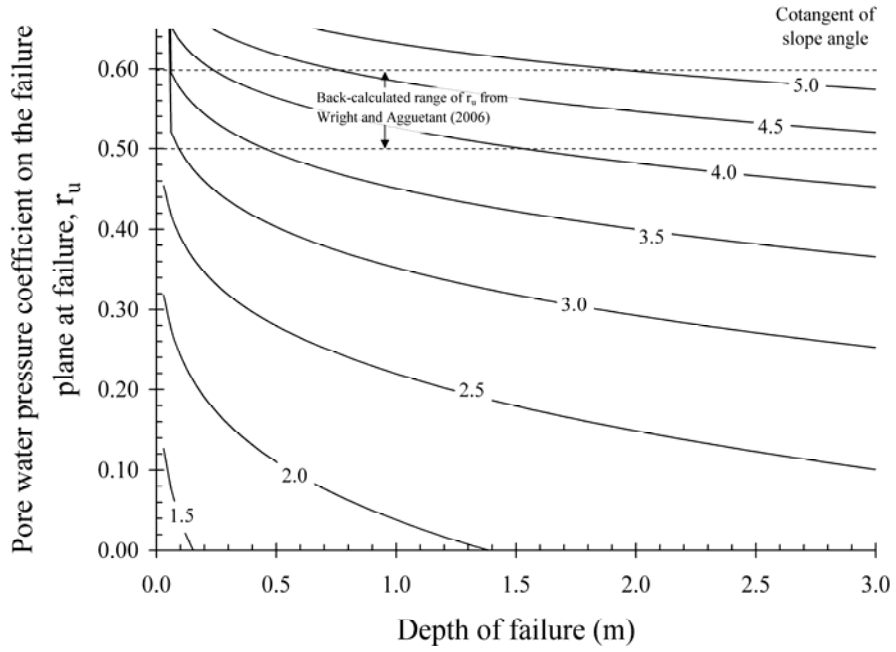
Figure B.6 Back calculated pore water pressure coefficients at failure using the secant friction angle for weathered Eagle Ford clay

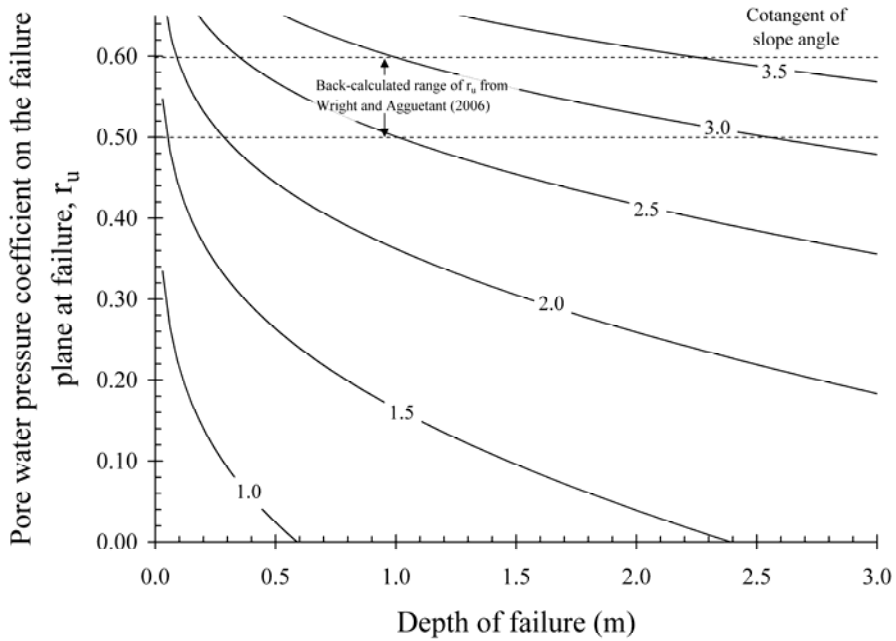
Figure B.7 Back calculated pore water pressure coefficients at failure using the secant friction angle for weathered Paris clay

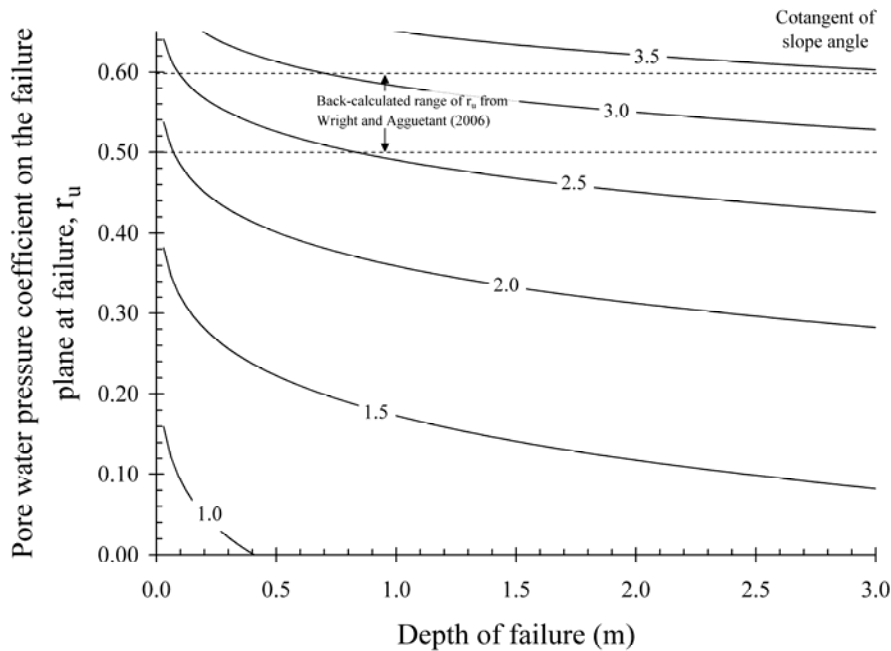
Figure B.8 Back calculated pore water pressure coefficients at failure using the secant friction angle for weathered Beaumont clay

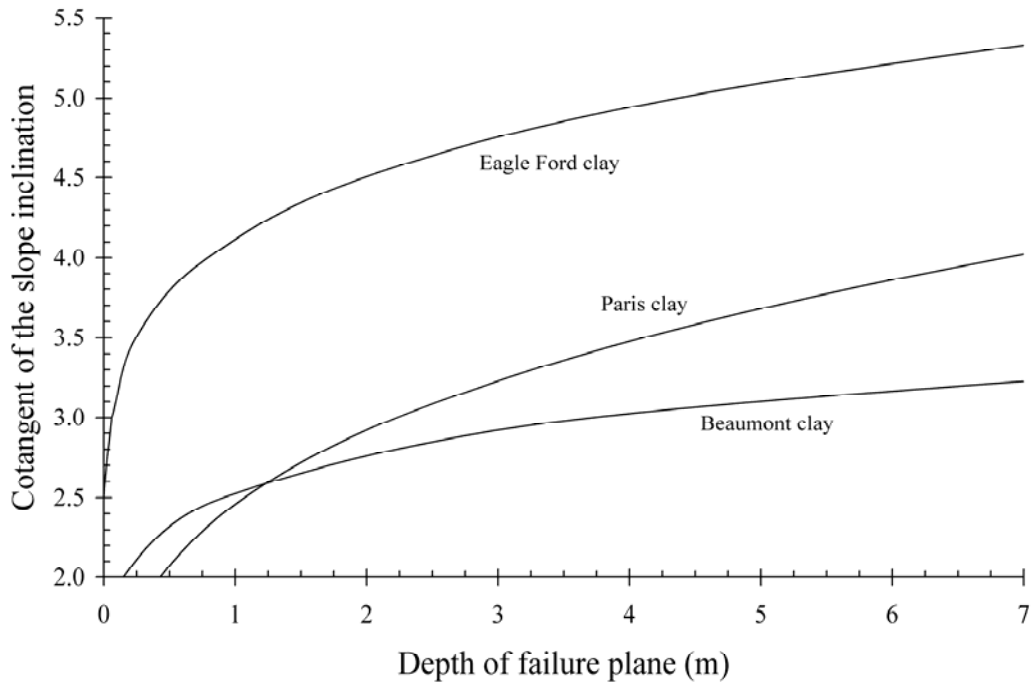
Figure B.9 Slope inclination for a given failure depth for conditions for limit equilibrium for infinite slope with flow parallel to the slope surface

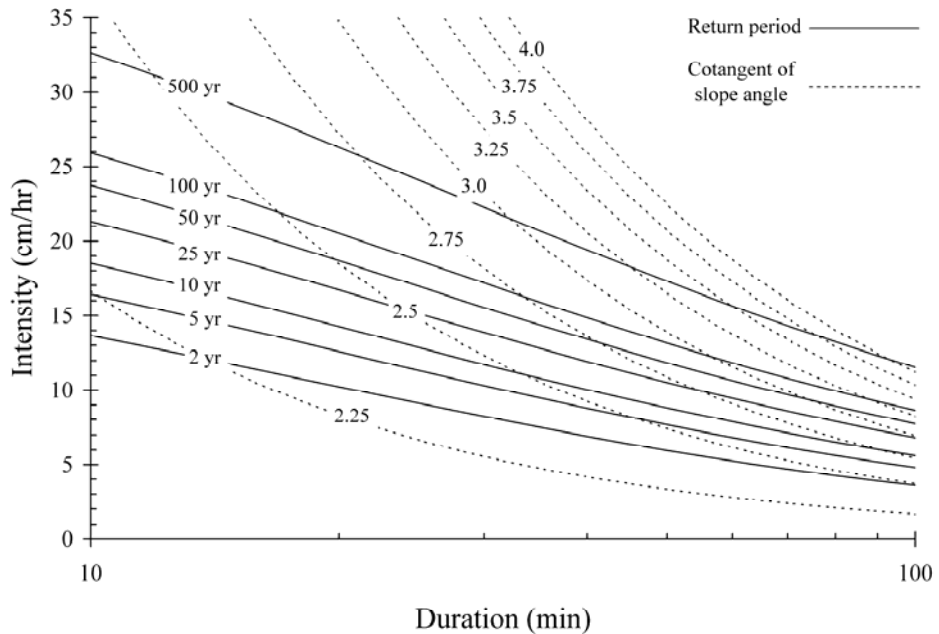
Figure C.4 Recurrence rate of failures for cracked Eagle Ford clay under Austin weather conditions given a failure depth of 1.1 meters

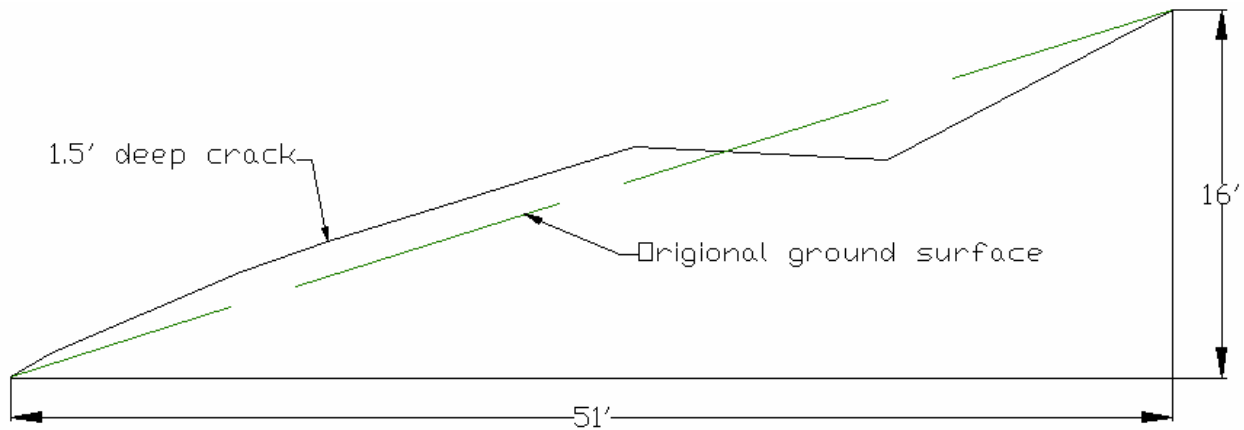
Figure D.30 Geometry of failure

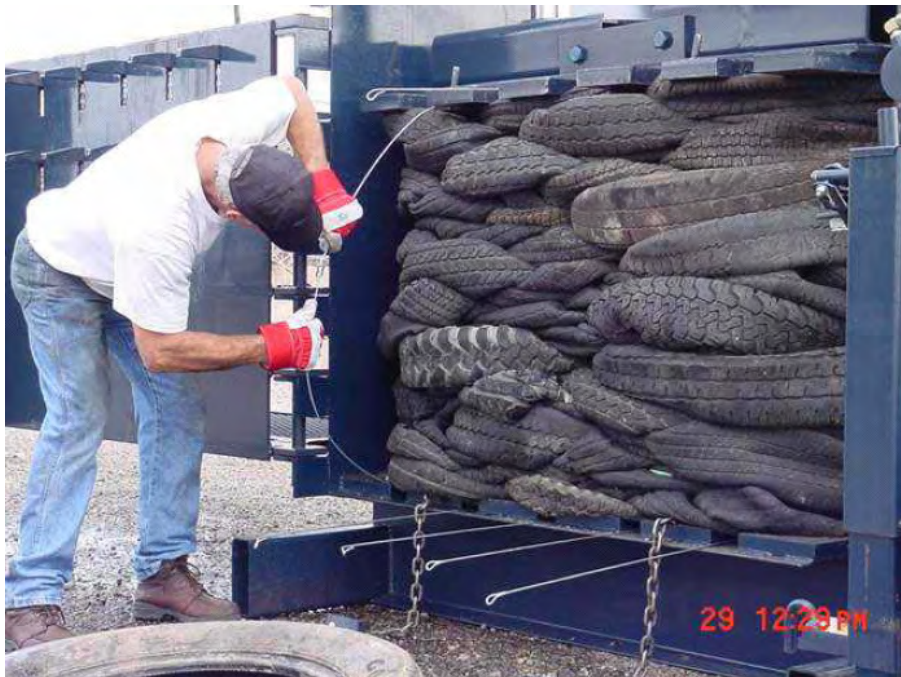
Figure D.40 Construction of tire bale 2001

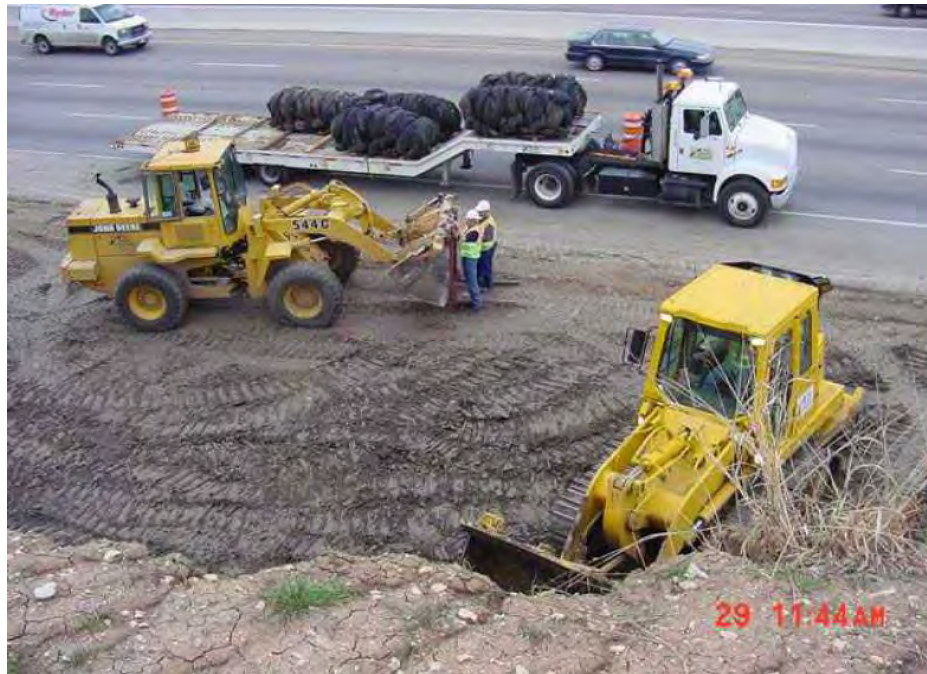
Figure D.41 Foundation preparation 2001

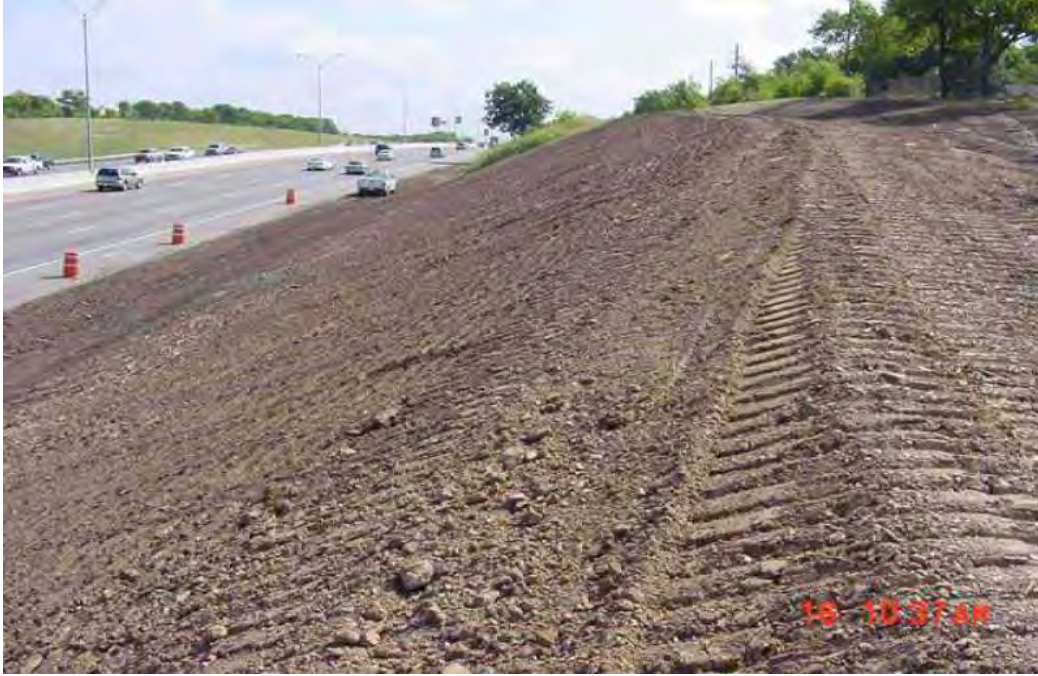
Figure D.45 Repaired slope 2001

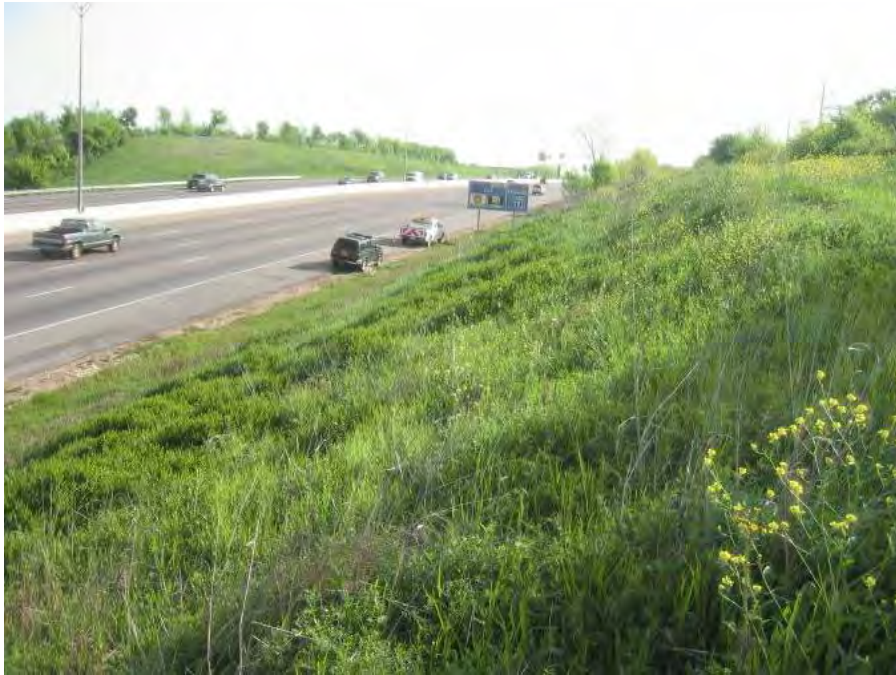
Figure D.46 Repaired slope 2005

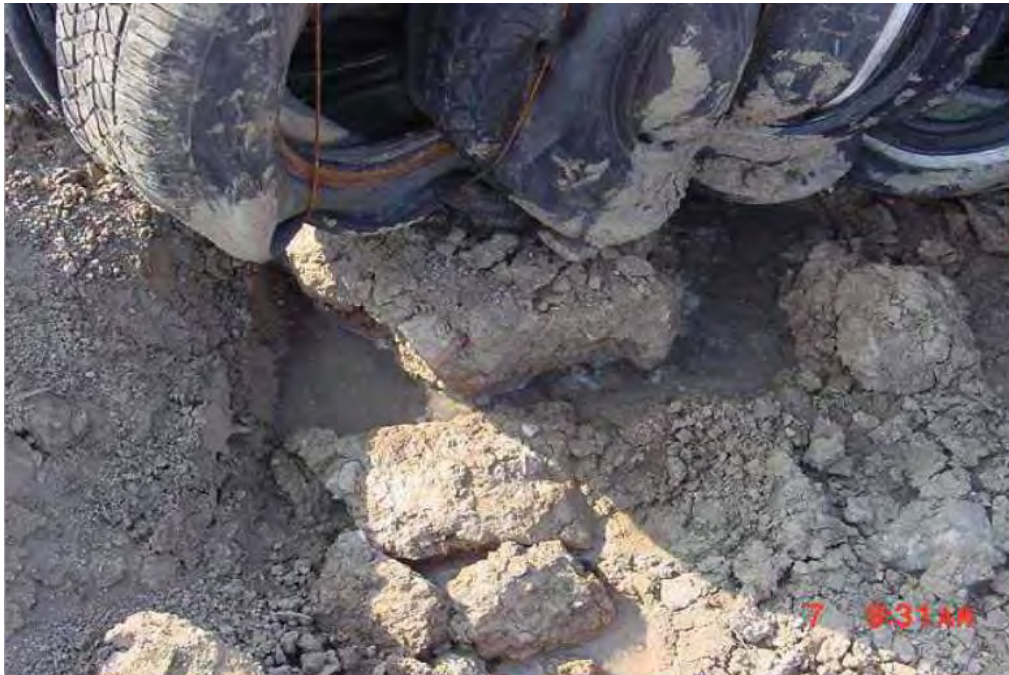
Figure D.48 Groundwater drainage through bales 2001

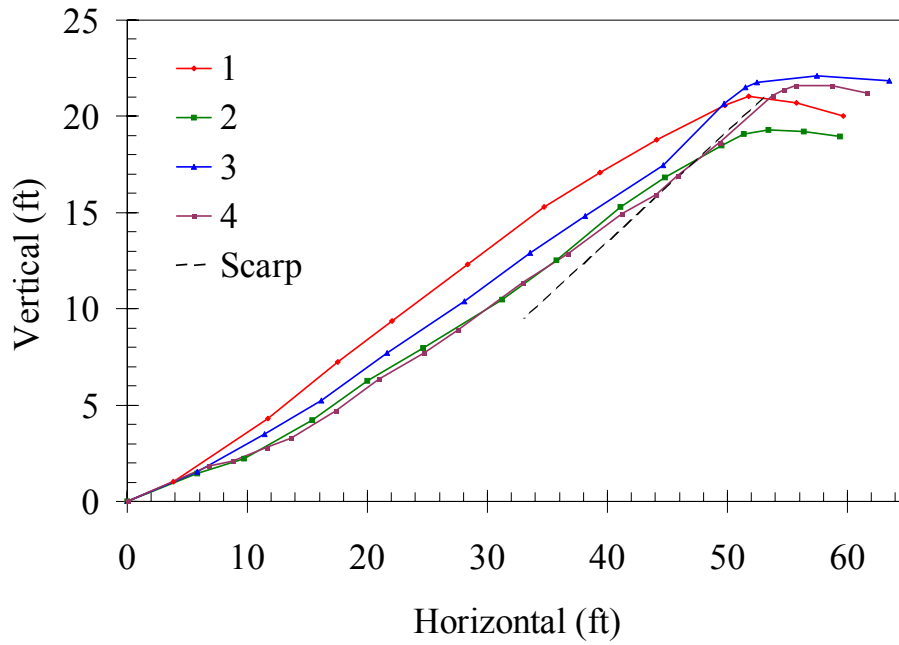
Figure D.49 Repaired slope profile measurements 2005

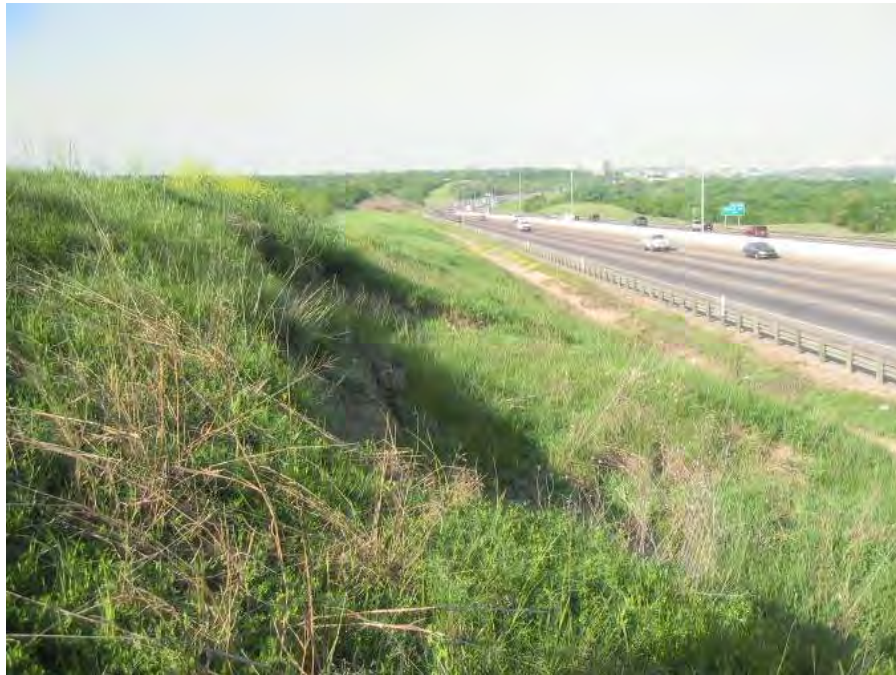
Figure D.50 Adjacent slope failure 2005

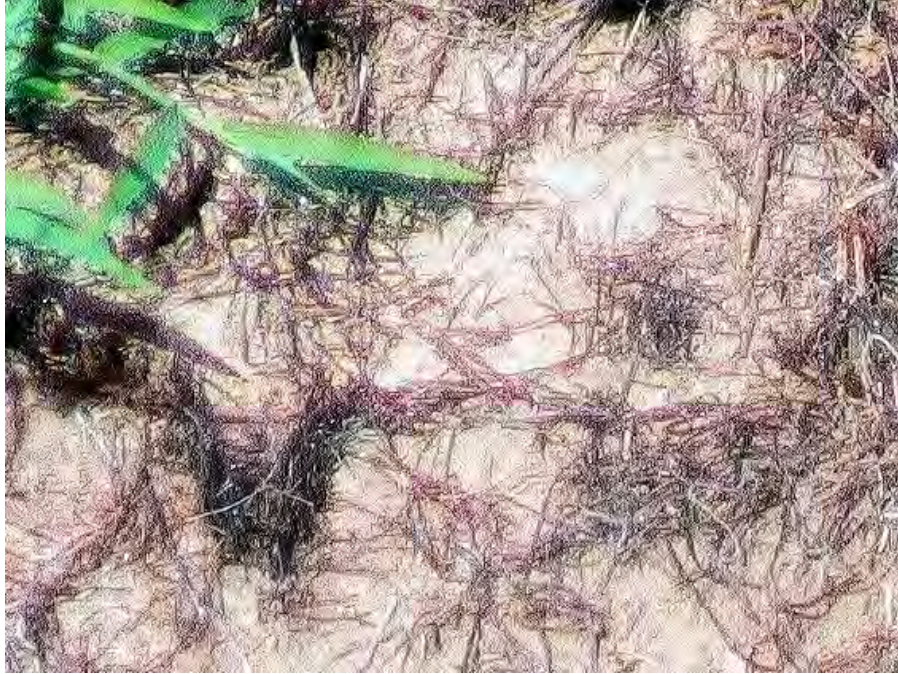
Figure D.58 Plan View of Embankment Surface; Notice that there are not any Visible Desiccation Cracks.

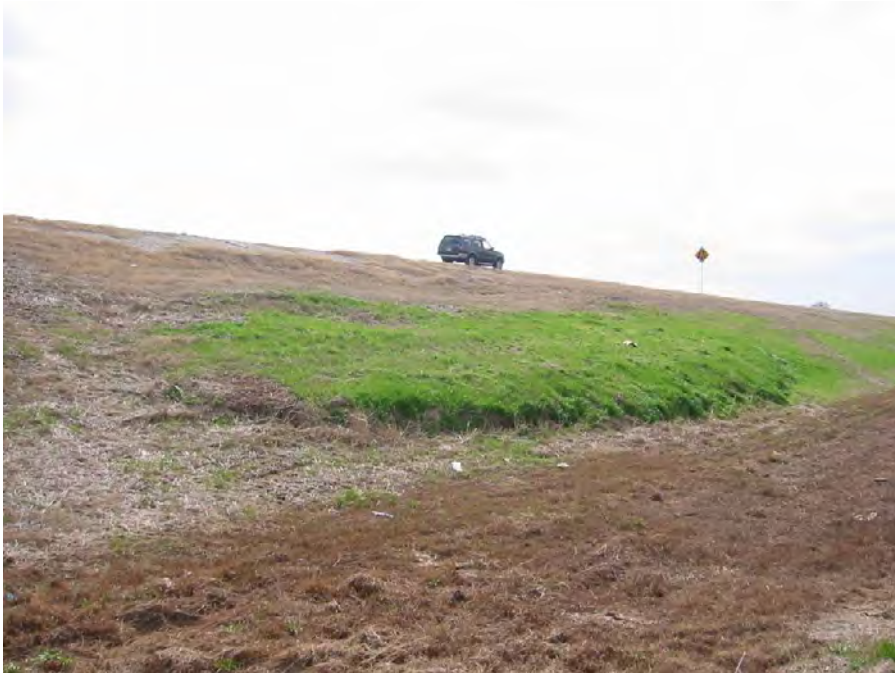
Figure D.64 View of failure facing eastward
