1. Report No. FHWA/TX-07/0-5202-2		2. Government Accession No.		3. Recipient's Catalog No.	
4. Title and Subtitle Field Suction and Effect of Cracking in Highly Plastic Clay			5. Report Date September 2006

Field Suction and Effect of Cracking in Highly Plastic Clay

CTR Technical Report:	0-5202-2
Report Date:	September 2006
Project:	0-5202
Project Title:	Determination of Field Suction Values in High PI Clays for Various Surface Conditions and Drain Installations
Sponsoring Agency:	Texas Department of Transportation
Performing Agency:	Center for Transportation Research at The University of Texas at Austin

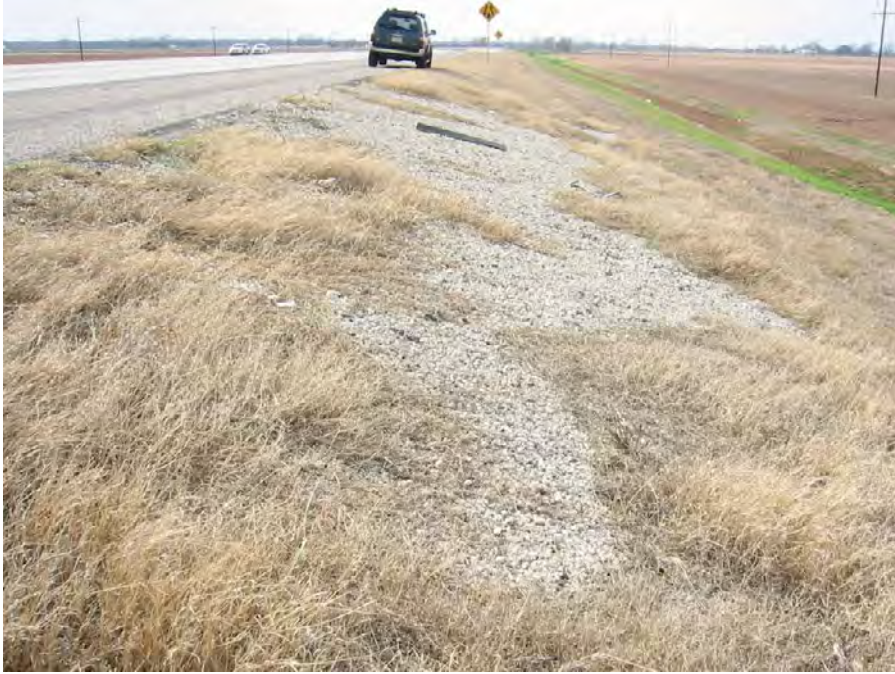
Figure D.65 View of remedial efforts at scarp of slide
