**2006 Flood in El Paso, Texas**

**Fall 2016**

**Ricardo Lugo**

**Geographical Information Systems in Water Resources**

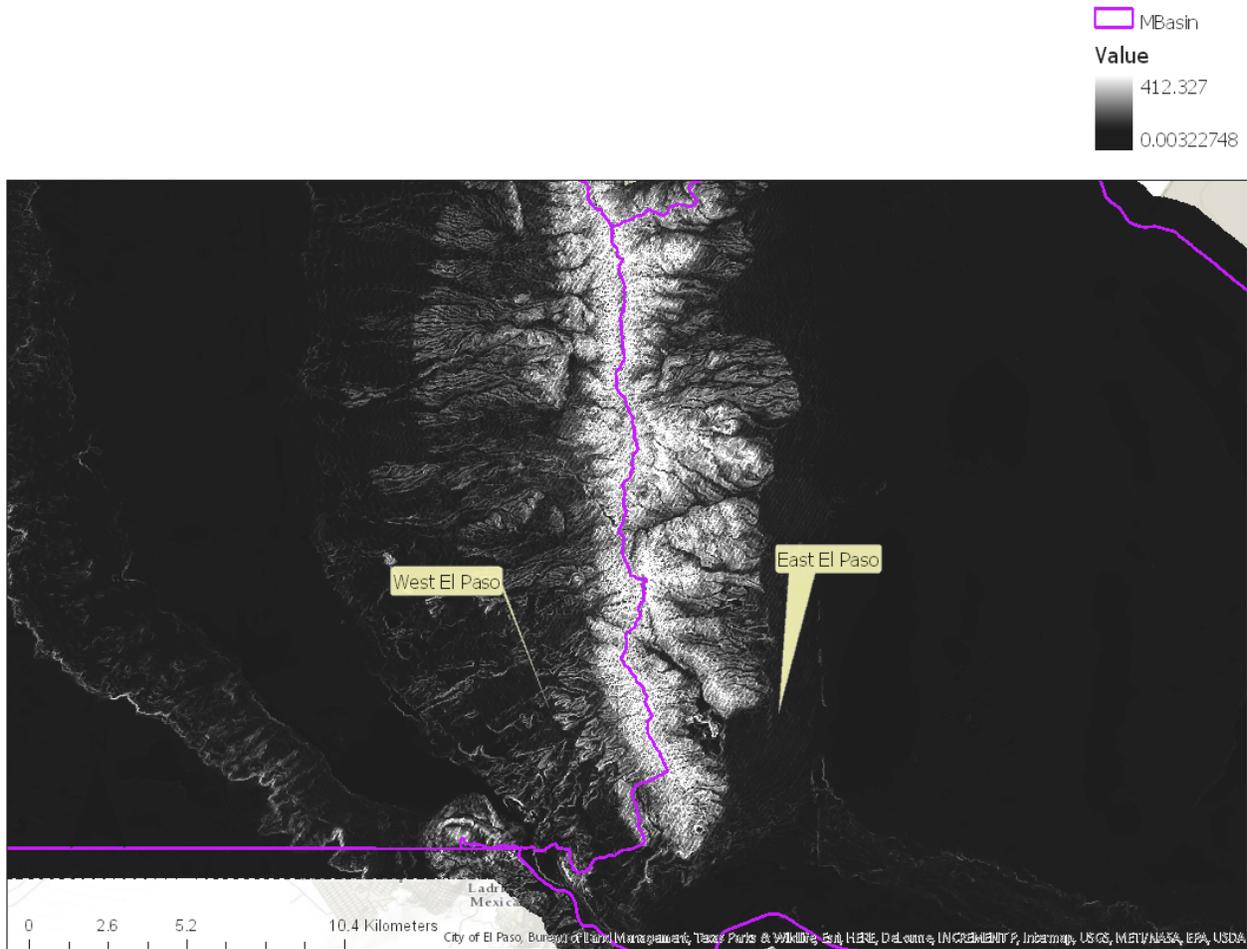
Figure 10. Percentage drop for the Franklin mountains in El Paso city.

By analyzing the terrain in ArcGIS, it is possible to determine the flow direction of the precipitation along with the areas that are most likely to flood during heavy storm events. Figure 10 shows the percentage drop of the El Paso area. From this figure, you can see that the east side has a sharper drop with less elevated area. The west side in contrast has less percentage drop but has a larger area with diverse topographic effects. When comparing it to figure 4 It also shows that this area is further developed than the east side. Figure 11 shows the flow direction of precipitation using the D8 model along the franklin mountains. Figure 12 can be used to determine the direction of flow on the mountains. On the eastside, the direction is predominantly towards 1 and on the west, side the direction is towards 8 and 16. This indicates that on the eastside the flow is generally towards a less urbanized area than on the west side. Again, this accounts for the greater damage seen on the west side of El Paso. We can then look at the lowest points on the surrounding area to see where water would tend to localize in (Figure 13). This suggest that these areas are more prone to flooding.
