# Flooding in Manayunk Neighborhood of Philadelphia

Samuel Brodfuehrer | GIS in Water Resources | December 8, 2017

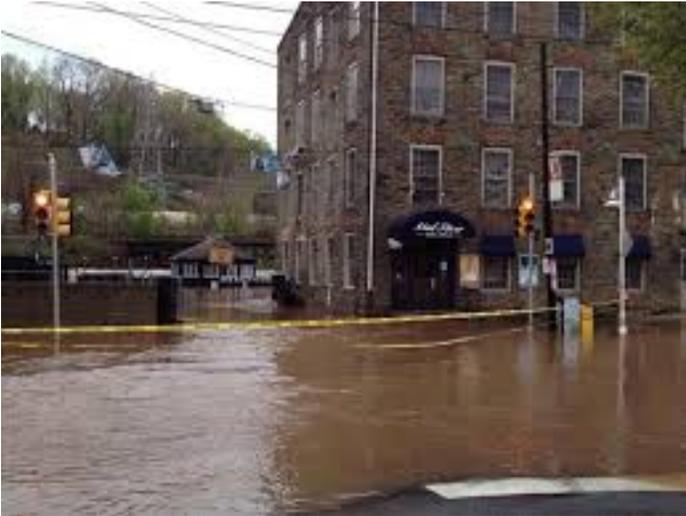
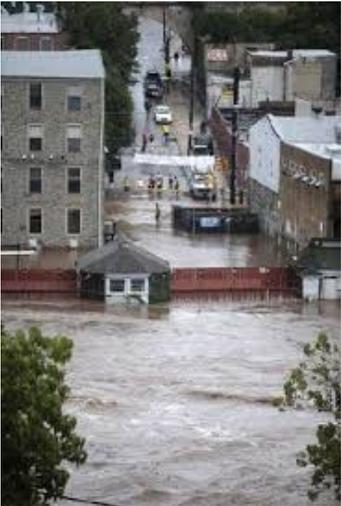
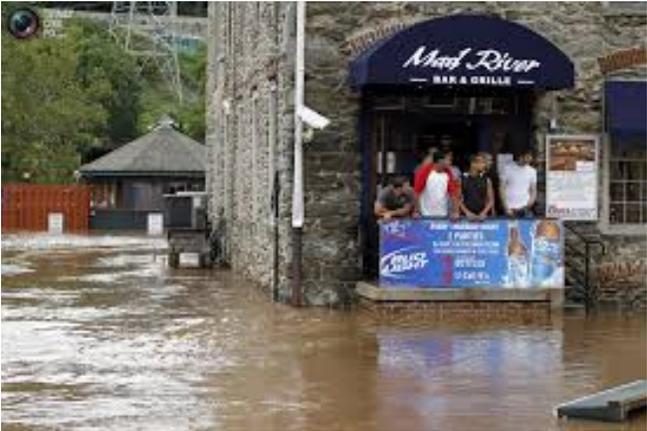
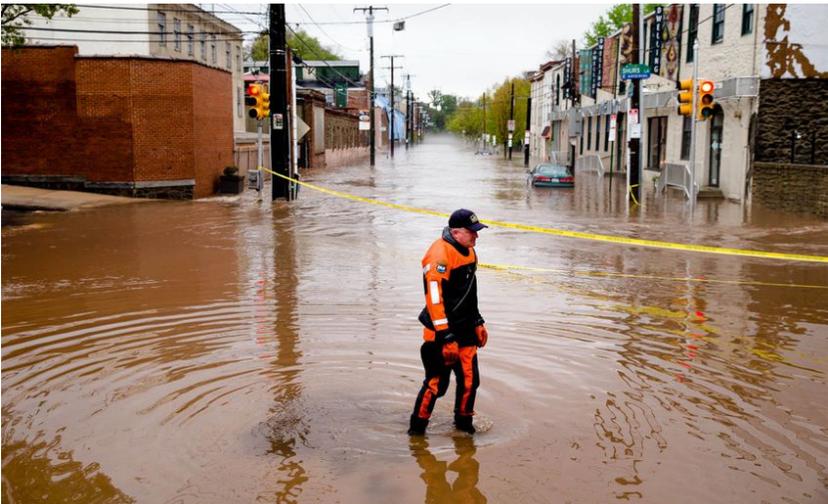
Appendix

confirm that the flooding is only around the Manayunk Brewery. This verifies the accuracy of this analysis. Some of these photographs can be seen in the Appendix.
