# HISTORIC FLOODING IN TIMARRON LAKES OF CREEKSIDE PARK NEIGHBORHOOD

CE 394K: GIS for Water Resources – Fall 2018

An investigation of the inundation depths of historic and recent storms in a residential area of The Woodlands, Texas that resulted in a lawsuit against the developers and engineers responsible for the construction of the neighborhood.

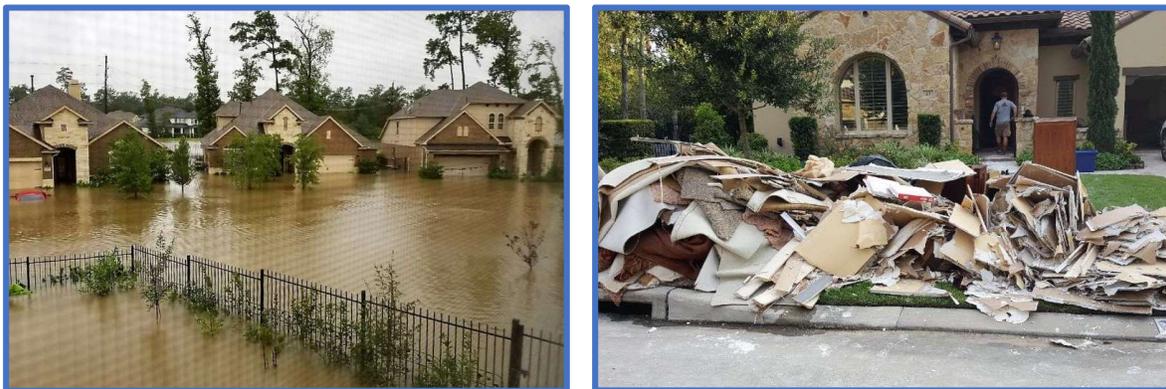
Figure 1: Left – 2017 Flooding in Timarron Lakes. Right – Resulting damages.

When Hurricane Harvey hit the Houston, Texas area in 2017, I was just beginning my senior year as a civil engineering student at The University of Texas at Austin. My family, however, was back home in The Woodlands dealing with the aftermath of one of the largest rain events that has ever impacted the state of Texas. Hurricane Harvey resulted in an approximate \$125 million dollars' worth of damage and the flooding of tens of thousands of Texan homes, including my grandparents' home, located in the Timarron Lakes section of the Creekside Park neighborhood in The Woodlands, Texas (NOAA, 2018). My grandparents fortunately evacuated their home before the storm made landfall, but returned to discover that the house that they purchased in 2015 had experienced 10 inches of flooding inside. Some of the resulting damage and cleanup process of their home can be seen in the right image of Figure 1 below. The left image of Figure 1 below shows flooding in the Timarron Lakes neighborhood after Hurricane Harvey passed through.
