FLOODING IN THE GUADALUPE RIVER BASIN AT NEW BRAUNFELS, TEXAS

Ashley Evans

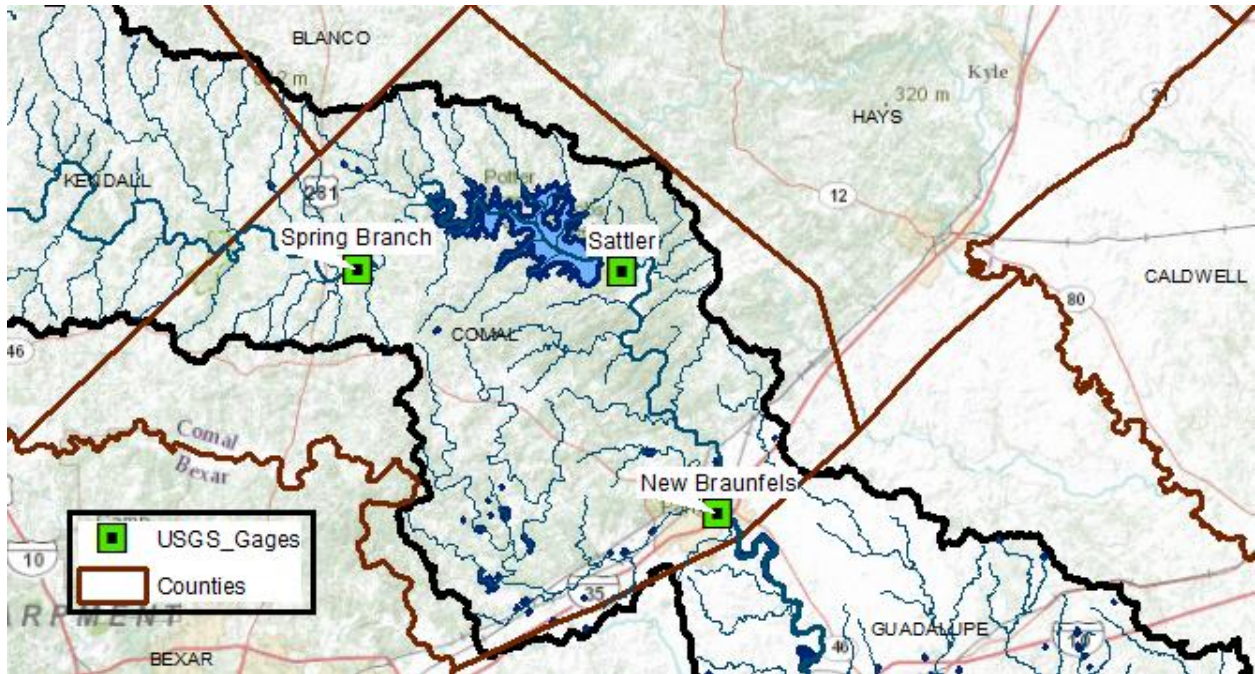
Figure 3: USGS Gages in Comal County

shapefile of Texas Counties downloaded from the Texas Parks and Wildlife Department was displayed for a spatial reference. Three USGS gages along the Mid Guadalupe River were selected for analysis, and are displayed in Figure 3 (08167800: Guadalupe Rv at Sattler, TX; 08169500: Guadalupe Rv at New Braunfels, TX; 08167500: Guadalupe Rv nr Spring Branch, TX).

The maximum mean daily gage height was obtained from USGS for each stream gage location displayed in Figure 3. Additionally, the gage datums were retrieved for each site. However, the datums were provided in the National Geodetic Vertical Datum of 1929 (NGVD29) and the DEM data is in the North American Datum of 1988 (NAD88). To translate the NGVD29 to NAD88, Corpscon was downloaded from the Army Corps of Engineers and run with the input and output as shown in Figure 30.

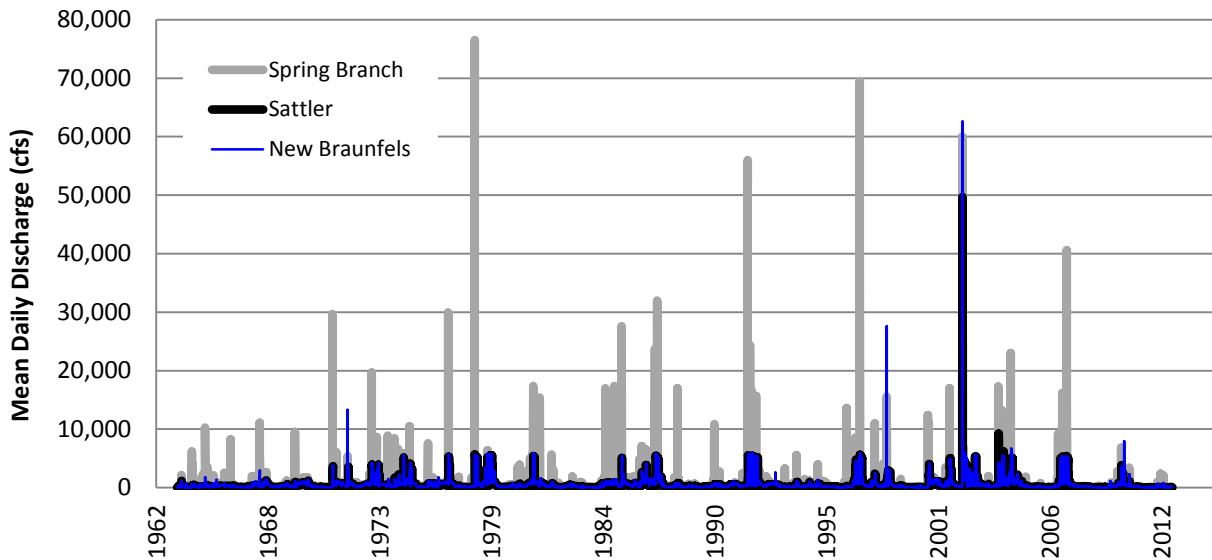
Figure 5: USGS Streamflow Data at New Braunfels, Sattler and Spring Branch

To illuminate the magnitude of the 1998 and 2002 floods, Figure 5 shows plots of streamflow data over time since the construction of the Canyon Lake dam in 1964 [9]; Figure 6 shows mean daily stream gage height for the years data was available.

Beginning most downstream at New Braunfels, three very large floods (above 10,000 cfs) are seen in 1972, 1998 and 2002. Moving toward Sattler, one large (above 10,000 cfs) flood is seen in 2002. Finally, considering Spring Branch above Canyon Lake, over 20 floods (including the 2002, but not the 1998, flood) above 10,000 cfs are evident. This is clear evidence that Canyon Lake is dampening flooding downstream. This also suggests that the location of maximum rainfall is important, and may be a determining factor in the differences between the 1998

and 2002 floods. However, considering data from all three USGS stations (especially the plots where the vertical axis is limited) flooding is a common occurrence in Comal County.

Thus, even in the 575 square miles of Comal County, the 1998 flood is seen distinctly at New Braunfels, but not above at Sattler or Spring Branch, while the 2002 flood was evident at all three locations. Since the data shown above show that Canyon Lake does help to dampen downstream flooding, it is interesting to note (and further consider) why the 1998 and 2002 floods do not follow the typical pattern of streamflow variation through these three USGS gages.

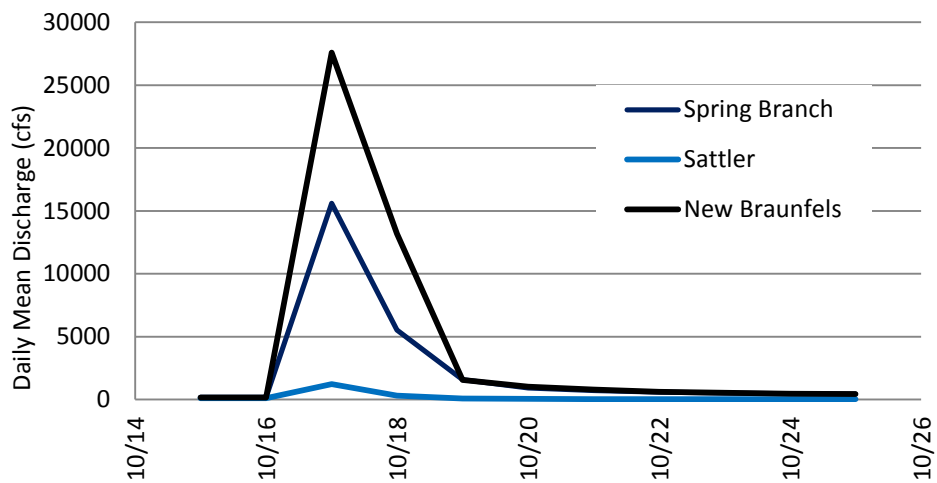
Figure 7: Streamflow Data Surrounding the 1998 Flood.

Daily streamflow data (Figure 7) show that the 1998 flood peak flow was reached in a single day. New Braunfels has the highest flow and Sattler, located in the middle, has the lowest flow. Lake storage data (Figure 8) shows that Canyon Lake increased in storage volume over the 17th and 18th of October. Thus, Canyon Lake retained the increased upstream streamflow. Both streamflow and lake storage data were retrieved from USGS.

The time series of precipitation was reflected in the streamflow data shown in Figure 7, and shows why the downstream USGS station received the highest flows. The main downpour of rain was received just above New Braunfels, below the Canyon Lake Dam. The time series, accompanied by a map of total rainfall, shows that over 20 inches of rain fell over New Braunfels in only two days. Streamflow increases are seen about a day sooner than the precipitation maximum due to large precipitation fall directly upstream of the USGS gage in New Braunfels the day before. The power of GIS in visualizing data over time and space is very apparent here.

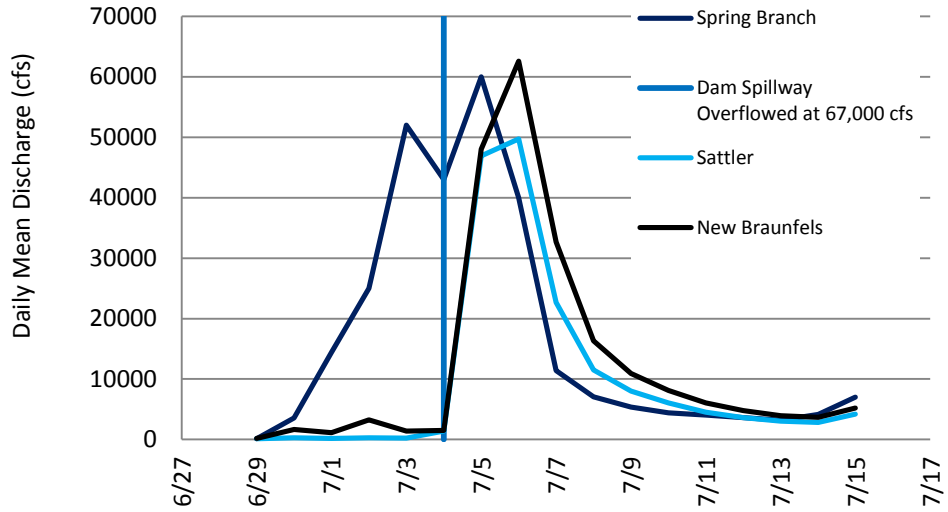
Figure 18: Streamflow Data Surrounding the 2002 Flood

Next, I investigated the same data for the 2002 flood. Daily streamflow data (Figure 18) show the effect of the dam spillway overflowing on July 4th. The downstream streamflows at New Braunfels and Sattler reflect that upstream and are near the reported 67,000 cfs that overflowed the spillway. Once the lake fell back below the spillway, the downstream flows significantly decreased, but was still higher than normal due to high controlled releases (of up to 5,100 cfs) by the Army Corps of Engineers and rainfall downstream of the dam [8].

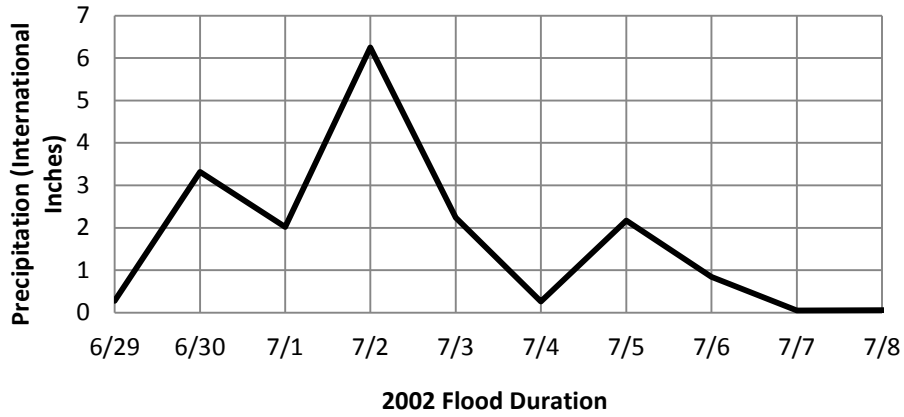
Figure 20: Precipitation over the 2002 Flood in New Braunfels

Total precipitation displayed in Figure 21 shows that over 20 inches of rain fell over New Braunfels again; however, this time, the rain fell over a week (Figure 20) – and fell over a much larger area (Figure 21).

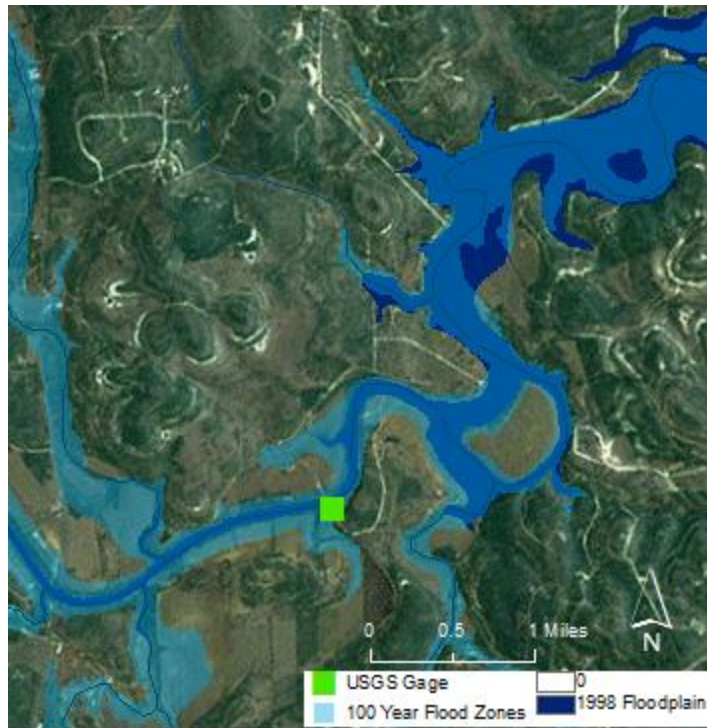
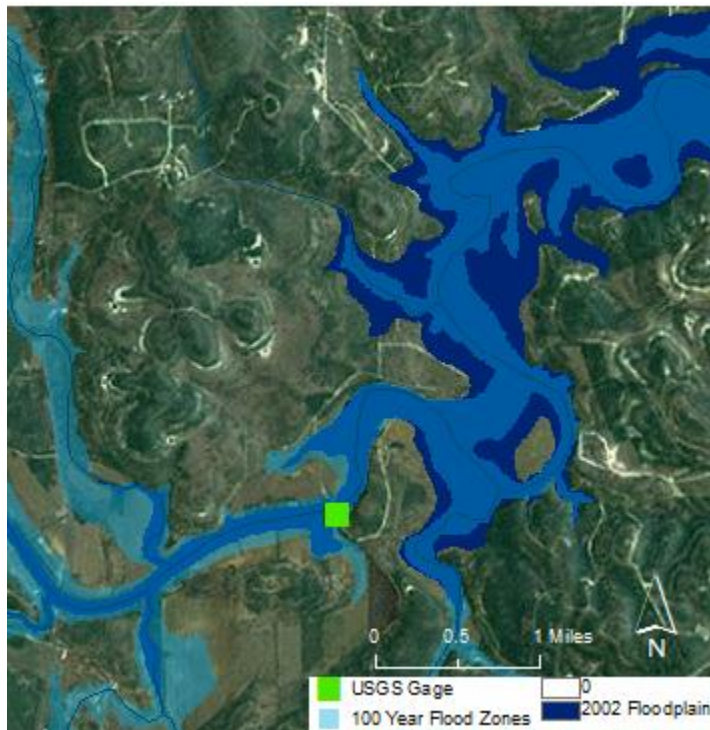
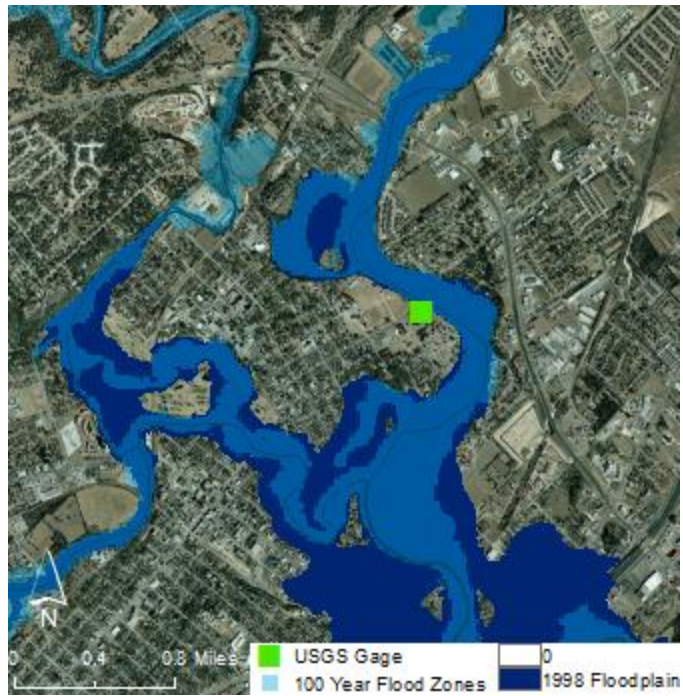
To process the actual floodplain from each flood, the raster calculator was then used to locate all elevations below the converted gage height for both floods at each of the three gage locations. In the case of the 2002 flood, the maximum mean gage heights before and after the spillway was breached (July 4th and July 6th) were processed for comparison at the two downstream locations. The raster calculator equation set the $DEM \leq \text{Gage Height}$. The output provided a raster file with values of 1 where the $DEM \leq \text{Gage Height}$ and 0 everywhere else. The symbology was changed so that 0 value cells were transparent and 1 value cells were filled with a blue color as depicted in the legends.

Figure 31 through Figure 36 show the floodplain for each flood and the 100 year FEMA floodplain. Both floods met or exceeded the 100 year floodplain at these three gage locations. At the Spring Branch gage, the 2002 flood had a wider floodplain than the 1998 flood. At the Sattler gage, the 1998 flood and the 2002 flood (before the Dam overflowed) approximately met the 100 year floodplain. However, after the spillway breach, the floodplain greatly increases extending beyond the 100 year floodplain. Lastly, analyzing the floodplains at the New Braunfels gage, the 1998 floodplain was actually wider than the 2002 floodplain. Prior to the spillway breach, the 2002 floodplain at New Braunfels was within the river boundaries.

Thus, the gage height data illustrates the extent of these floods as meeting or exceeding the 100 year floodplain, and the sudden increase in the floodplains downstream of the Dam after the spillway overflowed. The data also, thus, shows that before the spillway breach, the Dam was preventing downstream flooding.
