Report No. CDOT-DTD-R-2001-6

# **Results and Recommendations of Forensic Investigation of Three Full-Scale GRS Abutment and Piers in Denver, Colorado**

**COLORADO DEPARTMENT OF TRANSPORTATION  
RESEARCH BRANCH**

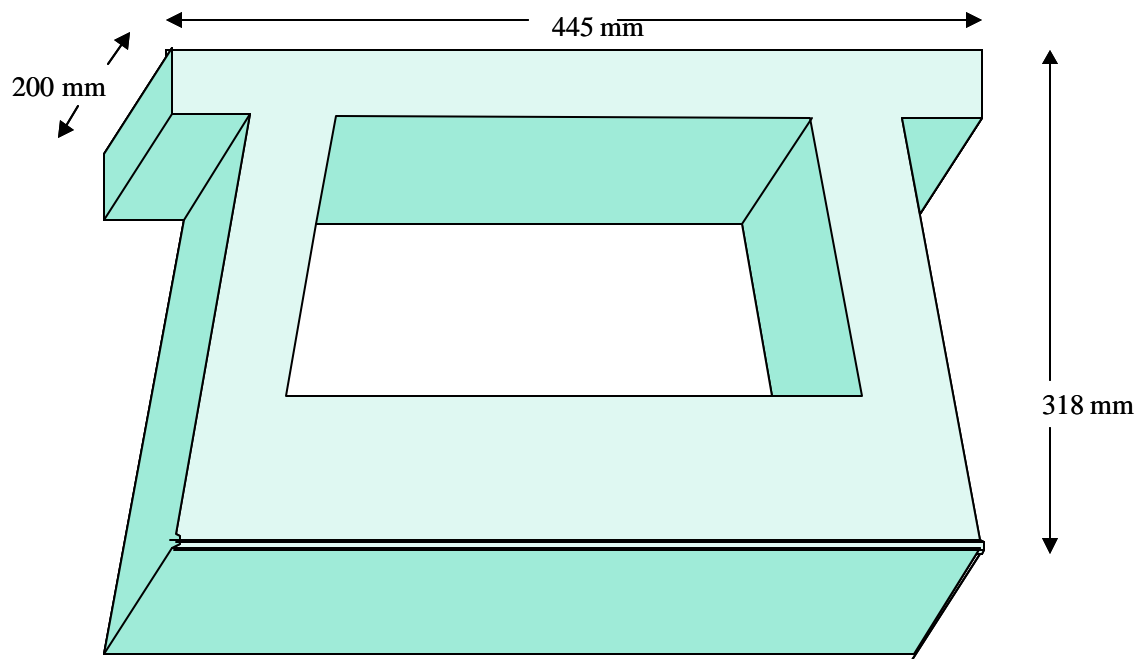
**Figure 4 Block from Center Pier Structure (324 N or 73 lb. in weight)**

The concrete blocks from the center pier (Figure 4, Photo 4) were the heaviest of the three structures at 324 Newtons (72.7 pounds), supplied by one manufacturer and most likely made of normal weight concrete. The blocks' dimensions are shown in Figure 4. They had a raised lip along the outside face. The blocks were laid with the lip up, forcing a small setback in the next row. This setback resulted in a uniform positive batter at the face (Figure 1). The blocks of this structure were the only ones that had any type of connection from one layer to the next other than friction with the fabric. It was noticed that the top several rows of the center pier experienced outward bowing (Photo 4 of Appendix A), possibly due to negligence in controlling the facing alignment during construction. There were no visible cracks in the external face and no internal broken blocks were found during dismantling of the center pier.

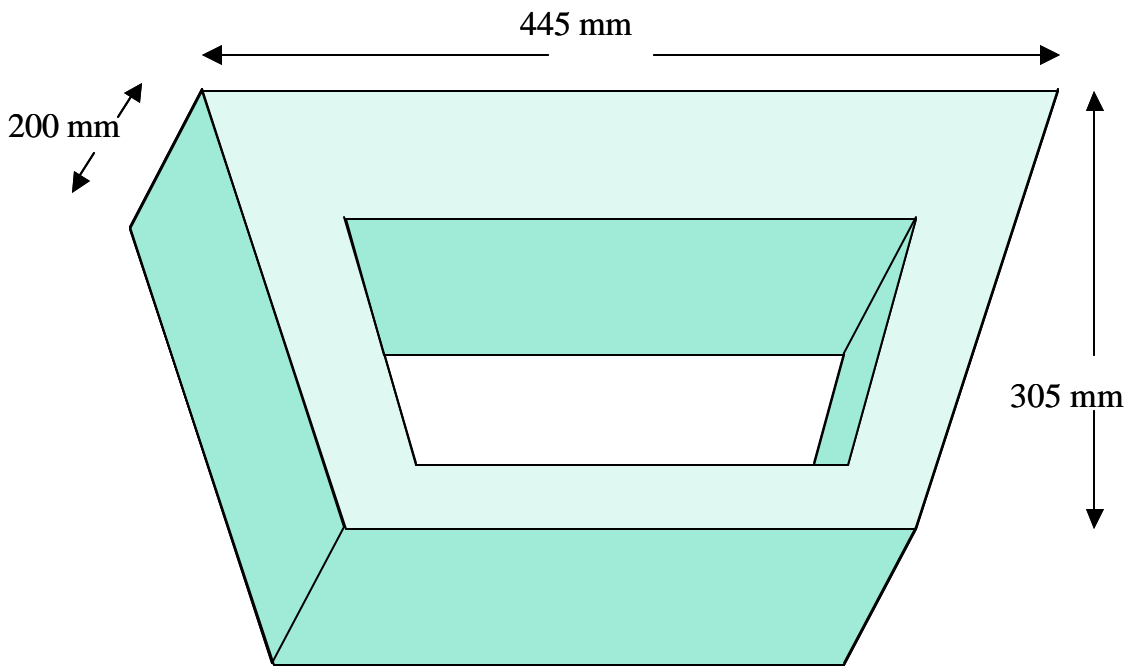
**Figure 5 Block from Outer Pier Structure ( 258 N or 58 lb. in weight)**

The outer pier was constructed of “D” shaped blocks – 203 mm high by 445 mm long and 305 mm wide (Figure 5). The outside faces of the blocks were 70 mm thick, the sides were 43 mm thick, and the backs were 60 mm thick. The same manufacturer supplied the blocks and there was no significant variation in the weight. The blocks used in the outer pier weighed 258 newtons (58 pounds). These blocks seemed to be denser than those used in the east abutment, and were most likely made of normal weight concrete. Because of the tapered sides the blocks can be placed in a curve easily. The ends of the outer pier were curved that way (Photo 10).

Since the blocks of the outer pier structure were severely cracked and the upper four rows showed significant movements (see Photos 5, 6 and 7), the external and internal conditions of blocks were thoroughly examined. The results of this examination are presented in the following subsections.

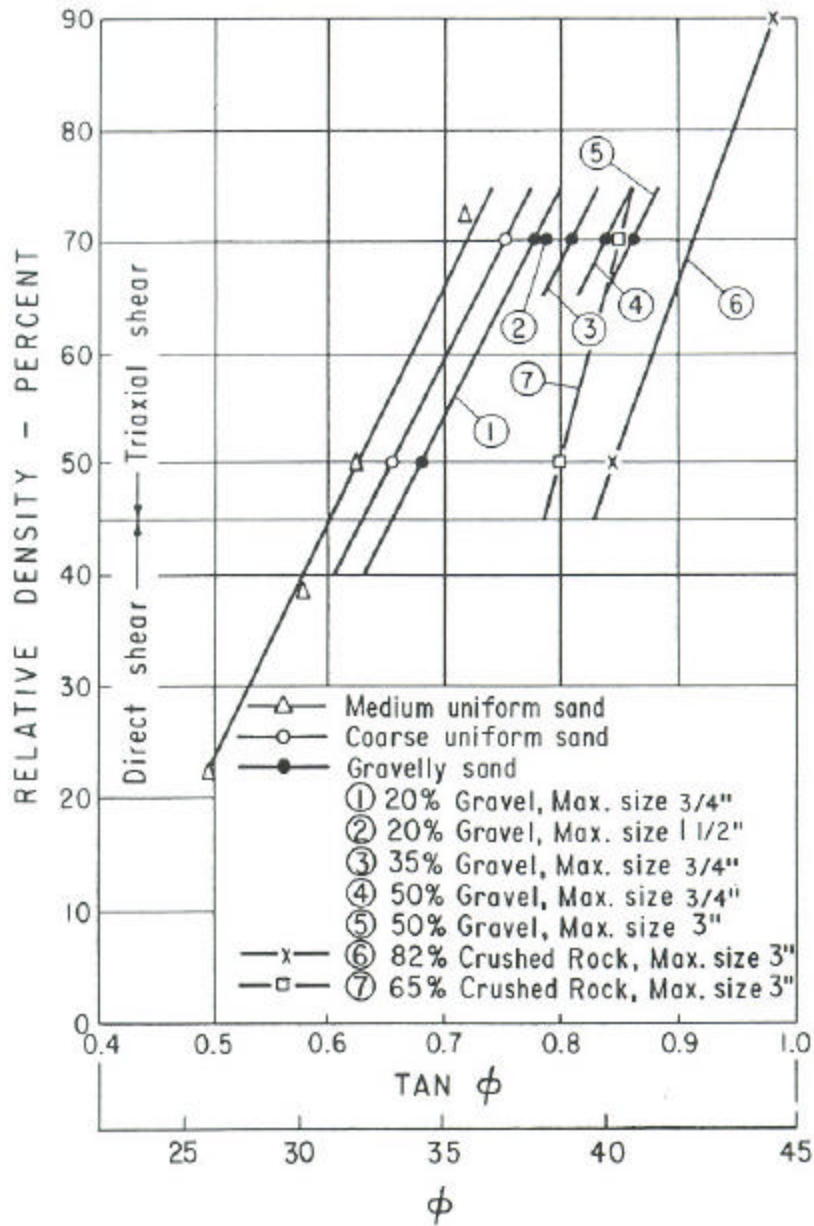
Figure 14 Effect of Relative Soil Density on the Soil Friction Angle, tan  $\phi$ , for Coarse-Grained Soils (USBR, 1998)

It was concluded in the FHWA study (FHWA 2000) that good backfill compaction is essential to satisfactory performance of GRS structures. Figure 14 shows the relation between relative density and the angle of internal friction (also expressed as  $\tan \phi$ ) for compacted coarse-grained soils (USBR, 1998). A soil with a friction angle of 40 degrees has almost four times the bearing capacity of a soil with a friction angle of 32 degrees.

Chapter 2 concluded that the backfill compaction level for the Havana Yard GRS structures was variable and low, especially close to the facing, not meeting CDOT requirements of 95% of AASHTO T-180 method (see Table 2). The non-smooth pier deformation response from row 11 to row 14 (Figures 8 and 9) could be attributed to the variable and low applied backfill compaction level. According to CDOT design specifications, a compaction level of 95% is required to achieve a minimum backfill friction angle of 34 degrees. Hence, the friction angle for the outer pier backfill is expected to be lower than 34 degrees, especially close to the facing. The comparatively low backfill compaction level led to a low strength (i.e., bearing capacity) and stiffness of the reinforced soil mass (Figure 14), lower reinforcement pull-out resistance, higher lateral earth pressures and facing connection loads, and non-uniform distribution of surcharge loads over the pier area, especially in the top zone. Therefore, the lower backfill compaction level resulted in relatively more deformation to the pier.

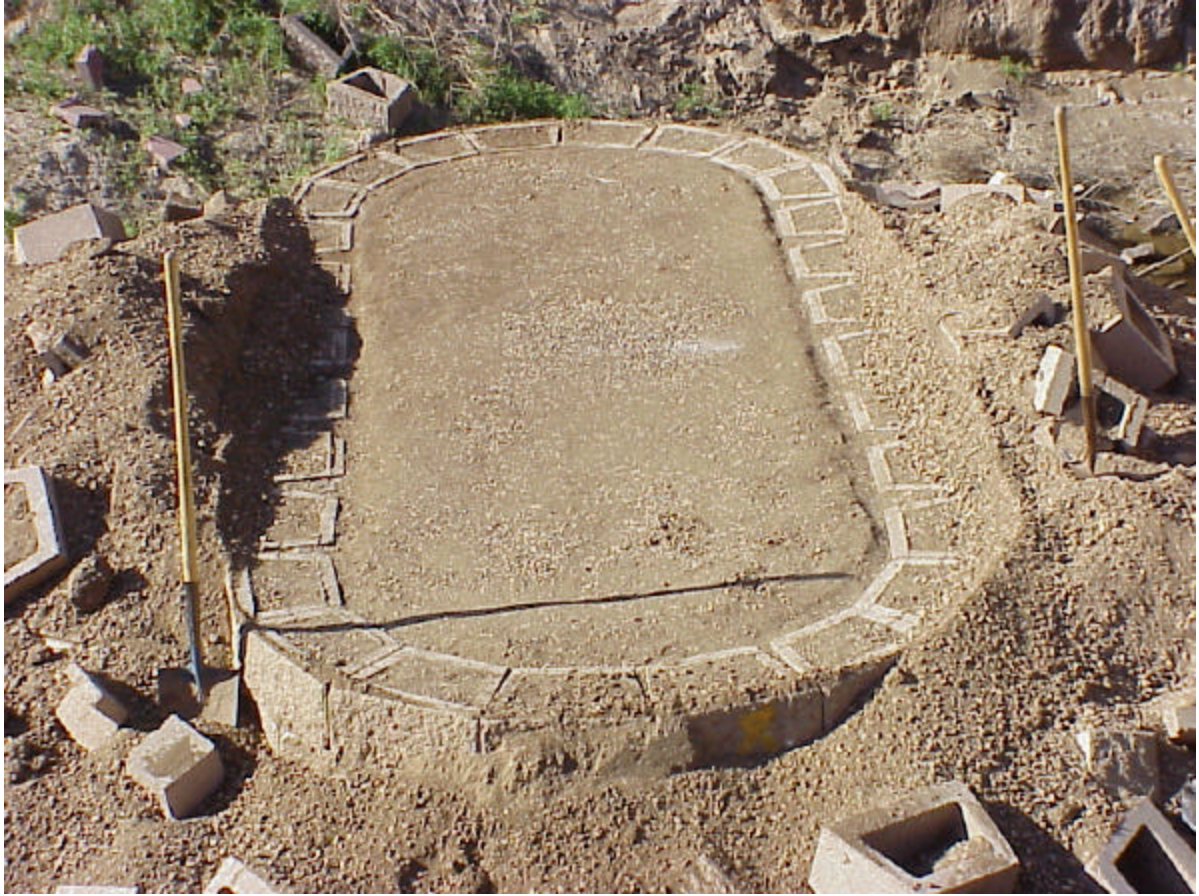
**Photo 10. Dismantling in Progress: The Outer Pier at Row 10 from bottom.**

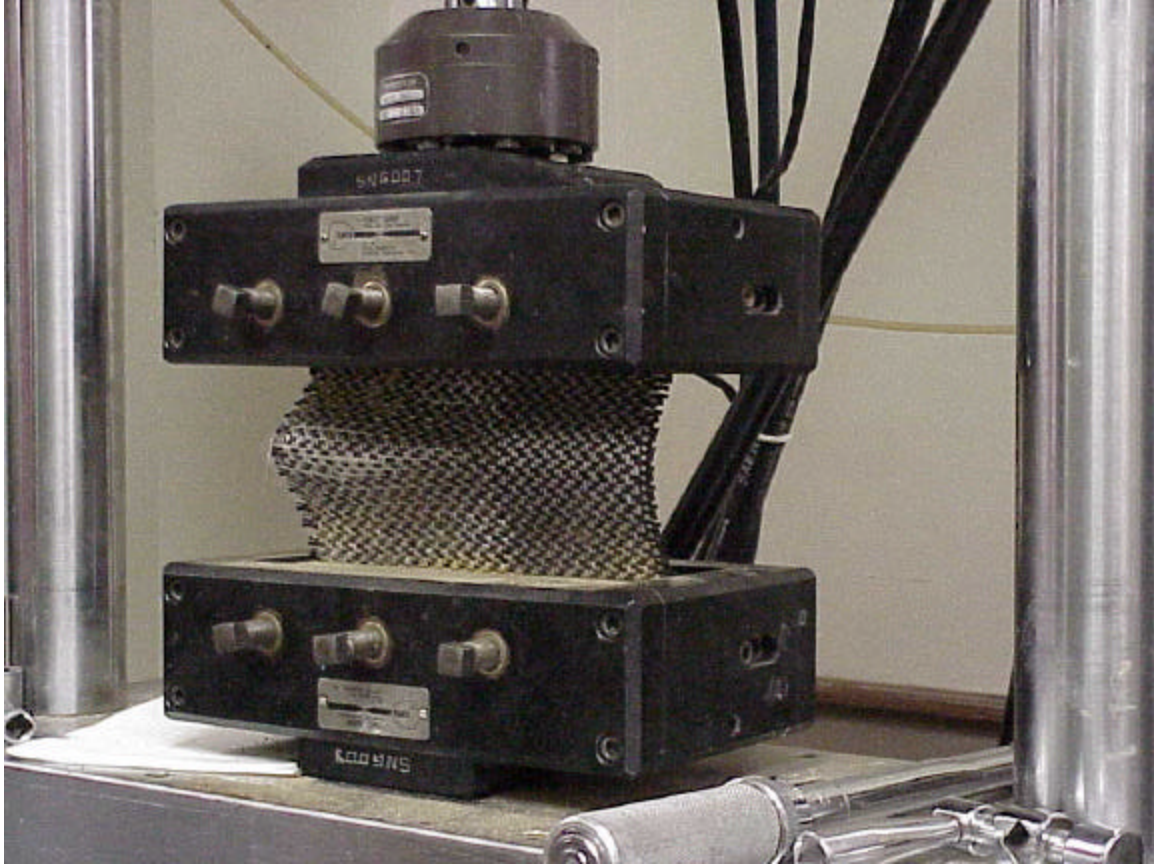
**Photo 16. A Fabric Specimen at the Failure Condition.**
