Summary of Recent Activities and Site Locations in TxDOT San Antonio District

March 2018

*Interagency Cooperation Contract: Support to the San Antonio District in
Geotechnical Characterization and Subgrade Stabilization*

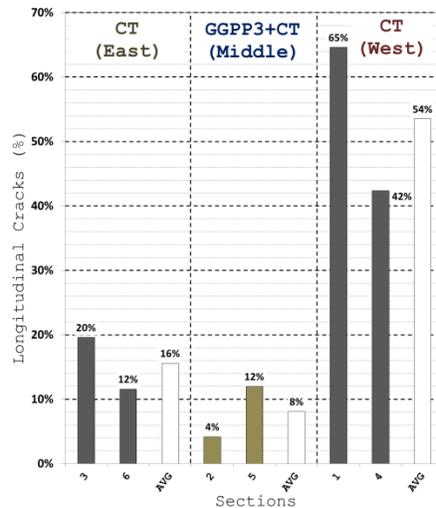
Fig. 2. Example of analysis for comparative evaluation of performance under environmental loads among test sections

Figure 2 presents an example of the analysis conducted for comparative evaluation of performance in geosynthetic-stabilized versus non-stabilized test sections. This example is shown for the percentage of longitudinal cracks in test sections. The horizontal axis of this graph corresponds to the test section numbers, sorted into reinforced versus non-reinforced groups. The vertical axis displays the percentage of longitudinal cracks calculated from condition survey data. The potential benefit of geosynthetics in reducing the percentage of cracks on the road is underscored in this example. While the average percentage of cracking in the geosynthetic-stabilized test sections located in the middle of the experimental area was 8%, other test sections located on the west and east sides had significantly larger percentage of cracks.

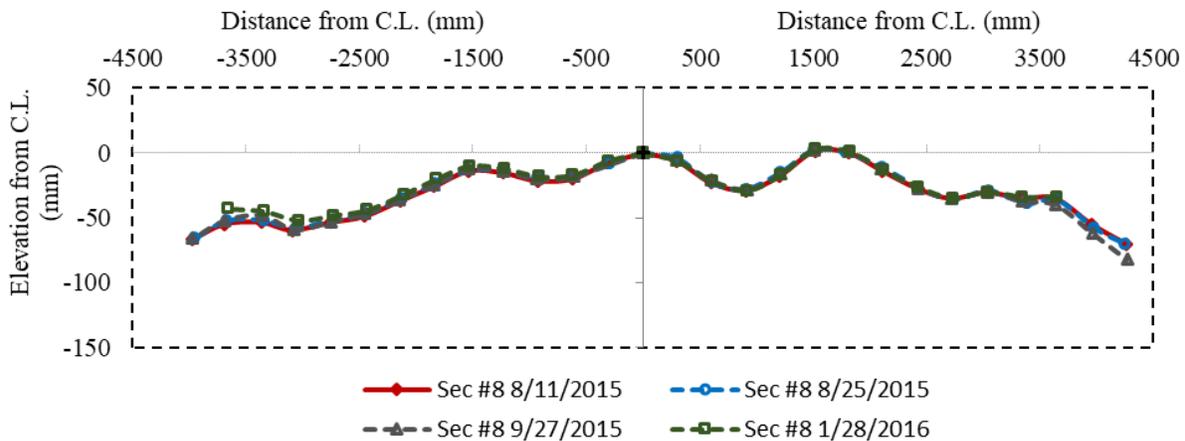
Fig. 8. Example of transverse profile of the road surface generated using total station data

After performing the total station survey, the coordinate data can be downloaded from the total station to the computer and plotted using a template created in Excel. The plots are created using the Pythagorean Theorem by subtracting the X and Y coordinates from the center point, taking the root of the squared difference, and plotting that distance with the elevation difference. The plots contain the survey results from previous site visits and are used to compare cross-section profiles over time. In addition to the plots, the slope of each side of the road is calculated and displayed in tabular form in the spreadsheet. An example of results from total station surveys is shown in Figure 8 and Table 2.

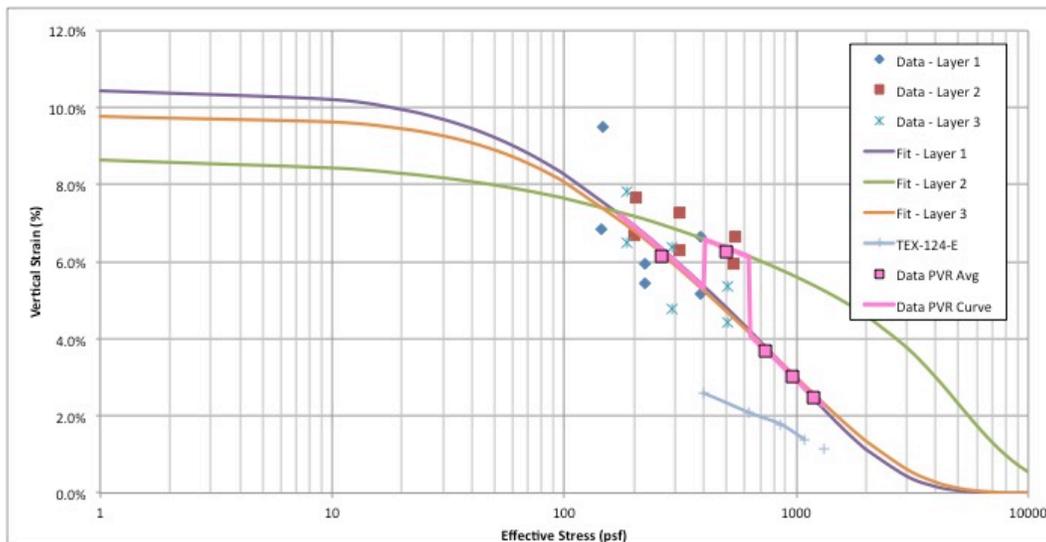
Fig. 15. Comparison of swelling curves from centrifuge data and Tex-124-E for B-04

By numerically integrating the curve-fitted function from Figure 15 using the trapezoid rule with 1,000 divisions between the top and bottom stresses of 173 and 1,311 psf, the PVR of the subgrade was determined to be 5.17 inches. For the Tex-124-E method, an Excel workbook calculated the PVR based on the input parameters from above and produced a PVR of 2.16 inches. The results for both methods, including the PVR curves—i.e. the swelling of each subgrade layer versus the original height of the subgrade layer—are shown in Figure 16, and the comparison between the cumulative PVR versus depth is shown in Table 5.

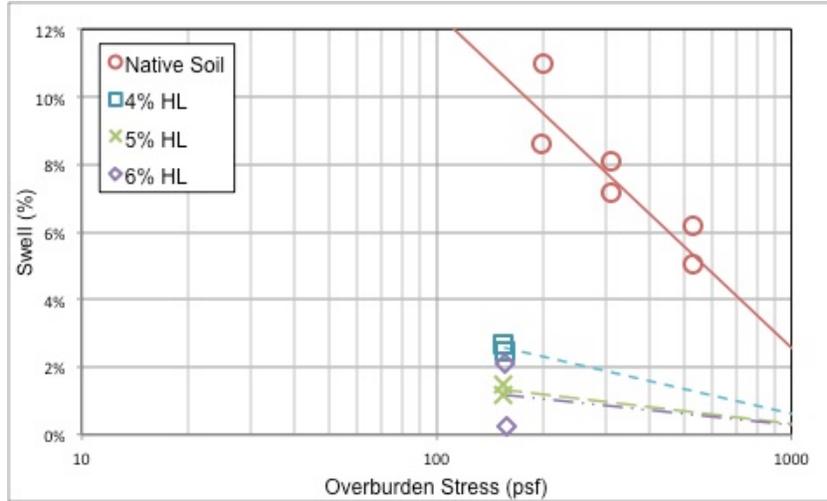
Fig. 17. Typical native and lime-treated stress-swell curves from US 87 B-02 (0.5' – 4')

Samples were taken from air-dried, processed material taken from the site. The material was moisture conditioned to the pre-determined water content, after which hydrated lime was mixed into the soil as a powder, and samples were then compacted to the target dry density. Swell testing in the centrifuge proceeded in accordance with the testing procedures. The treated PVR was then calculated according to the DMS-C procedure, substituting the stress-swell curve for the treated soil in place of the native soil for a desired depth of treatment. Figure 17 and Table 6 show some typical swelling results obtained for Boring 2 at the US 87 site (Site 13). The addition of hydrated lime was found to reduce the swelling significantly for this soil.

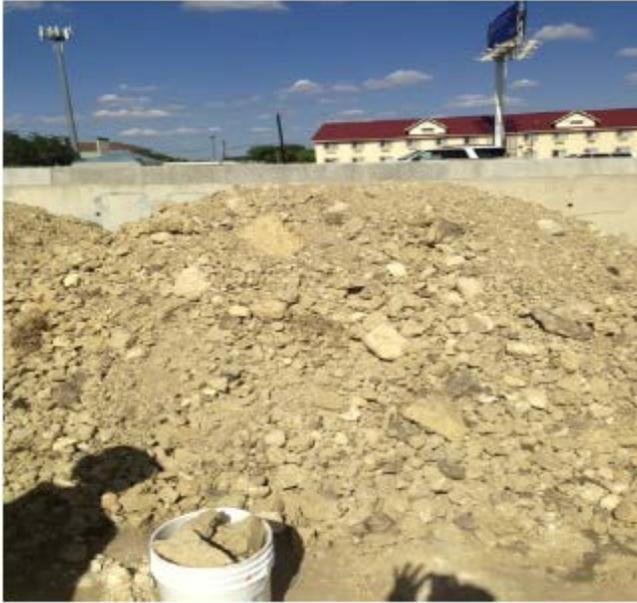
Fig. 19. Soil from stockpile sampled at Site 1

Site 1 was located at a construction area on the eastbound side of Interstate 10, between the access road and Exit 558 off-ramp. The excavation was about 10 feet wide, 20 feet long and 6-8 feet deep. A yellow-tan to grey clay layer (Del Rio Clay), extending below a depth of 2 feet in the excavation, was identified for extensive characterization and testing. Centrifuge swelling tests and soil characterization were utilized to compare the PVR using the DMS-C approach and Tex-124-E.

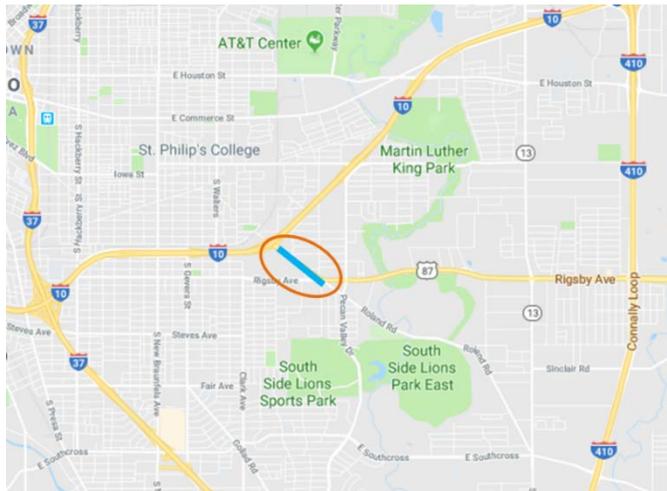
Fig. 43. US 87 site

Site 13 corresponds to a roadway rehabilitation project covering a half-mile sloping stretch. The roadway at this site exhibited extensive cracking and heaving.
