Moisture Migration in Geogrid Reinforced Expansive Subgrades

R. Gupta, University of Texas at Austin, Texas, USA
J.S. McCartney, University of Arkansas at Fayetteville, Arkansas, USA
C.L. Nogueira, Universidade Federal de Ouro Preto, Ouro Preto, Brasil
J.G. Zornberg, University of Texas at Austin, Texas USA

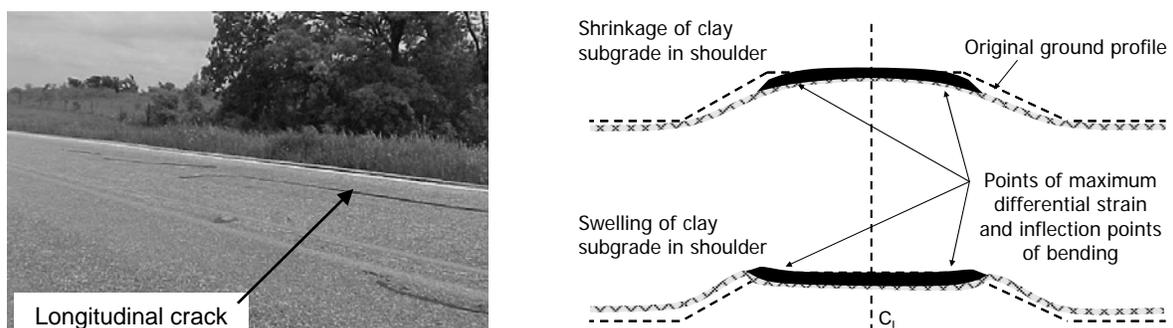
Figure 1. (a) Flexible pavement with longitudinal crack; (b) Schematic of cracking due to subgrade volume change

A strong linkage between moisture migration and longitudinal cracking has not been well established in the literature. Accordingly, the goal of this study is to investigate the migration of moisture under the pavement in order to assess the likelihood of differential shrinkage and swelling between the center and edges of the pavement. Specifically, the horizontal and vertical components of the volumetric strain due to shrinkage and swelling may impose tensile, shear, and bending stresses at the point under the pavement at which moisture does not fluctuate. An exaggerated representation of the vertical component of subgrade movement is shown in Figure 1(b). The first case shows the edges of the pavement bending downwards, as the subgrade soil in the shoulder shrinks during drying. The second case shows the edges of the pavement bending upwards as the subgrade in the shoulder swells during wetting. In both cases, differential movement between the shoulders and the centerline of the road will lead to longitudinal cracks that are closer to the edge of the pavement, similar to those observed in Figure 1(a).

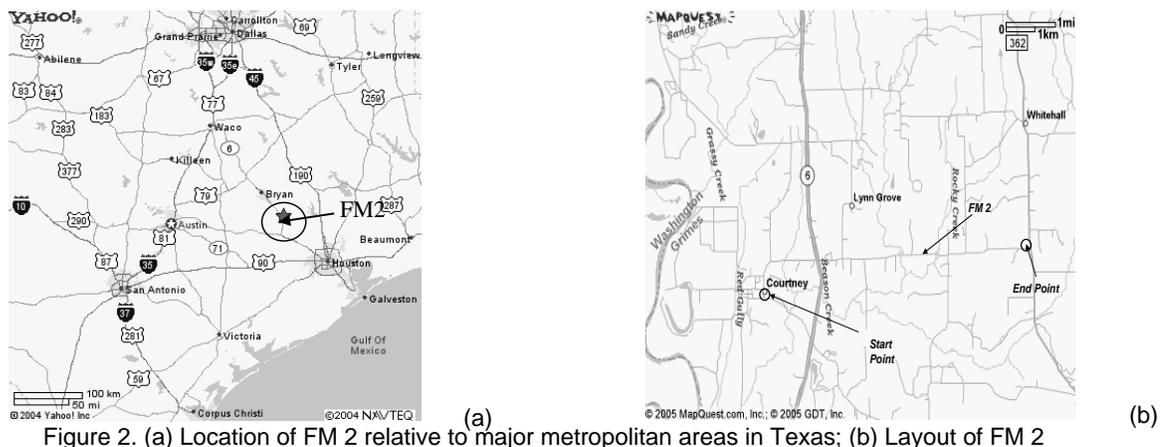
Figure 2. (a) Location of FM 2 relative to major metropolitan areas in Texas; (b) Layout of FM 2

Texas Farm-to-Market Road No.2 (FM2) is located in the Grimes County, in southeast Texas. Figure 2(a) shows FM 2 relative to major metropolitan areas in Texas. The total length of the road is 6.4 miles of which 2.4 miles lie towards the west of State Highway 6 (SH 6) at Courtney and rest 4 miles continues eastward and ends at FM 362 as shown in Figure 2(b). The average daily traffic (ADT) was 800 in 2002 and is expected to increase to 1300 vehicles in 2022. Trucks account for 6.6 percent of the ADT. The expected total number of equivalent 18-kip single axle loadings (ESAL) is 91,000 in one direction for the 20 year period from 2002 to 2022. The speed limit on FM2 is 55 miles per hour.

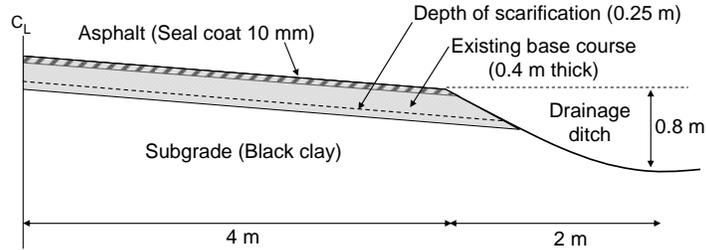
Figure 3. Original pavement cross-section at FM2 with scarification plan (not to scale)

A typical pavement cross section of the FM2 pavement before rehabilitation is shown in Figure 3. The roadway was severely deteriorated before rehabilitation, with longitudinal cracking and rutting. Degradation was likely due to both water seepage through the cracked asphalt and water infiltration into the subgrade clay. Due to the relatively thick existing base course layer (0.4 m), TxDOT decided to scarify only the top 0.25 m of this material. The proposed scarification plan for the new pavement test sections is shown in Figure 3. The roadway has a slope of 3% from the centerline to the edge of the road, and there is approximately a 0.8 m drop-off from the edge of the pavement to the trough of the drainage ditch.

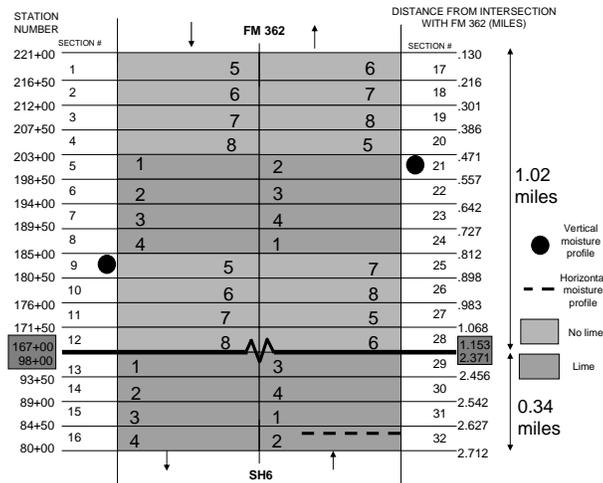
Figure 4. FM 2 layout with moisture sensor profile installation locations

The University of Texas at Austin proposed a modification to this rehabilitation program to by changing the type of geogrid at different sections, and by not using lime treatment in some of the sections. Specifically, eight test sections were proposed to investigate different types of geogrids and the use or not of lime stabilization, as summarized in Table 1. These test sections include an unreinforced section and three geosynthetic-reinforced sections. Geosynthetic types 1 and 2 are geogrids while geosynthetic type 3 is a woven geotextile. The eight pavement cross sections were repeated four times each (for a total of 32 sections) throughout the length of the road in order to account for changes in behavior due to location and environmental conditions (slope, soil conditions, vegetation). The location of the different pavement cross sections along the length of the road are shown in Figure 4. Moisture sensors were installed into the subgrade soil at several locations along FM 2 to monitor typical moisture migration patterns under the pavement and in the shoulders. This study focuses on the results from two vertical profiles of moisture sensors installed at Stations 199 and 184, and one horizontal profile installed at Station 84, as shown in Figure 4.

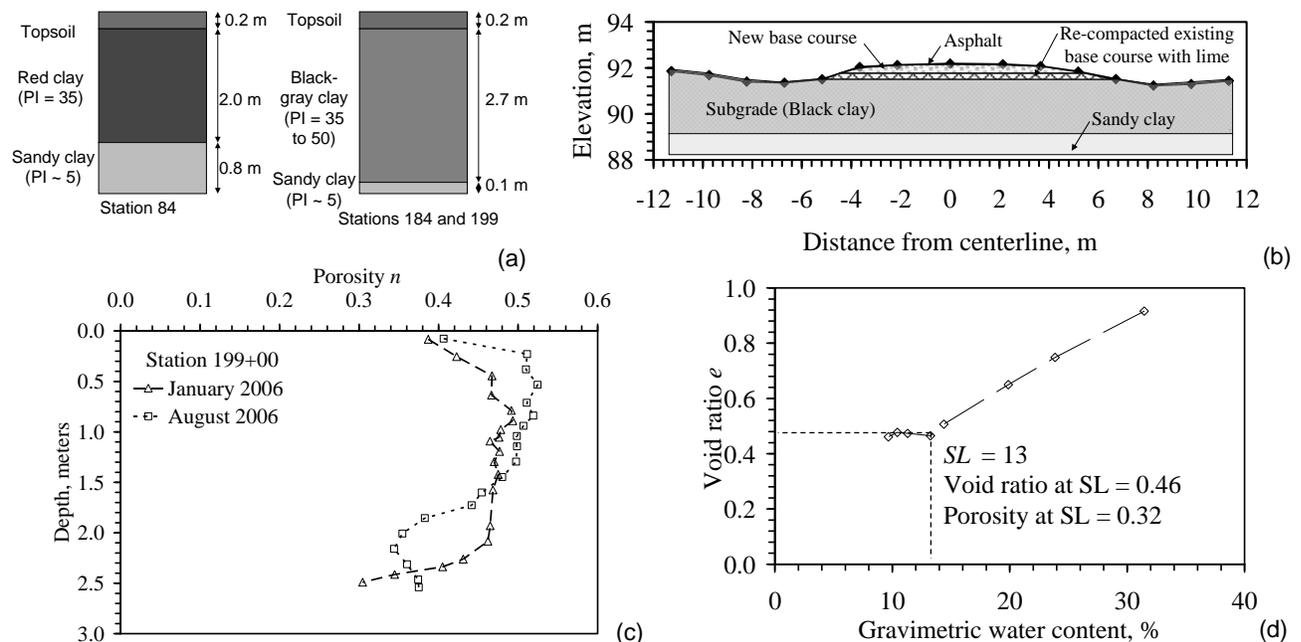
Figure 5. (a) Boring summary; (b) Elevation profile at Station 199; (c) Porosity profile; (d) Shrinkage curve

The clay subgrade at FM 2 varies along the four miles of pavement. Cores of the first 3 meters of soil were obtained at three locations. The thicknesses of the soil layers at the moisture sensor installations are shown in Figure 5(a). Two predominant clays were noted: a red clay with medium plasticity index (PI=35) and a black-gray clay with high plasticity index (PI=50). The black-gray clay is common in the Bryan district and is colloquially referred to as “Blacklands”. At the end of the borings (around 3 meters) an intact sandy clay layer was collected. A survey was conducted to obtain an elevation profile of the pavement-shoulder surface at Station 199, as shown in Figure 5(b). The soil profile at this location is also included in this figure. The seal coat of asphalt extends to ± 4.0 m and partially covers the run-out of the base course. Vertical profiles of the porosity of the black clay at Station 199 for two times during the year are shown in Figure 5(c). The average porosity (n) is 0.45 and the dry density (ρ_d) corresponding to this porosity is 1500 kg/m^3 (assuming that the soils are saturated and $G_s = 2.7$). A shrinkage curve was obtained for an intact core of the black clay, as shown in Figure 5(d). The shrinkage limit (SL) is 13.

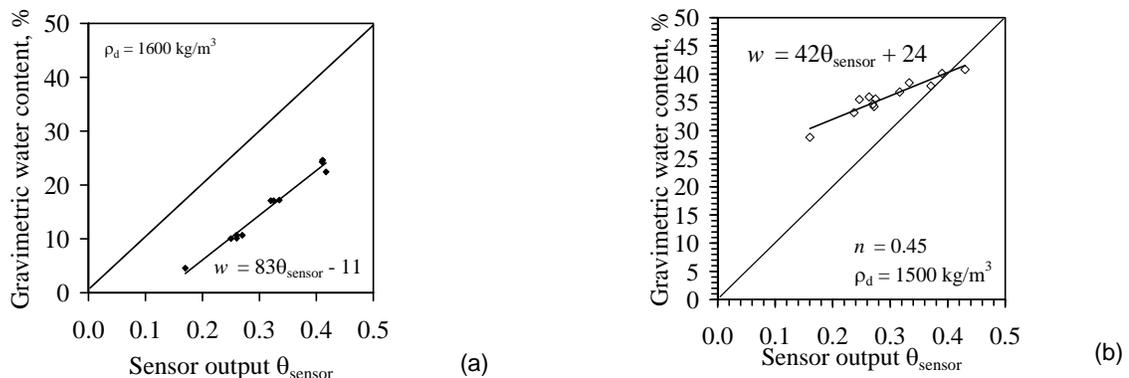
Figure 6. Moisture sensor calibration: (a) Calibration for remolded red clay; (b) Calibration for in-situ black clay

The procedures for installation were different for the horizontal and vertical arrays of sensors. The horizontal array was installed in compacted red clay, while the vertical arrays were installed in quasi-undisturbed conditions. Accordingly, the moisture sensors were calibrated for compacted red clay in the lab, and separately for the black clay in-situ. A barrel of red clay was dried in the lab and several 3 kg samples were conditioned to a range of gravimetric water contents expected in the field (5 to 25%). Specimens of the red clay were compacted to a dry density (ρ_d) of 1600 kg/m^3 in a rectangular mold sized to fit the sensor with 30 mm of clearance on each side. A piston compactor was used to control the energy imparted to the soil during compaction, and the moisture sensor was placed into the middle of three lifts. After compaction, a measurement was made with the moisture sensor. The relationship between the gravimetric water content of the red clay and the sensor reading is shown in Figure 6(a). In a strict sense, this calibration curve is valid for the unsaturated red clay at this particular dry density. Accordingly, it may not provide the exact water content for the clay after swelling or shrinkage occurs. Nonetheless, this calibration equation provides a first estimate of the water content in the subgrade. For the black clay, the sensor output was correlated with the gravimetric water content of a sample of soil obtained from the location at which the moisture sensor was installed, as shown in Figure 6(b). The average porosity and dry density from the borings that were conducted at the time of installation are also shown. A linear calibration equation was obtained for this soil, falling above the 1:1 line. The range in gravimetric water content of 29 to 41 shown in this figure reflects the initial gravimetric water content during installation of the moisture sensors. This calibration curve also includes data from sensors from arrays at other locations in the black clay that are not discussed in this paper.

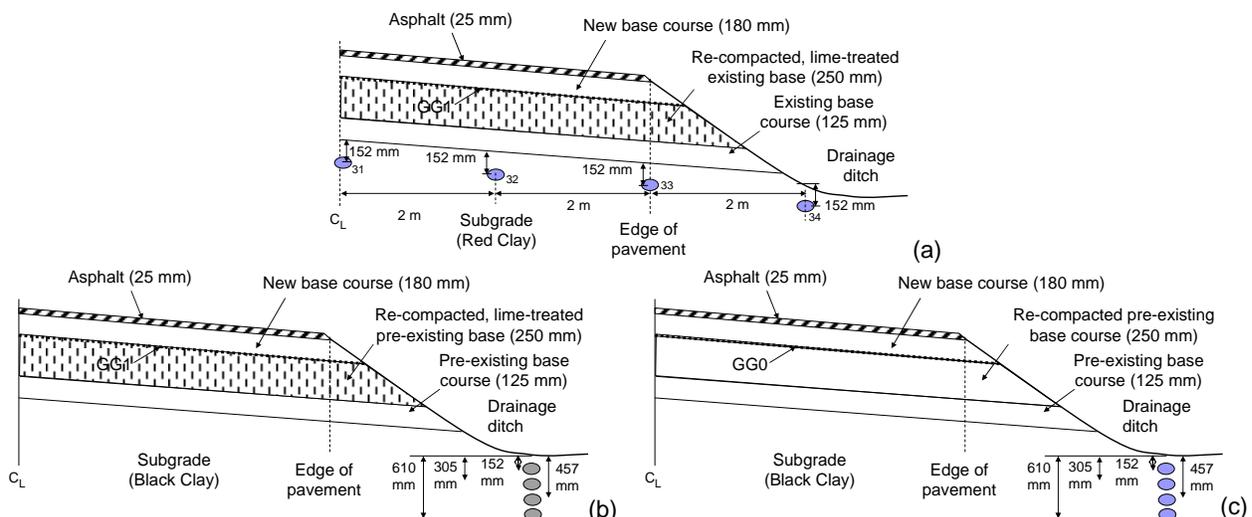
Figure 7. Sensors: (a) Horizontal array at Station 84; (b) Vertical array at Station 184; (c) Vertical array at Station 199

The pavement profile and horizontal sensor locations at Station 84 are shown in Figure 7(a), while those for the vertical profiles at Stations 184 and 199 are shown in Figures 7(b) and 7(c). The low hydraulic conductivity of the asphalt seal coat ($<10^{-9} \text{ m/s}$) and the slope of the roadway indicate that rainfall onto the pavement will runoff into the drainage ditch, so it is considered impermeable. The drainage ditch is assumed to be the primary infiltration pathway into the subgrade. The horizontal array of sensors is useful to assess the movement of water under the road, while the vertical arrays are useful to assess moisture fluctuations in the soil profile without the influence of the pavement boundary.

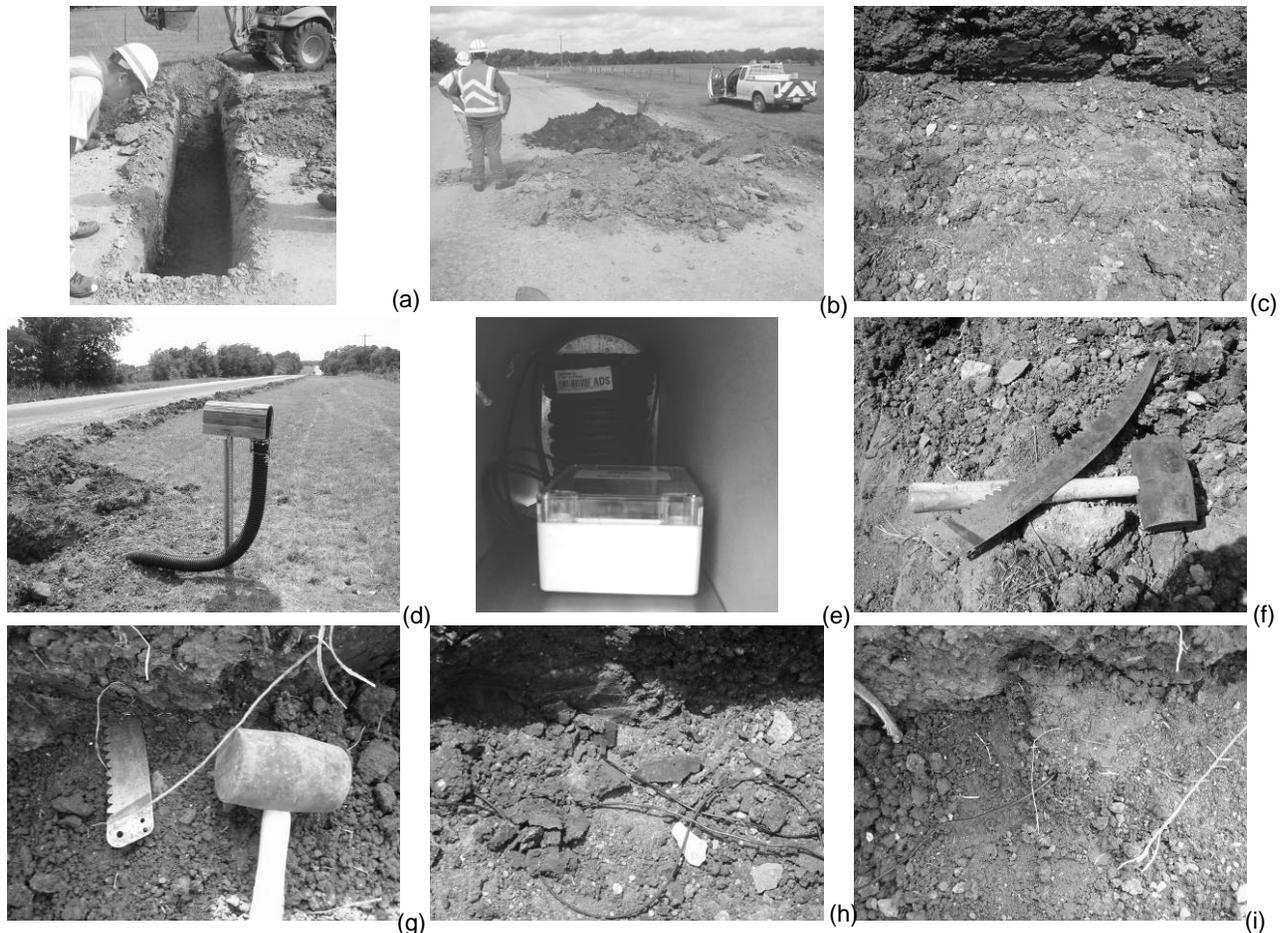
Figure 8. Moisture sensor installation procedures: (a) Trenching; (b) Separation of base and subgrade; (c) Leveling of installation site; (d) Protective tubing and datalogger containment system; (e) Datalogger; (f) Tools for pre-insertion of sensor; (g) Pre-insertion; (h) Installed sensor; (i) Compaction near sensor head

The moisture sensors in the horizontal array at Station 84 were installed in remolded soil (consistent with the calibration). For this location, a trench perpendicular to the direction of the road was excavated through one of the lanes using a backhoe [Figure 8(a)]. Care was taken to separate the base course and the subgrade for later replacement of the road section [Figure 8(b)]. The soil was leveled at the sensor locations [Figure 8(c)], the sensors were placed as indicated in Figure 7(a), and the subgrade was carefully backfilled around the sensors. The sensor cables were passed through a corrugated plastic tube to a mailbox containment system [Figure 8(d)]. The cables were connected to a datalogger inside the mailbox containment system for easy access [Figure 8(e)]. The moisture sensors in the vertical sensor arrays at Stations 184 and 199 were installed into intact soil by creating a pilot hole for the sensor. After digging a 0.75 m deep hole at the monitoring location, a saw blade was used to create a small slit into the soil using several blows from a rubber mallet [Figure 8(d) and 8(e)]. After carefully removing the saw blade, the moisture sensor was inserted into the slit, and soil was backfilled over the sensor end [Figure 8(f) and 8(g)]. The subgrade was then backfilled into the hole and compacted by hand using the hammer.

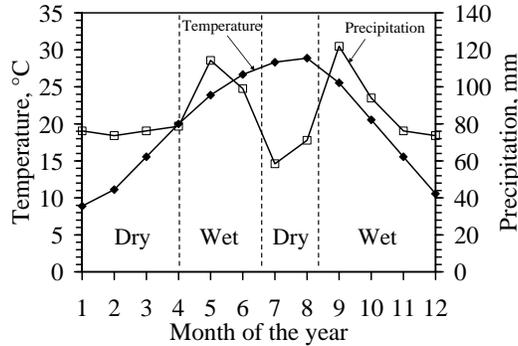
Figure 9. Average monthly climate data based on 30 years of weather records from College Station

Although the closest weather station to the site is at Hempstead, approximately 3 miles from the road, this weather station has only been in operation since January 2006. Accordingly, the historic weather patterns were obtained from a weather station located in College Station, which is also in the Bryan district of Texas. The monthly average records of temperature and precipitation for last 30 years in College Station (WSI Corporation 2005) are shown in Figure 9. The average high temperature was around 36 °C in August and average low temperature was 3 °C in January. The average annual precipitation was calculated to be 1013 mm, with high rainfall amounts in May, June, September and October. The site has two dry seasons in a year divided by two rainy seasons.

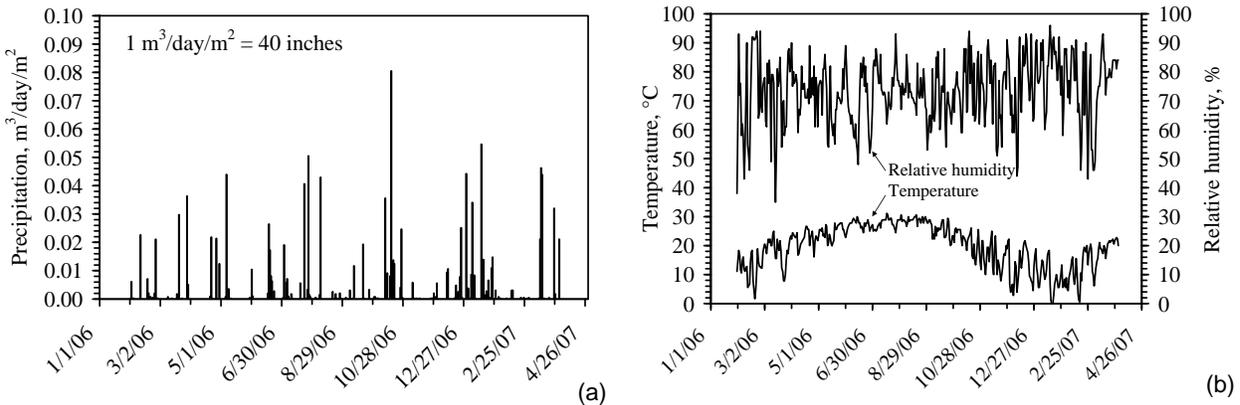
Figure 10. Weather data at Hempstead: (a) Precipitation data; (b) Temperature and relative humidity data

Daily weather data from the station in Hempstead, TX was more useful for day-to-day assessment of the environmental conditions at the FM2 site. The precipitation is shown in Figure 10(a). This figure indicates that periods of intense rain occurred between October and February of 2006, while periods of little rainfall were observed in the late spring and late summer. This is consistent with the pattern of two wet and two dry seasons shown in Figure 9. The temperature and relative humidity at Hempstead are shown in Figure 10(b). This figure indicates that the relative humidity fluctuates between 50 and 92%, while the temperature ranges from 0 to 31 °C.

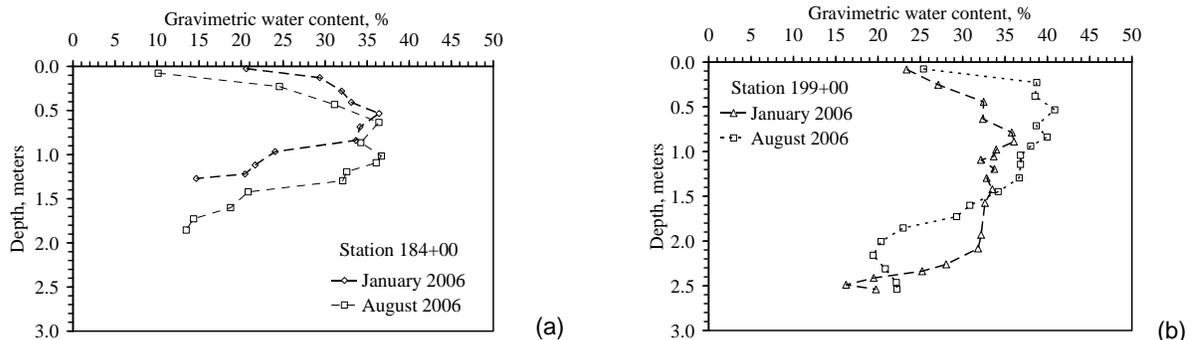
Figure 11. Gravimetric water content profiles from the boreholes: (a) Station 184; (b) Station 199

The samples obtained from split-tube samples during the borings were used to determine the in-situ water content profiles at different times of the year. The gravimetric water content profiles at the times of two different borings are shown in Figure 11(a) and 11(b) for Stations 184 and 199. The soil has a relatively dry surface layer (with $w < SL$), likely due to the onset of a dry period. However, the gravimetric water content values deeper in the profiles from January 2006 are representative of relatively dry conditions, while the profiles from August are representative of relatively wet conditions. However, the gravimetric water content difference is not significantly different for the two periods.

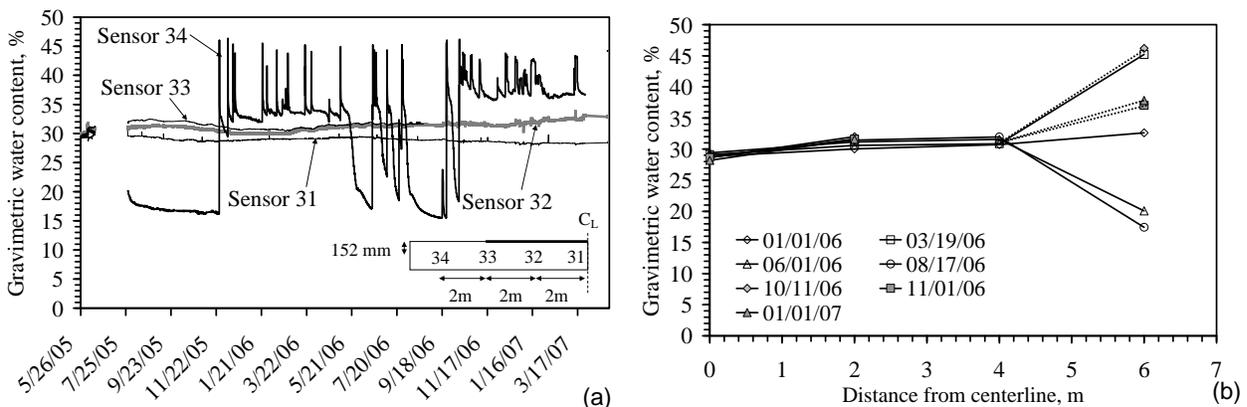
Figure 12. Moisture data for Station 84 (red clay): (a) Time series for each sensor; (b) Horizontal moisture isochrones

The monitoring results for the horizontal array at Station 84 are shown in Figure 12(a). The installation time for Station 84 was May 26, 2005, which was before the roadway had been rehabilitated (construction finished in fall 2005). The datalogger did not start working consistently until July 28, 2005 due to an issue with the batteries. Discussion with the site operators indicates that the site was relatively dry during construction in the summer of 2005. This dry period is reflected in the significant drop in gravimetric water content measured by Sensor 34 in the drainage ditch. The shrinkage curve for this soil was not obtained, but a gravimetric water content of 20% during this dry period is likely close to the shrinkage limit. After December of 2005, the moisture sensor 34 in the ditch showed significant fluctuations in water content, ranging from 16% to 46%. However, the water content inferred by the three sensors under the road was about 30% and did not fluctuate. A slight increase in water content was observed by the sensors under the pavement, likely due to spatial equilibration of gravimetric water content after construction. Despite the difference in moisture fluctuations between the subgrade in the drainage ditch and that under the pavement, no longitudinal cracks have been observed to date. This location is geogrid-reinforced, and the base course is lime treated, so the pavement is relatively stiff. As the soil at this location is relatively wet under the pavement, an extended dry period would be required to cause different movement. However, there has not been an extended dry period in the time since construction.

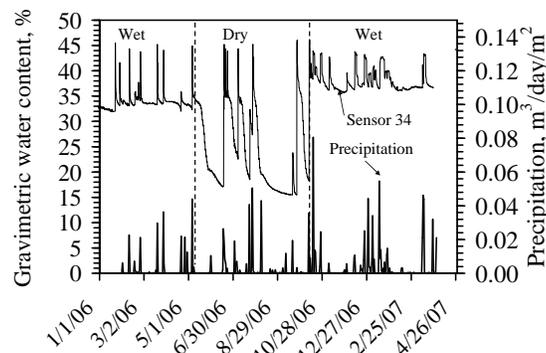
Figure 13. Comparison between gravimetric water content in the drainage ditch with precipitation (Station 84)

A comparison between the precipitation and the gravimetric water content at the shoulder of Station 84 is shown in Figure 13. The spikes in water content in the clay in the drainage ditch are generally consistent with the timing of rainfall events at Hempstead (5 miles from FM2), although there are some obvious inconsistencies (10/20/2006). There was a dry period in the summer of 2006 during which the soil dried, but the rest of 2006 and 2007 were relatively wet.

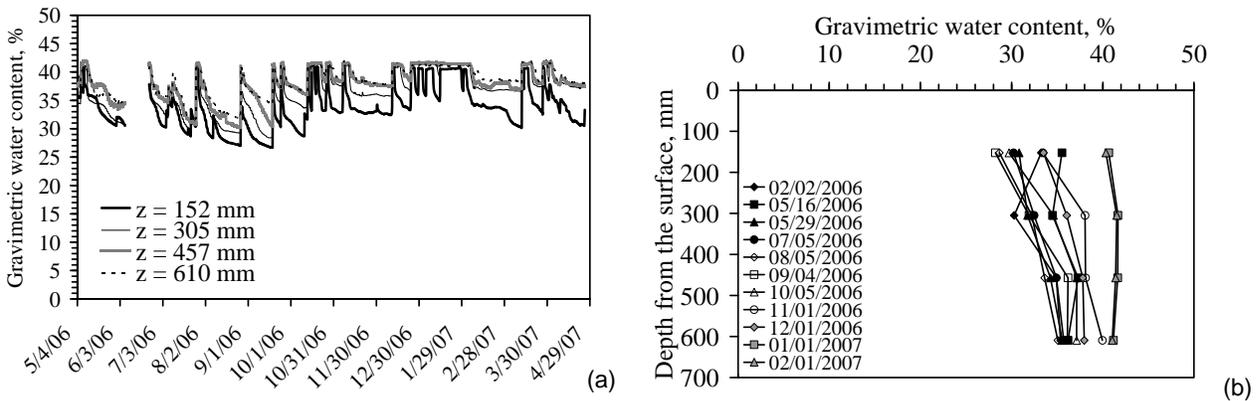
Figure 14. Gravimetric water content data for Station 184: (a) Time series for each sensor; (b) Isochrones

Horizontal moisture sensor arrays were also installed under the road at several other locations, but the installations were damaged by lawnmowers and rodents. Accordingly vertical arrays of sensors were installed in the drainage ditch at Stations 184 and 199 one year after the installation of the sensors at Station 84. These installations were installed to infer the range of water contents in the field, as well as the rate of movement of wetting or drying fronts in the subgrade under the shoulder. The time series for the sensors at Station 184 are shown in Figure 14(a), and vertical moisture profiles at different times are shown in Figure 14(b). The water content at this location was observed to vary between

26% and 43%, consistently above the shrinkage limit (13). In particular, the sensor at 610 mm routinely showed an increase in water content of 5% in the period of 2-3 days. Using the saturated hydraulic conductivity (k_s) obtained in the laboratory, this travel time is associated with a gradient of 3400 [$i = d/(k_s t)$]. This high gradient is due to wetting of a relatively dry soil. A longer time is required for the soil to dry than to wet, as the hydraulic conductivity of unsaturated soil is less than saturated soil, and as the gradient due to evapotranspiration is lower than that associated with wetting of a dry soil. The surface of the soil shows a wider variation in water content than deeper in the profile. This location has no shade from trees, so dry conditions are expected.

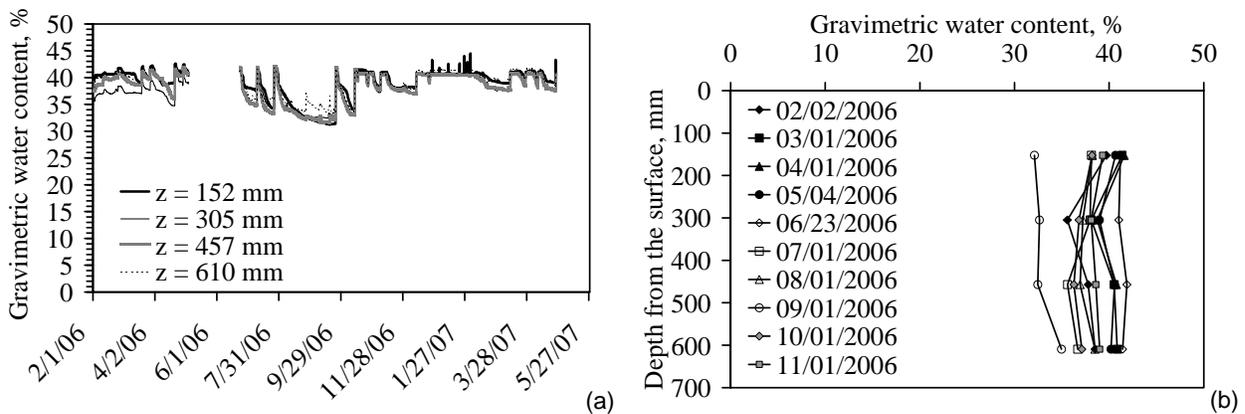
Figure 15. Gravimetric water content data for Station 199: (a) Time series for each sensor; (b) Isochrones

The gravimetric water content time series for the vertical array of sensors at Station 199 is shown in Figure 15(a), and selected moisture profiles are shown in Figure 15(b). All the sensors showed similar trend in gravimetric water content with time. The gravimetric water content was observed to vary between 30% and 43%. This location is shaded by trees, and ponded water was routinely observed during most field trips to the site, which indicates why the subgrade in the drainage ditch did not reach as low of gravimetric content values as that at Station 184.

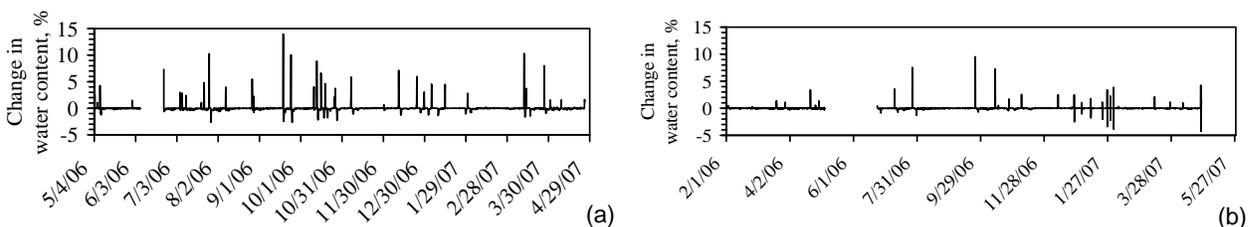
Figure 16. Change in water content of the surface sensor (152 mm): (a) Station 184; (b) Station 199

The daily changes in gravimetric water content for Stations 184 and 199 are shown in Figures 16(a) and 16(b). Positive increases in water content of 14% were observed during the course of a day, during heavy rainfall (with ponding) occurring after a dry period. However, significant negative changes in gravimetric water content are less likely (e.g., less than 3% changes in water content were observed in a day) due to the lower hydraulic conductivity of unsaturated soils.

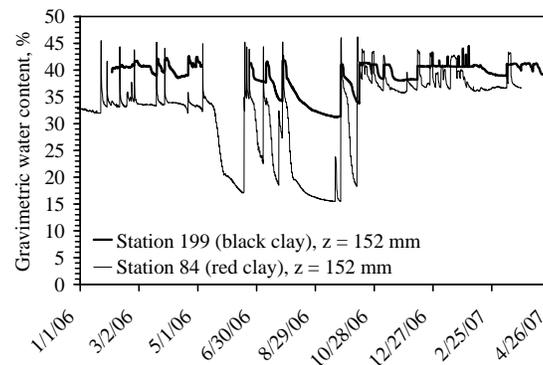
Figure 17. Comparisons between surface gravimetric water content measurements in the drainage ditch

A comparison between the gravimetric water content measured by the sensors closest to the ground surface in the drainage ditch at Stations 84 and 199 is shown in Figure 17. The timing of the changes in water content is similar for the two sites, despite the different soil types. The magnitude of moisture variation is similar for the two sites, with large changes in gravimetric water content occurring over the period of several days.
